Access Compliance Report

Public Rights-of-Way

(Island Curb Cuts)

Intersection ID: 25147	Main Street: CARMEL_ESTATES_RD	Cross Street: REA_RD	Location:	N
ADA ID: 8AF6D608DA35	Curb Cut Type: MedianRefuge2	Initial Pass/Fail: Fail	Overall Compliance: No	Severity Score: 12.5
Codes/Mitigation Info/Possible Solution		Field Measurements/Component Compliance

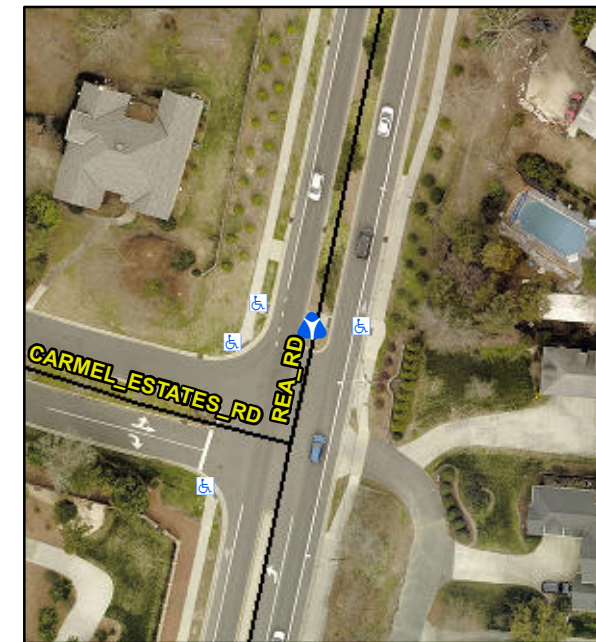
Compliance	Description	Data	Compliance	Description	Data
Yes	Refuge 1 Length (In)	76.5	N/A	Gutter 1 Ponding?	N/A
Yes	Refuge 1 Width (In)	66.5	N/A	Gutter 1 Lip Ht (In)	N/A
Yes	Refuge 1 Slope (%)	2.0	N/A	Gutter 1 Slope (%)	N/A
Yes	Refuge 1 X Slope (%)	3.9	N/A	Gutter 1 X Slope (%)	N/A
N/A	Painted X Walk1?	No	N/A	DWS 1 Provided?	N/A
N/A	X Walk 1 Direction	To W	N/A	DWS 1 Contrast?	N/A
N/A	X Walk 1 Width (In)	N/A	N/A	DWS 1 Length (In)	N/A
N/A	Road 1 Slope (%)	4.9	N/A	DWS 1 Full Width?	N/A
N/A	Road 1 X Slope (%)	1.8	N/A	DWS 1 Offset (In)	N/A
Yes	Refuge 2 Length (In)	76.5	N/A	Gutter 2 Ponding?	N/A
Yes	Refuge 2 Width (In)	66.5	N/A	Gutter 2 Lip Ht (In)	N/A
Yes	Refuge 2 Slope (%)	0.2	N/A	Gutter 2 Slope (%)	N/A
No	Refuge 2 X Slope (%)	6.0	N/A	Gutter 2 X Slope (%)	N/A
N/A	Painted X Walk2?	No	N/A	DWS 2 Provided?	N/A
N/A	X Walk 2 Direction	To E	N/A	DWS 2 Contrast?	N/A
N/A	X Walk 2 Width (In)	N/A	N/A	DWS 2 Length (In)	N/A

N/A	Road 2 Slope (%)	4.9	N/A	DWS 2 Full Width?	N/A
N/A	Road 2 X Slope (%)	1.3	N/A	DWS 2 Offset (In)	N/A
N/A	Refuge 3 Length (in)	N/A	N/A	Gutter 3 Ponding?	N/A
N/A	Refuge 3 Width (in)	N/A	N/A	Gutter 3 Lip Ht (in)	N/A
N/A	Refuge 3 Slope (%)	N/A	N/A	Gutter 3 Slope (%)	N/A
N/A	Refuge 3 XSlope (%)	N/A	N/A	Gutter 3 XSlope (%)	N/A
N/A	Painted X Walk3?	N/A	N/A	DWS 3 Provided?	N/A
N/A	X Walk 3 Direction	N/A	N/A	DWS 3 Contrast?	N/A
N/A	X Walk 3 Width (in)	N/A	N/A	DWS 3 Length (in)	N/A
N/A	Road 3 Slope (%)	N/A	N/A	DWS 3 Full Width?	N/A
N/A	Road 3 XSlope (%)	N/A	N/A	DWS 3 Offset (in)	N/A
Yes	Any Obstructions?	N/A	N/A	Storm Grate/Utility Hazard?	N/A
N/A	Obstruction Type		N/A	Storm Grate/Utility Type	
		N/A			N/A
N/A	Surface Condition	Good

Remove & Replace Entire Refuge.
