Access Compliance Report

Public Rights-of-Way

(Island Curb Cuts)

Intersection ID: 13936	Main Street: S_KINGS_DR	Cross Street: CHARLOTTETOWNE_AV	Location: NW
ADA ID: 8AFF6D069789	Curb Cut Type: MedianRefuge2	Initial Pass/Fail: Fail	Overall Compliance: No
Severity Score: 12.5			
Codes/Mitigation Info/Possible Solution		Field Measurements/Component Compliance

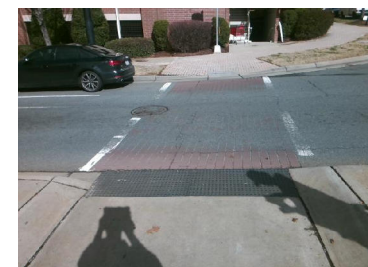
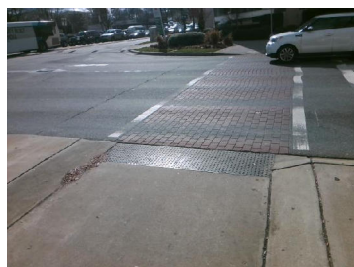
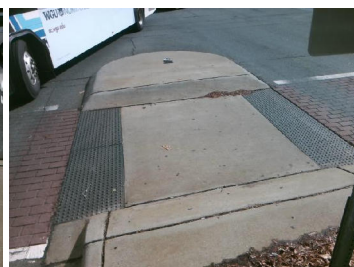
Compliance	Description	Data	Compliance	Description	Data
Yes	Refuge 1 Length (In)	66.0	N/A	Gutter 1 Ponding?	N/A
Yes	Refuge 1 Width (In)	95.0	N/A	Gutter 1 Lip Ht (In)	N/A
Yes	Refuge 1 Slope (%)	0.3	N/A	Gutter 1 Slope (%)	N/A
No	Refuge 1 X Slope (%)	5.7	N/A	Gutter 1 X Slope (%)	N/A
N/A	Painted X Walk1?	Yes	N/A	DWS 1 Provided?	N/A
N/A	X Walk 1 Direction	To NE	N/A	DWS 1 Contrast?	N/A
N/A	X Walk 1 Width (In)	113.0	N/A	DWS 1 Length (In)	N/A
N/A	Road 1 Slope (%)	4.9	N/A	DWS 1 Full Width?	N/A
N/A	Road 1 X Slope (%)	2.3	N/A	DWS 1 Offset (In)	N/A
Yes	Refuge 2 Length (In)	66.0	N/A	Gutter 2 Ponding?	N/A
Yes	Refuge 2 Width (In)	95.0	N/A	Gutter 2 Lip Ht (In)	N/A
Yes	Refuge 2 Slope (%)	0.9	N/A	Gutter 2 Slope (%)	N/A
Yes	Refuge 2 X Slope (%)	4.2	N/A	Gutter 2 X Slope (%)	N/A
N/A	Painted X Walk2?	Yes	N/A	DWS 2 Provided?	N/A
N/A	X Walk 2 Direction	To SW	N/A	DWS 2 Contrast?	N/A
N/A	X Walk 2 Width (In)	112.0	N/A	DWS 2 Length (In)	N/A

N/A	Road 2 Slope (%)	4.6	N/A	DWS 2 Full Width?	N/A
N/A	Road 2 X Slope (%)	1.8	N/A	DWS 2 Offset (In)	N/A
N/A	Refuge 3 Length (in)	N/A	N/A	Gutter 3 Ponding?	N/A
N/A	Refuge 3 Width (in)	N/A	N/A	Gutter 3 Lip Ht (in)	N/A
N/A	Refuge 3 Slope (%)	N/A	N/A	Gutter 3 Slope (%)	N/A
N/A	Refuge 3 XSlope (%)	N/A	N/A	Gutter 3 XSlope (%)	N/A
N/A	Painted X Walk3?	N/A	N/A	DWS 3 Provided?	N/A
N/A	X Walk 3 Direction	N/A	N/A	DWS 3 Contrast?	N/A
N/A	X Walk 3 Width (in)	N/A	N/A	DWS 3 Length (in)	N/A
N/A	Road 3 Slope (%)	N/A	N/A	DWS 3 Full Width?	N/A
N/A	Road 3 XSlope (%)	N/A	N/A	DWS 3 Offset (in)	N/A
Yes	Any Obstructions?	N/A	N/A	Storm Grate/Utility Hazard?	N/A
N/A	Obstruction Type		N/A	Storm Grate/Utility Type	
		N/A			N/A
N/A	Surface Condition	Good

Remove & Replace Entire Refuge.
