Access Compliance Report

Public Rights-of-Way

(Island Curb Cuts)

Intersection ID: 18567	Main Street: MICHAEL_BAKER_PL	Cross Street: RUNNYMEDE_LN	Location: W
ADA ID: 8D1742067015	Curb Cut Type: MedianRefuge2	Initial Pass/Fail: Fail	Overall Compliance: No
Codes/Mitigation Info/Possible Solution		Field Measurements/Component Compliance

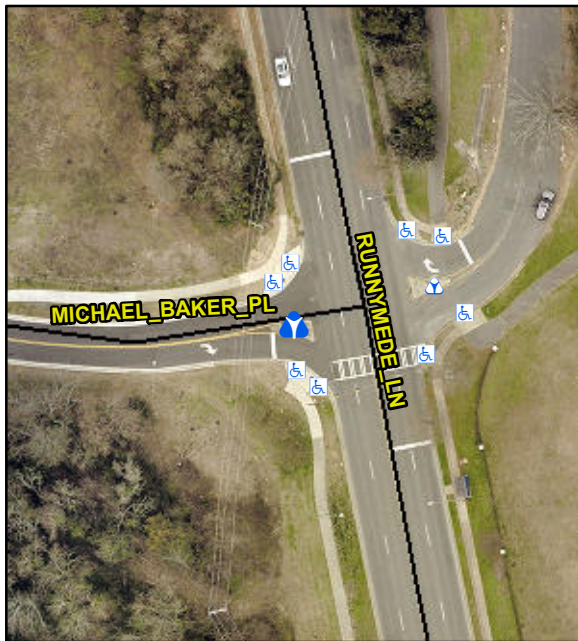
Compliance	Description	Data	Compliance	Description	Data
No	Refuge 1 Length (In)	24.0	N/A	Gutter 1 Ponding?	N/A
Yes	Refuge 1 Width (In)	72.0	N/A	Gutter 1 Lip Ht (In)	N/A
Yes	Refuge 1 Slope (%)	1.8	N/A	Gutter 1 Slope (%)	N/A
No	Refuge 1 X Slope (%)	5.3	N/A	Gutter 1 X Slope (%)	N/A
N/A	Painted X Walk1?	No	N/A	DWS 1 Provided?	N/A
N/A	X Walk 1 Direction	To SE	N/A	DWS 1 Contrast?	N/A
N/A	X Walk 1 Width (In)	N/A	N/A	DWS 1 Length (In)	N/A
N/A	Road 1 Slope (%)	2.9	N/A	DWS 1 Full Width?	N/A
N/A	Road 1 X Slope (%)	6.8	N/A	DWS 1 Offset (In)	N/A
No	Refuge 2 Length (In)	24.0	N/A	Gutter 2 Ponding?	N/A
Yes	Refuge 2 Width (In)	72.0	N/A	Gutter 2 Lip Ht (In)	N/A
Yes	Refuge 2 Slope (%)	2.9	N/A	Gutter 2 Slope (%)	N/A
No	Refuge 2 X Slope (%)	6.5	N/A	Gutter 2 X Slope (%)	N/A
N/A	Painted X Walk2?	No	N/A	DWS 2 Provided?	N/A
N/A	X Walk 2 Direction	To NW	N/A	DWS 2 Contrast?	N/A
N/A	X Walk 2 Width (In)	N/A	N/A	DWS 2 Length (In)	N/A

N/A	Road 2 Slope (%)	3.8	N/A	DWS 2 Full Width?	N/A
N/A	Road 2 X Slope (%)	2.0	N/A	DWS 2 Offset (In)	N/A
N/A	Refuge 3 Length (in)	N/A	N/A	Gutter 3 Ponding?	N/A
N/A	Refuge 3 Width (in)	N/A	N/A	Gutter 3 Lip Ht (in)	N/A
N/A	Refuge 3 Slope (%)	N/A	N/A	Gutter 3 Slope (%)	N/A
N/A	Refuge 3 XSlope (%)	N/A	N/A	Gutter 3 XSlope (%)	N/A
N/A	Painted X Walk3?	N/A	N/A	DWS 3 Provided?	N/A
N/A	X Walk 3 Direction	N/A	N/A	DWS 3 Contrast?	N/A
N/A	X Walk 3 Width (in)	N/A	N/A	DWS 3 Length (in)	N/A
N/A	Road 3 Slope (%)	N/A	N/A	DWS 3 Full Width?	N/A
N/A	Road 3 XSlope (%)	N/A	N/A	DWS 3 Offset (in)	N/A
Yes	Any Obstructions?	N/A	N/A	Storm Grate/Utility Hazard?	N/A
N/A	Obstruction Type		N/A	Storm Grate/Utility Type	
		N/A			N/A
N/A	Surface Condition	Good

Possible Solutions:

Remove & Replace Entire Refuge.
