Access Compliance Report

Public Rights-of-Way

(Island Curb Cuts)

Intersection ID: 51243	Main Street: NORTHCREST SHOPPING CENTER DR	Access Street: W W T HARRIS BV	Location: NE
ADA ID: 8DB963D6ECF1	Curb Cut Type: IslandRefuge3	Initial Pass/Fail: Fail	Overall Compliance: No
Severity Score: 36.25			
Codes/Mitigation Info/Possible Solution		Field Measurements/Component Compliance

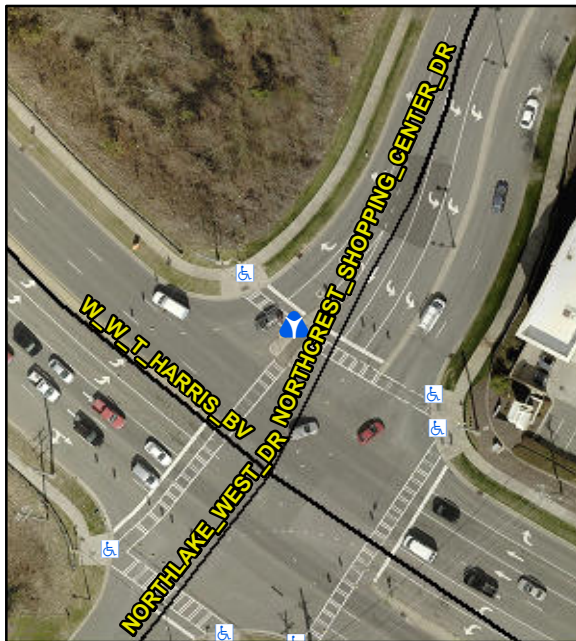
Compliance	Description	Data	Compliance	Description	Data
Yes	Refuge 1 Length (In)	37.0	N/A	Gutter 1 Ponding?	N/A
Yes	Refuge 1 Width (In)	70.0	N/A	Gutter 1 Lip Ht (In)	N/A
Yes	Refuge 1 Slope (%)	2.0	N/A	Gutter 1 Slope (%)	N/A
Yes	Refuge 1 X Slope (%)	1.8	N/A	Gutter 1 X Slope (%)	N/A
N/A	Painted X Walk1?	Yes	N/A	DWS 1 Provided?	N/A
N/A	X Walk 1 Direction	To SE	N/A	DWS 1 Contrast?	N/A
N/A	X Walk 1 Width (In)	74.0	N/A	DWS 1 Length (In)	N/A
N/A	Road 1 Slope (%)	2.9	N/A	DWS 1 Full Width?	N/A
N/A	Road 1 X Slope (%)	0.0	N/A	DWS 1 Offset (In)	N/A
Yes	Refuge 2 Length (In)	183.0	N/A	Gutter 2 Ponding?	N/A
Yes	Refuge 2 Width (In)	70.0	N/A	Gutter 2 Lip Ht (In)	N/A
Yes	Refuge 2 Slope (%)	2.3	N/A	Gutter 2 Slope (%)	N/A
Yes	Refuge 2 X Slope (%)	2.6	N/A	Gutter 2 X Slope (%)	N/A
N/A	Painted X Walk2?	Yes	N/A	DWS 2 Provided?	N/A
N/A	X Walk 2 Direction	To SW	N/A	DWS 2 Contrast?	N/A
N/A	X Walk 2 Width (In)	77.0	N/A	DWS 2 Length (In)	N/A

N/A	Road 2 Slope (%)	2.2	N/A	DWS 2 Full Width?	N/A
N/A	Road 2 X Slope (%)	4.6	N/A	DWS 2 Offset (In)	N/A
Yes	Refuge 3 Length (in)	51.5	N/A	Gutter 3 Ponding?	N/A
Yes	Refuge 3 Width (in)	70.0	N/A	Gutter 3 Lip Ht (in)	N/A
Yes	Refuge 3 Slope (%)	0.8	N/A	Gutter 3 Slope (%)	N/A
Yes	Refuge 3 XSlope (%)	3.6	N/A	Gutter 3 XSlope (%)	N/A
N/A	Painted X Walk3?	Yes	N/A	DWS 3 Provided?	N/A
N/A	X Walk 3 Direction	To NW	N/A	DWS 3 Contrast?	N/A
N/A	X Walk 3 Width (in)	75.0	N/A	DWS 3 Length (in)	N/A
N/A	Road 3 Slope (%)	3.4	N/A	DWS 3 Full Width?	N/A
N/A	Road 3 XSlope (%)	1.2	N/A	DWS 3 Offset (in)	N/A
Yes	Any Obstructions?	N/A	N/A	Storm Grate/Utility Hazard?	N/A
N/A	Obstruction Type		N/A	Storm Grate/Utility Type	
			N/A		N/A
N/A	Surface Condition	Good

Possible Solutions:

Remove & Replace Entire Refuge.

Total Cost: \$ 3000.00
