# Access Compliance Report

## Public Rights-of-Way

### (Island Curb Cuts)

Intersection ID: 10040084	Main Street: TUCKASEEGEE_RD	Cross Street: N/A	Location: S
ADA ID: 8E22188EB79F	Curb Cut Type: MedianRefuge2	Initial Pass/Fail: Fail	Overall Compliance: No
Codes/Mitigation Info/Possible Solution		Field Measurements/Component Compliance

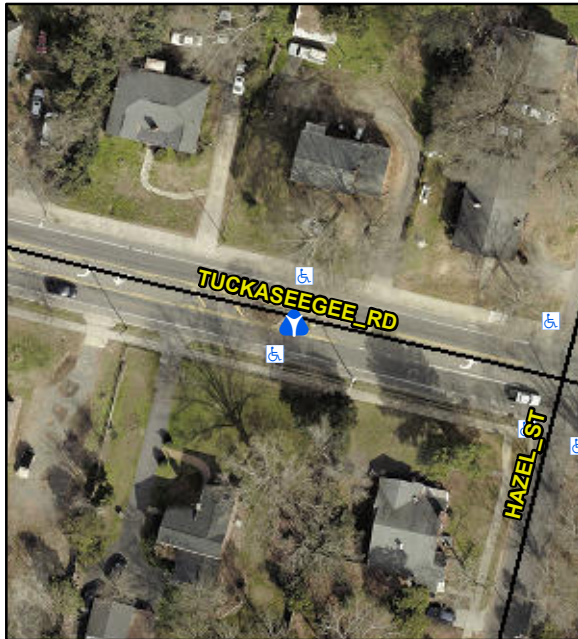
Compliance	Description	Data	Compliance	Description	Data
Yes	Refuge 1 Length (In)	61.5	N/A	Gutter 1 Ponding?	N/A
Yes	Refuge 1 Width (In)	117.0	N/A	Gutter 1 Lip Ht (In)	N/A
No	Refuge 1 Slope (%)	5.4	N/A	Gutter 1 Slope (%)	N/A
Yes	Refuge 1 X Slope (%)	2.2	N/A	Gutter 1 X Slope (%)	N/A
N/A	Painted X Walk1?	No	N/A	DWS 1 Provided?	N/A
N/A	X Walk 1 Direction	To S	N/A	DWS 1 Contrast?	N/A
N/A	X Walk 1 Width (In)	N/A	N/A	DWS 1 Length (In)	N/A
N/A	Road 1 Slope (%)	2.0	N/A	DWS 1 Full Width?	N/A
N/A	Road 1 X Slope (%)	3.6	N/A	DWS 1 Offset (In)	N/A
Yes	Refuge 2 Length (In)	61.5	N/A	Gutter 2 Ponding?	N/A
Yes	Refuge 2 Width (In)	117.0	N/A	Gutter 2 Lip Ht (In)	N/A
No	Refuge 2 Slope (%)	5.8	N/A	Gutter 2 Slope (%)	N/A
Yes	Refuge 2 X Slope (%)	0.6	N/A	Gutter 2 X Slope (%)	N/A
N/A	Painted X Walk2?	No	N/A	DWS 2 Provided?	N/A
N/A	X Walk 2 Direction	To N	N/A	DWS 2 Contrast?	N/A
N/A	X Walk 2 Width (In)	N/A	N/A	DWS 2 Length (In)	N/A

N/A	Road 2 Slope (%)	1.4	N/A	DWS 2 Full Width?	N/A
N/A	Road 2 X Slope (%)	4.6	N/A	DWS 2 Offset (In)	N/A
N/A	Refuge 3 Length (in)	N/A	N/A	Gutter 3 Ponding?	N/A
N/A	Refuge 3 Width (in)	N/A	N/A	Gutter 3 Lip Ht (in)	N/A
N/A	Refuge 3 Slope (%)	N/A	N/A	Gutter 3 Slope (%)	N/A
N/A	Refuge 3 XSlope (%)	N/A	N/A	Gutter 3 XSlope (%)	N/A
N/A	Painted X Walk3?	N/A	N/A	DWS 3 Provided?	N/A
N/A	X Walk 3 Direction	N/A	N/A	DWS 3 Contrast?	N/A
N/A	X Walk 3 Width (in)	N/A	N/A	DWS 3 Length (in)	N/A
N/A	Road 3 Slope (%)	N/A	N/A	DWS 3 Full Width?	N/A
N/A	Road 3 XSlope (%)	N/A	N/A	DWS 3 Offset (in)	N/A
Yes	Any Obstructions?	N/A	N/A	Storm Grate/Utility Hazard?	N/A
N/A	Obstruction Type		N/A	Storm Grate/Utility Type	
			N/A		N/A
N/A	Surface Condition	Good

**Remove & Replace Entire Refuge.**
