Access Compliance Report

Public Rights-of-Way

(Island Curb Cuts)

Intersection ID: 14144	Main Street: BRIAR_CREEK_RD	Cross Street: GREEN_OAKS_LN	Location: NE
ADA ID: 8ECB2D136D73	Curb Cut Type: MedianRefuge2	Initial Pass/Fail: Fail	Overall Compliance: No
Codes/Mitigation Info/Possible Solution		Field Measurements/Component Compliance	
Severity Score: 0

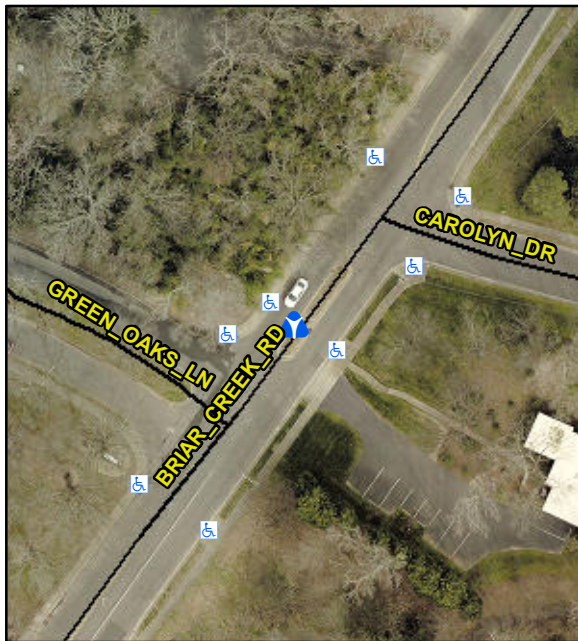
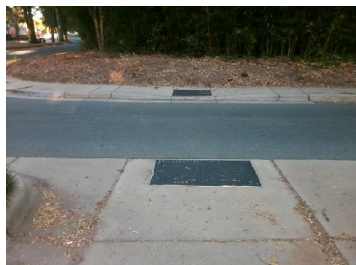
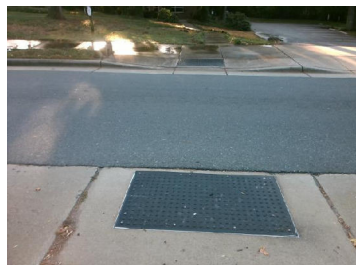
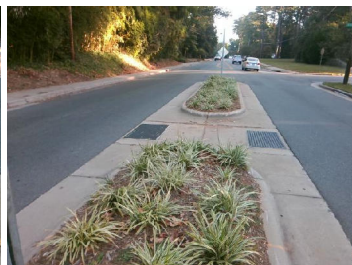
Compliance	Description	Data	Compliance	Description	Data
Yes	Refuge 1 Length (In)	61.0	N/A	Gutter 1 Ponding?	N/A
Yes	Refuge 1 Width (In)	115.0	N/A	Gutter 1 Lip Ht (In)	N/A
Yes	Refuge 1 Slope (%)	1.1	N/A	Gutter 1 Slope (%)	N/A
Yes	Refuge 1 X Slope (%)	4.2	N/A	Gutter 1 X Slope (%)	N/A
N/A	Painted X Walk1?	No	N/A	DWS 1 Provided?	N/A
N/A	X Walk 1 Direction	To NW	N/A	DWS 1 Contrast?	N/A
N/A	X Walk 1 Width (In)	N/A	N/A	DWS 1 Length (In)	N/A
N/A	Road 1 Slope (%)	4.1	N/A	DWS 1 Full Width?	N/A
N/A	Road 1 X Slope (%)	4.4	N/A	DWS 1 Offset (In)	N/A
Yes	Refuge 2 Length (In)	61.0	N/A	Gutter 2 Ponding?	N/A
Yes	Refuge 2 Width (In)	115.0	N/A	Gutter 2 Lip Ht (In)	N/A
Yes	Refuge 2 Slope (%)	1.5	N/A	Gutter 2 Slope (%)	N/A
Yes	Refuge 2 X Slope (%)	3.1	N/A	Gutter 2 X Slope (%)	N/A
N/A	Painted X Walk2?	No	N/A	DWS 2 Provided?	N/A
N/A	X Walk 2 Direction	To SE	N/A	DWS 2 Contrast?	N/A
N/A	X Walk 2 Width (In)	N/A	N/A	DWS 2 Length (In)	N/A

N/A	Road 2 Slope (%)	2.5	N/A	DWS 2 Full Width?	N/A
N/A	Road 2 X Slope (%)	4.3	N/A	DWS 2 Offset (In)	N/A
N/A	Refuge 3 Length (in)	N/A	N/A	Gutter 3 Ponding?	N/A
N/A	Refuge 3 Width (in)	N/A	N/A	Gutter 3 Lip Ht (in)	N/A
N/A	Refuge 3 Slope (%)	N/A	N/A	Gutter 3 Slope (%)	N/A
N/A	Refuge 3 XSlope (%)	N/A	N/A	Gutter 3 XSlope (%)	N/A
N/A	Painted X Walk3?	N/A	N/A	DWS 3 Provided?	N/A
N/A	X Walk 3 Direction	N/A	N/A	DWS 3 Contrast?	N/A
N/A	X Walk 3 Width (in)	N/A	N/A	DWS 3 Length (in)	N/A
N/A	Road 3 Slope (%)	N/A	N/A	DWS 3 Full Width?	N/A
N/A	Road 3 XSlope (%)	N/A	N/A	DWS 3 Offset (in)	N/A
Yes	Any Obstructions?	N/A	N/A	Storm Grate/Utility Hazard?	N/A
N/A	Obstruction Type		N/A	Storm Grate/Utility Type	
		N/A			N/A
N/A	Surface Condition	Good

Possible Solutions:

Remove & Replace Entire Refuge.
