# Access Compliance Report

## Public Rights-of-Way

### (Island Curb Cuts)

Intersection ID: 28389	Main Street: ARDREY_KELL_RD	Cross Street: LANCASTER_HY	Location:	N
ADA ID: 914CCCD150CA	Curb Cut Type: MedianRefuge2	Initial Pass/Fail: Fail	Overall Compliance: No	Severity Score: 25
Codes/Mitigation Info/Possible Solution		Field Measurements/Component Compliance

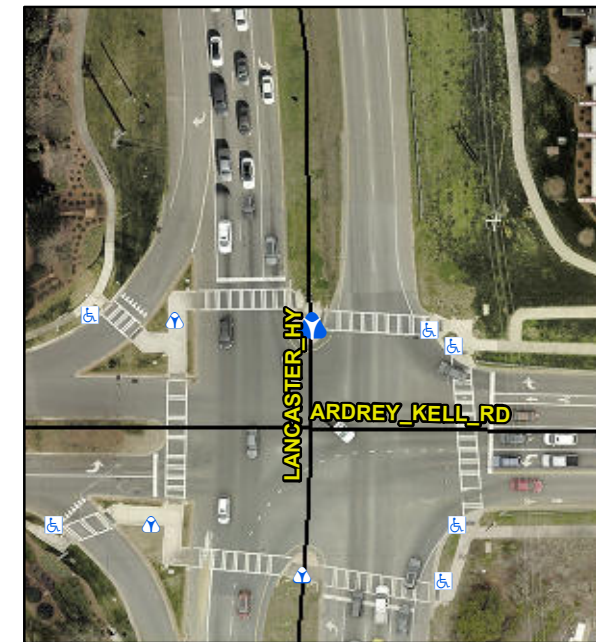
Compliance	Description	Data	Compliance	Description	Data
Yes	Refuge 1 Length (In)	127.5	N/A	Gutter 1 Ponding?	N/A
Yes	Refuge 1 Width (In)	90.0	N/A	Gutter 1 Lip Ht (In)	N/A
No	Refuge 1 Slope (%)	8.7	N/A	Gutter 1 Slope (%)	N/A
Yes	Refuge 1 X Slope (%)	3.9	N/A	Gutter 1 X Slope (%)	N/A
N/A	Painted X Walk1?	Yes	N/A	DWS 1 Provided?	N/A
N/A	X Walk 1 Direction	To E	N/A	DWS 1 Contrast?	N/A
N/A	X Walk 1 Width (In)	110.0	N/A	DWS 1 Length (In)	N/A
N/A	Road 1 Slope (%)	3.8	N/A	DWS 1 Full Width?	N/A
N/A	Road 1 X Slope (%)	3.0	N/A	DWS 1 Offset (In)	N/A
Yes	Refuge 2 Length (In)	127.5	N/A	Gutter 2 Ponding?	N/A
Yes	Refuge 2 Width (In)	90.0	N/A	Gutter 2 Lip Ht (In)	N/A
No	Refuge 2 Slope (%)	8.0	N/A	Gutter 2 Slope (%)	N/A
Yes	Refuge 2 X Slope (%)	0.4	N/A	Gutter 2 X Slope (%)	N/A
N/A	Painted X Walk2?	Yes	N/A	DWS 2 Provided?	N/A
N/A	X Walk 2 Direction	To NW	N/A	DWS 2 Contrast?	N/A
N/A	X Walk 2 Width (In)	110.0	N/A	DWS 2 Length (In)	N/A

N/A	Road 2 Slope (%)	0.0	N/A	DWS 2 Full Width?	N/A
N/A	Road 2 X Slope (%)	5.5	N/A	DWS 2 Offset (In)	N/A
N/A	Refuge 3 Length (in)	N/A	N/A	Gutter 3 Ponding?	N/A
N/A	Refuge 3 Width (in)	N/A	N/A	Gutter 3 Lip Ht (in)	N/A
N/A	Refuge 3 Slope (%)	N/A	N/A	Gutter 3 Slope (%)	N/A
N/A	Refuge 3 XSlope (%)	N/A	N/A	Gutter 3 XSlope (%)	N/A
N/A	Painted X Walk3?	N/A	N/A	DWS 3 Provided?	N/A
N/A	X Walk 3 Direction	N/A	N/A	DWS 3 Contrast?	N/A
N/A	X Walk 3 Width (in)	N/A	N/A	DWS 3 Length (in)	N/A
N/A	Road 3 Slope (%)	N/A	N/A	DWS 3 Full Width?	N/A
N/A	Road 3 XSlope (%)	N/A	N/A	DWS 3 Offset (in)	N/A
Yes	Any Obstructions?	N/A	N/A	Storm Grate/Utility Hazard?	N/A
N/A	Obstruction Type		N/A	Storm Grate/Utility Type	
			N/A		N/A
N/A	Surface Condition	Good

Possible Solutions:

**Remove & Replace Entire Refuge.**

**\$ 3000.00**
