Access Compliance Report

Public Rights-of-Way

(Island Curb Cuts)

Intersection ID: 17650	Main Street: CRESTHILL_DR	Cross Street: IDLEWILD_RD	Location: NW
ADA ID: 947FCDCA5759	Curb Cut Type: MedianRefuge2	Initial Pass/Fail: Fail	Overall Compliance: No
Codes/Mitigation Info/Possible Solution		Field Measurements/Component Compliance	
Severity Score: 12.5

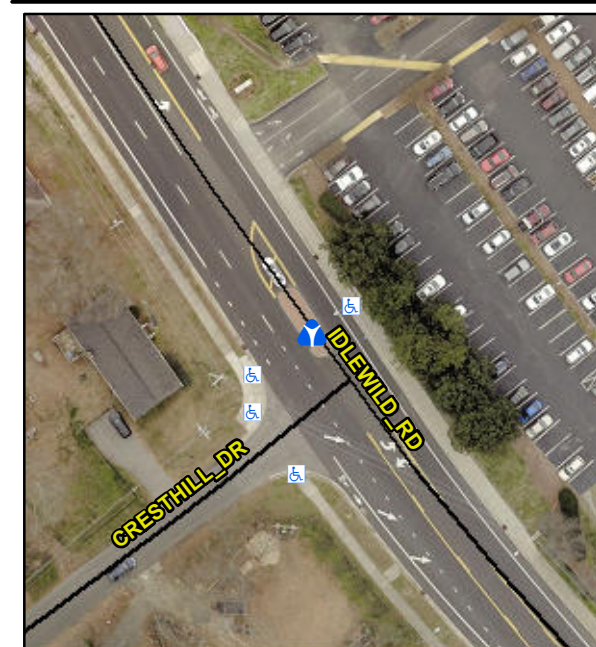
Compliance	Description	Data	Compliance	Description	Data
Yes	Refuge 1 Length (In)	70.0	N/A	Gutter 1 Ponding?	N/A
Yes	Refuge 1 Width (In)	122.0	N/A	Gutter 1 Lip Ht (In)	N/A
Yes	Refuge 1 Slope (%)	0.3	N/A	Gutter 1 Slope (%)	N/A
No	Refuge 1 X Slope (%)	5.9	N/A	Gutter 1 X Slope (%)	N/A
N/A	Painted X Walk1?	No	N/A	DWS 1 Provided?	N/A
N/A	X Walk 1 Direction	To NE	N/A	DWS 1 Contrast?	N/A
N/A	X Walk 1 Width (In)	N/A	N/A	DWS 1 Length (In)	N/A
N/A	Road 1 Slope (%)	4.1	N/A	DWS 1 Full Width?	N/A
N/A	Road 1 X Slope (%)	2.1	N/A	DWS 1 Offset (In)	N/A
Yes	Refuge 2 Length (In)	70.0	N/A	Gutter 2 Ponding?	N/A
Yes	Refuge 2 Width (In)	122.0	N/A	Gutter 2 Lip Ht (In)	N/A
Yes	Refuge 2 Slope (%)	1.7	N/A	Gutter 2 Slope (%)	N/A
Yes	Refuge 2 X Slope (%)	4.7	N/A	Gutter 2 X Slope (%)	N/A
N/A	Painted X Walk2?	No	N/A	DWS 2 Provided?	N/A
N/A	X Walk 2 Direction	To SW	N/A	DWS 2 Contrast?	N/A
N/A	X Walk 2 Width (In)	N/A	N/A	DWS 2 Length (In)	N/A

N/A	Road 2 Slope (%)	4.4	N/A	DWS 2 Full Width?	N/A
N/A	Road 2 X Slope (%)	3.4	N/A	DWS 2 Offset (In)	N/A
N/A	Refuge 3 Length (in)	N/A	N/A	Gutter 3 Ponding?	N/A
N/A	Refuge 3 Width (in)	N/A	N/A	Gutter 3 Lip Ht (in)	N/A
N/A	Refuge 3 Slope (%)	N/A	N/A	Gutter 3 Slope (%)	N/A
N/A	Refuge 3 XSlope (%)	N/A	N/A	Gutter 3 XSlope (%)	N/A
N/A	Painted X Walk3?	N/A	N/A	DWS 3 Provided?	N/A
N/A	X Walk 3 Direction	N/A	N/A	DWS 3 Contrast?	N/A
N/A	X Walk 3 Width (in)	N/A	N/A	DWS 3 Length (in)	N/A
N/A	Road 3 Slope (%)	N/A	N/A	DWS 3 Full Width?	N/A
N/A	Road 3 XSlope (%)	N/A	N/A	DWS 3 Offset (in)	N/A
Yes	Any Obstructions?	N/A	N/A	Storm Grate/Utility Hazard?	N/A
N/A	Obstruction Type		N/A	Storm Grate/Utility Type	
		N/A			N/A
N/A	Surface Condition	Good

Possible Solutions:

Remove & Replace Entire Refuge.

Total Cost:

\$ 3000.00
