Access Compliance Report

Public Rights-of-Way

(Island Curb Cuts)

Intersection ID: 10040108	Main Street: TUCKASEEGEE_RD	Cross Street: N/A	Location:	W
ADA ID: 97085FC57C21	Curb Cut Type: MedianRefuge2	Initial Pass/Fail: Fail	Overall Compliance: No	Severity Score: 0
Codes/Mitigation Info/Possible Solution		Field Measurements/Component Compliance

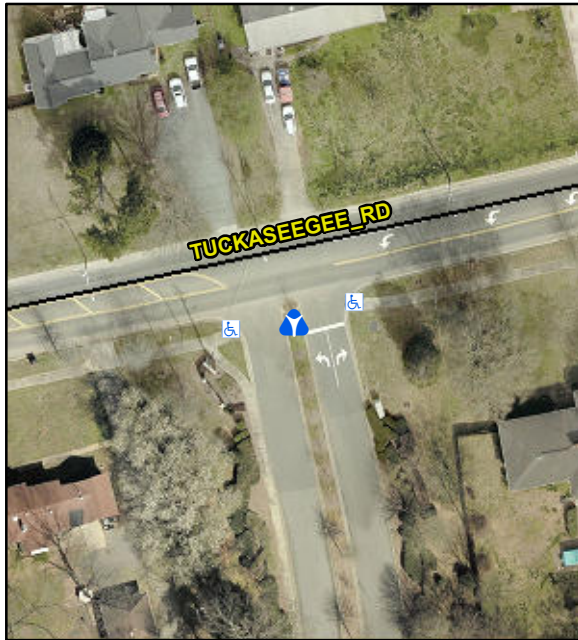
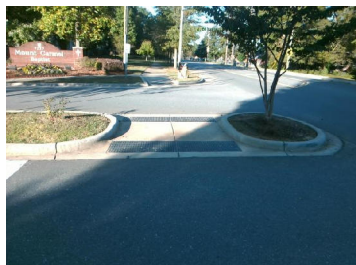
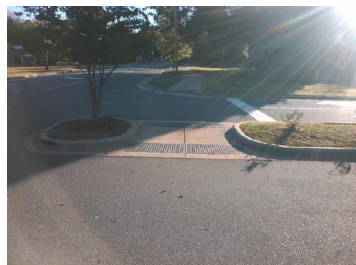
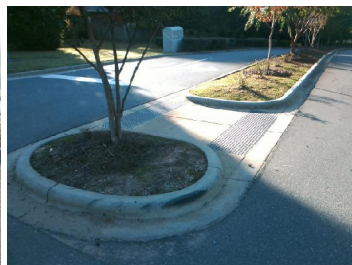
Compliance	Description	Data	Compliance	Description	Data
Yes	Refuge 1 Length (In)	67.0	N/A	Gutter 1 Ponding?	N/A
Yes	Refuge 1 Width (In)	93.0	N/A	Gutter 1 Lip Ht (In)	N/A
Yes	Refuge 1 Slope (%)	0.3	N/A	Gutter 1 Slope (%)	N/A
Yes	Refuge 1 X Slope (%)	2.6	N/A	Gutter 1 X Slope (%)	N/A
N/A	Painted X Walk1?	No	N/A	DWS 1 Provided?	N/A
N/A	X Walk 1 Direction	To W	N/A	DWS 1 Contrast?	N/A
N/A	X Walk 1 Width (In)	N/A	N/A	DWS 1 Length (In)	N/A
N/A	Road 1 Slope (%)	3.0	N/A	DWS 1 Full Width?	N/A
N/A	Road 1 X Slope (%)	0.3	N/A	DWS 1 Offset (In)	N/A
Yes	Refuge 2 Length (In)	67.0	N/A	Gutter 2 Ponding?	N/A
Yes	Refuge 2 Width (In)	93.0	N/A	Gutter 2 Lip Ht (In)	N/A
Yes	Refuge 2 Slope (%)	0.5	N/A	Gutter 2 Slope (%)	N/A
Yes	Refuge 2 X Slope (%)	2.1	N/A	Gutter 2 X Slope (%)	N/A
N/A	Painted X Walk2?	No	N/A	DWS 2 Provided?	N/A
N/A	X Walk 2 Direction	To E	N/A	DWS 2 Contrast?	N/A
N/A	X Walk 2 Width (In)	N/A	N/A	DWS 2 Length (In)	N/A

N/A	Road 2 Slope (%)	3.3	N/A	DWS 2 Full Width?	N/A
N/A	Road 2 X Slope (%)	0.3	N/A	DWS 2 Offset (In)	N/A
N/A	Refuge 3 Length (in)	N/A	N/A	Gutter 3 Ponding?	N/A
N/A	Refuge 3 Width (in)	N/A	N/A	Gutter 3 Lip Ht (in)	N/A
N/A	Refuge 3 Slope (%)	N/A	N/A	Gutter 3 Slope (%)	N/A
N/A	Refuge 3 XSlope (%)	N/A	N/A	Gutter 3 XSlope (%)	N/A
N/A	Painted X Walk3?	N/A	N/A	DWS 3 Provided?	N/A
N/A	X Walk 3 Direction	N/A	N/A	DWS 3 Contrast?	N/A
N/A	X Walk 3 Width (in)	N/A	N/A	DWS 3 Length (in)	N/A
N/A	Road 3 Slope (%)	N/A	N/A	DWS 3 Full Width?	N/A
N/A	Road 3 XSlope (%)	N/A	N/A	DWS 3 Offset (in)	N/A
Yes	Any Obstructions?	N/A	N/A	Storm Grate/Utility Hazard?	N/A
N/A	Obstruction Type		N/A	Storm Grate/Utility Type	
			N/A		N/A
N/A	Surface Condition	Good

Possible Solutions:

Remove & Replace Entire Refuge.
