Access Compliance Report

Public Rights-of-Way

(Island Curb Cuts)

Intersection ID: 16585	Main Street: ASHMORE_DR	Cross Street: E_INDEPENDENCE_BV	Location: SW
ADA ID: 974733ED663A	Curb Cut Type: MedianRefuge2	Initial Pass/Fail: Fail	Overall Compliance: No
Codes/Mitigation Info/Possible Solution		Field Measurements/Component Compliance

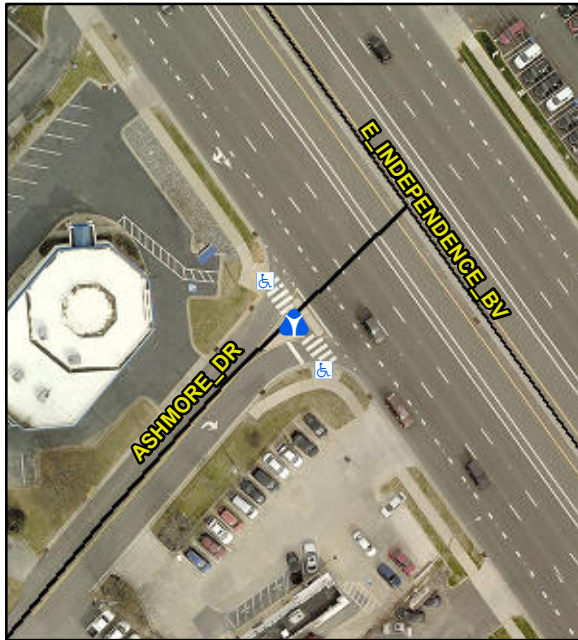
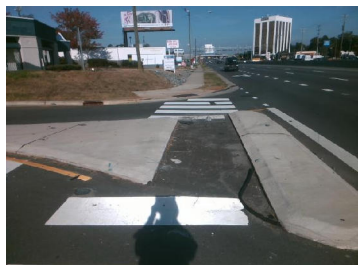
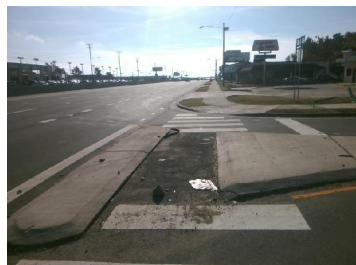
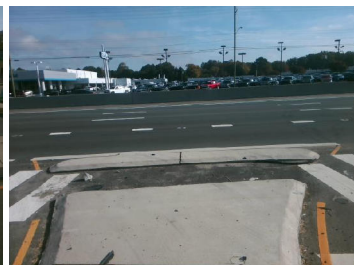
Compliance	Description	Data	Compliance	Description	Data
Yes	Refuge 1 Length (In)	80.0	N/A	Gutter 1 Ponding?	N/A
Yes	Refuge 1 Width (In)	61.0	N/A	Gutter 1 Lip Ht (In)	N/A
Yes	Refuge 1 Slope (%)	2.2	N/A	Gutter 1 Slope (%)	N/A
Yes	Refuge 1 X Slope (%)	2.5	N/A	Gutter 1 X Slope (%)	N/A
N/A	Painted X Walk1?	Yes	N/A	DWS 1 Provided?	N/A
N/A	X Walk 1 Direction	To NW	N/A	DWS 1 Contrast?	N/A
N/A	X Walk 1 Width (In)	120.0	N/A	DWS 1 Length (In)	N/A
N/A	Road 1 Slope (%)	1.6	N/A	DWS 1 Full Width?	N/A
N/A	Road 1 X Slope (%)	2.0	N/A	DWS 1 Offset (In)	N/A
Yes	Refuge 2 Length (In)	80.0	N/A	Gutter 2 Ponding?	N/A
Yes	Refuge 2 Width (In)	61.0	N/A	Gutter 2 Lip Ht (In)	N/A
Yes	Refuge 2 Slope (%)	0.3	N/A	Gutter 2 Slope (%)	N/A
Yes	Refuge 2 X Slope (%)	3.6	N/A	Gutter 2 X Slope (%)	N/A
N/A	Painted X Walk2?	Yes	N/A	DWS 2 Provided?	N/A
N/A	X Walk 2 Direction	To SE	N/A	DWS 2 Contrast?	N/A
N/A	X Walk 2 Width (In)	119.0	N/A	DWS 2 Length (In)	N/A

N/A	Road 2 Slope (%)	0.4	N/A	DWS 2 Full Width?	N/A
N/A	Road 2 X Slope (%)	1.8	N/A	DWS 2 Offset (In)	N/A
N/A	Refuge 3 Length (in)	N/A	N/A	Gutter 3 Ponding?	N/A
N/A	Refuge 3 Width (in)	N/A	N/A	Gutter 3 Lip Ht (in)	N/A
N/A	Refuge 3 Slope (%)	N/A	N/A	Gutter 3 Slope (%)	N/A
N/A	Refuge 3 XSlope (%)	N/A	N/A	Gutter 3 XSlope (%)	N/A
N/A	Painted X Walk3?	N/A	N/A	DWS 3 Provided?	N/A
N/A	X Walk 3 Direction	N/A	N/A	DWS 3 Contrast?	N/A
N/A	X Walk 3 Width (in)	N/A	N/A	DWS 3 Length (in)	N/A
N/A	Road 3 Slope (%)	N/A	N/A	DWS 3 Full Width?	N/A
N/A	Road 3 XSlope (%)	N/A	N/A	DWS 3 Offset (in)	N/A
Yes	Any Obstructions?	N/A	N/A	Storm Grate/Utility Hazard?	N/A
N/A	Obstruction Type		N/A	Storm Grate/Utility Type	
		N/A			N/A
N/A	Surface Condition	Good

Possible Solutions:

Remove & Replace Entire Refuge.
