Access Compliance Report

Public Rights-of-Way

(Island Curb Cuts)

Intersection ID: 8113	Main Street: ORR_RD	Cross Street: GRIER_RD	Location: NW
ADA ID: 99375F699CDC	Curb Cut Type: IslandRefuge3	Initial Pass/Fail: Fail	Overall Compliance: No
Codes/Mitigation Info/Possible Solution		Field Measurements/Component Compliance

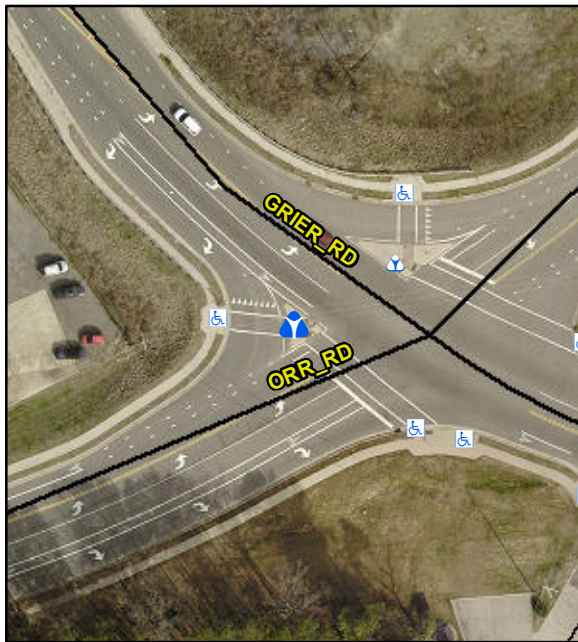
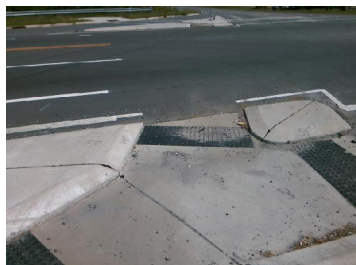
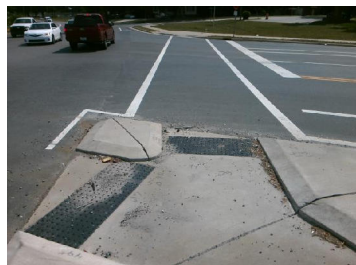
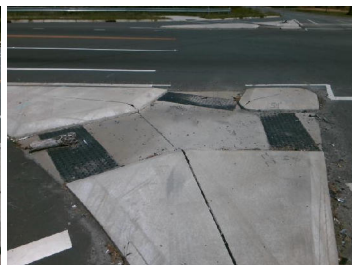
Compliance	Description	Data	Compliance	Description	Data
Yes	Refuge 1 Length (In)	49.0	N/A	Gutter 1 Ponding?	N/A
Yes	Refuge 1 Width (In)	61.0	N/A	Gutter 1 Lip Ht (In)	N/A
Yes	Refuge 1 Slope (%)	0.5	N/A	Gutter 1 Slope (%)	N/A
Yes	Refuge 1 X Slope (%)	0.0	N/A	Gutter 1 X Slope (%)	N/A
N/A	Painted X Walk1?	No	N/A	DWS 1 Provided?	N/A
N/A	X Walk 1 Direction	To NE	N/A	DWS 1 Contrast?	N/A
N/A	X Walk 1 Width (In)	N/A	N/A	DWS 1 Length (In)	N/A
N/A	Road 1 Slope (%)	0.5	N/A	DWS 1 Full Width?	N/A
N/A	Road 1 X Slope (%)	1.5	N/A	DWS 1 Offset (In)	N/A
Yes	Refuge 2 Length (In)	54.0	N/A	Gutter 2 Ponding?	N/A
Yes	Refuge 2 Width (In)	62.0	N/A	Gutter 2 Lip Ht (In)	N/A
Yes	Refuge 2 Slope (%)	1.3	N/A	Gutter 2 Slope (%)	N/A
Yes	Refuge 2 X Slope (%)	1.1	N/A	Gutter 2 X Slope (%)	N/A
N/A	Painted X Walk2?	Yes	N/A	DWS 2 Provided?	N/A
N/A	X Walk 2 Direction	To SE	N/A	DWS 2 Contrast?	N/A
N/A	X Walk 2 Width (In)	113.0	N/A	DWS 2 Length (In)	N/A

N/A	Road 2 Slope (%)	0.5	N/A	DWS 2 Full Width?	N/A
N/A	Road 2 X Slope (%)	2.7	N/A	DWS 2 Offset (In)	N/A
Yes	Refuge 3 Length (in)	53.0	N/A	Gutter 3 Ponding?	N/A
Yes	Refuge 3 Width (in)	60.0	N/A	Gutter 3 Lip Ht (in)	N/A
Yes	Refuge 3 Slope (%)	2.1	N/A	Gutter 3 Slope (%)	N/A
Yes	Refuge 3 XSlope (%)	2.7	N/A	Gutter 3 XSlope (%)	N/A
N/A	Painted X Walk3?	Yes	N/A	DWS 3 Provided?	N/A
N/A	X Walk 3 Direction	To W	N/A	DWS 3 Contrast?	N/A
N/A	X Walk 3 Width (in)	105.0	N/A	DWS 3 Length (in)	N/A
N/A	Road 3 Slope (%)	0.3	N/A	DWS 3 Full Width?	N/A
N/A	Road 3 XSlope (%)	2.7	N/A	DWS 3 Offset (in)	N/A
Yes	Any Obstructions?	N/A	N/A	Storm Grate/Utility Hazard?	N/A
N/A	Obstruction Type		N/A	Storm Grate/Utility Type	
		N/A			N/A
N/A	Surface Condition	Good

Remove & Replace Entire Refuge.
