Access Compliance Report

Public Rights-of-Way

(Island Curb Cuts)

Intersection ID: 10034533	Main Street: PINEVILLE-MATTHEWS_RD	Cross Street: N/A	Location: N/A
ADA ID: 9F60C846C775	Curb Cut Type: MedianRefuge2	Initial Pass/Fail: Fail	Overall Compliance: No
Severity Score: 1.25			
Codes/Mitigation Info/Possible Solution		Field Measurements/Component Compliance

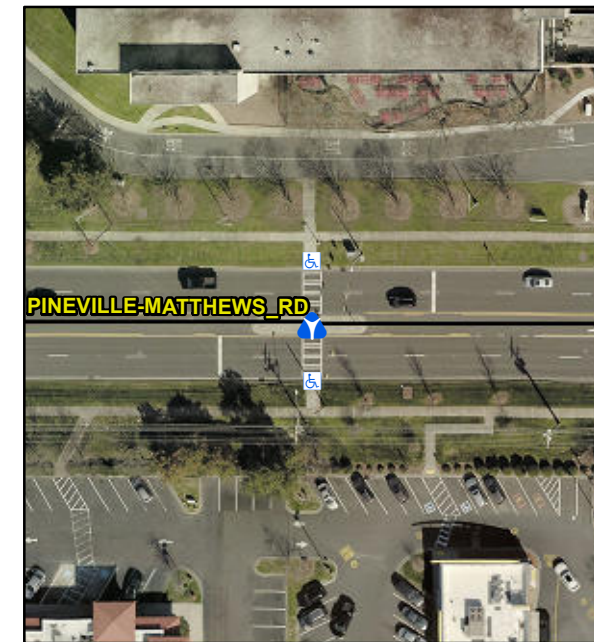
Compliance	Description	Data	Compliance	Description	Data
Yes	Refuge 1 Length (In)	55.5	N/A	Gutter 1 Ponding?	N/A
Yes	Refuge 1 Width (In)	97.0	N/A	Gutter 1 Lip Ht (In)	N/A
Yes	Refuge 1 Slope (%)	3.5	N/A	Gutter 1 Slope (%)	N/A
Yes	Refuge 1 X Slope (%)	0.7	N/A	Gutter 1 X Slope (%)	N/A
N/A	Painted X Walk1?	Yes	N/A	DWS 1 Provided?	N/A
N/A	X Walk 1 Direction	To S	N/A	DWS 1 Contrast?	N/A
N/A	X Walk 1 Width (In)	112.0	N/A	DWS 1 Length (In)	N/A
N/A	Road 1 Slope (%)	2.1	N/A	DWS 1 Full Width?	N/A
N/A	Road 1 X Slope (%)	2.0	N/A	DWS 1 Offset (In)	N/A
Yes	Refuge 2 Length (In)	55.5	N/A	Gutter 2 Ponding?	N/A
Yes	Refuge 2 Width (In)	97.0	N/A	Gutter 2 Lip Ht (In)	N/A
Yes	Refuge 2 Slope (%)	3.8	N/A	Gutter 2 Slope (%)	N/A
No	Refuge 2 X Slope (%)	2.22.0	N/A	Gutter 2 X Slope (%)	N/A
N/A	Painted X Walk2?	Yes	N/A	DWS 2 Provided?	N/A
N/A	X Walk 2 Direction	To N	N/A	DWS 2 Contrast?	N/A
N/A	X Walk 2 Width (In)	112.0	N/A	DWS 2 Length (In)	N/A

N/A	Road 2 Slope (%)	2.0	N/A	DWS 2 Full Width?	N/A
N/A	Road 2 X Slope (%)	2.8	N/A	DWS 2 Offset (In)	N/A
N/A	Refuge 3 Length (in)	N/A	N/A	Gutter 3 Ponding?	N/A
N/A	Refuge 3 Width (in)	N/A	N/A	Gutter 3 Lip Ht (in)	N/A
N/A	Refuge 3 Slope (%)	N/A	N/A	Gutter 3 Slope (%)	N/A
N/A	Refuge 3 XSlope (%)	N/A	N/A	Gutter 3 XSlope (%)	N/A
N/A	Painted X Walk3?	N/A	N/A	DWS 3 Provided?	N/A
N/A	X Walk 3 Direction	N/A	N/A	DWS 3 Contrast?	N/A
N/A	X Walk 3 Width (in)	N/A	N/A	DWS 3 Length (in)	N/A
N/A	Road 3 Slope (%)	N/A	N/A	DWS 3 Full Width?	N/A
N/A	Road 3 XSlope (%)	N/A	N/A	DWS 3 Offset (in)	N/A
Yes	Any Obstructions?	N/A	N/A	Storm Grate/Utility Hazard?	N/A
N/A	Obstruction Type		N/A	Storm Grate/Utility Type	
		N/A			N/A
N/A	Surface Condition	Good

Possible Solutions:

Remove & Replace Entire Refuge.
