# Access Compliance Report

## Public Rights-of-Way

### (Island Curb Cuts)

| Intersection ID: 43131 | Main Street: DR_WEBBER_AV | Cross Street: BEATTIES_FORD_RD | Location: | N |

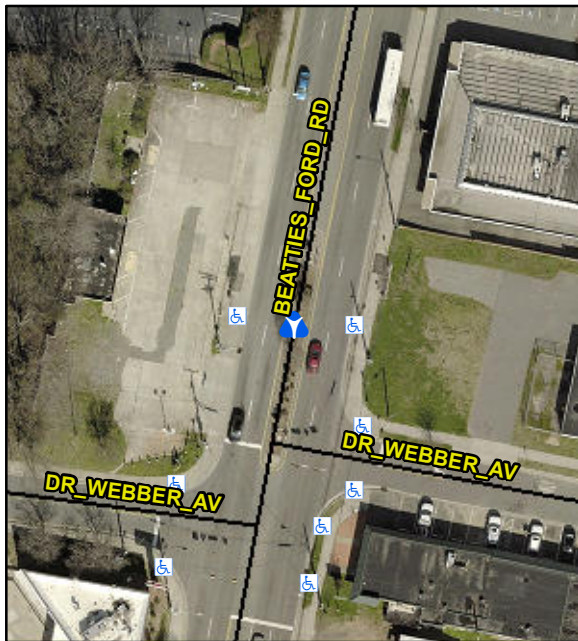
| Compliance | Description | Data | Compliance | Description | Data |
|---|---|---|---|---|---|
| N/A | Road 1 X Slope (%) | 2.0 | No | DWS 1 Offset (In) | 7.0 |
| N/A | Road 2 X Slope (%) | 1.7 | No | DWS 2 Offset (In) | 8.0 |

Possible Solutions:

**Remove & Replace Detectable Warning System.**
