Access Compliance Report

Public Rights-of-Way

(Island Curb Cuts)

Intersection ID: 10040074	Main Street: TUCKASEEGEE_RD	Cross Street: N/A	Location: S
ADA ID: A0B606D87541	Curb Cut Type: MedianRefuge2	Initial Pass/Fail: Fail	Overall Compliance: No
Codes/Mitigation Info/Possible Solution		Field Measurements/Component Compliance

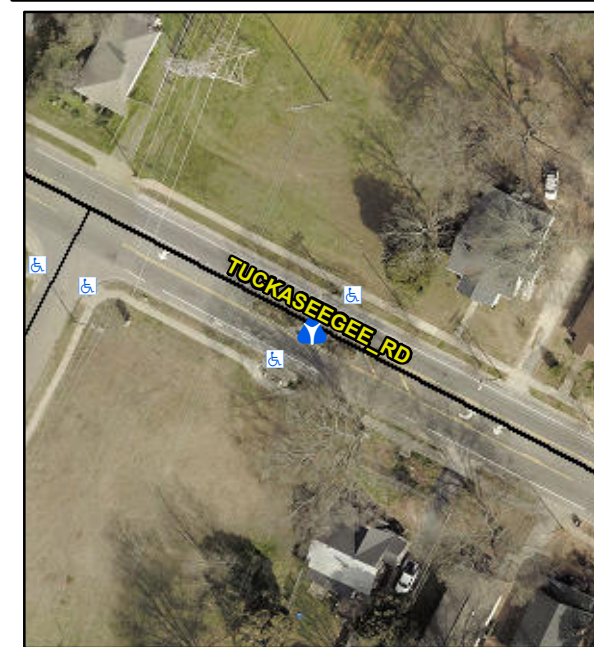
Compliance	Description	Data	Compliance	Description	Data
Yes	Refuge 1 Length (In)	77.5	N/A	Gutter 1 Ponding?	N/A
Yes	Refuge 1 Width (In)	157.0	N/A	Gutter 1 Lip Ht (In)	N/A
Yes	Refuge 1 Slope (%)	2.6	N/A	Gutter 1 Slope (%)	N/A
Yes	Refuge 1 X Slope (%)	0.5	N/A	Gutter 1 X Slope (%)	N/A
N/A	Painted X Walk1?	No	N/A	DWS 1 Provided?	N/A
N/A	X Walk 1 Direction	To S	N/A	DWS 1 Contrast?	N/A
N/A	X Walk 1 Width (In)	N/A	N/A	DWS 1 Length (In)	N/A
N/A	Road 1 Slope (%)	1.9	N/A	DWS 1 Full Width?	N/A
N/A	Road 1 X Slope (%)	4.9	N/A	DWS 1 Offset (In)	N/A
Yes	Refuge 2 Length (In)	77.5	N/A	Gutter 2 Ponding?	N/A
Yes	Refuge 2 Width (In)	157.0	N/A	Gutter 2 Lip Ht (In)	N/A
Yes	Refuge 2 Slope (%)	4.7	N/A	Gutter 2 Slope (%)	N/A
Yes	Refuge 2 X Slope (%)	2.1	N/A	Gutter 2 X Slope (%)	N/A
N/A	Painted X Walk2?	No	N/A	DWS 2 Provided?	N/A
N/A	X Walk 2 Direction	To N	N/A	DWS 2 Contrast?	N/A
N/A	X Walk 2 Width (In)	N/A	N/A	DWS 2 Length (In)	N/A

N/A	Road 2 Slope (%)	1.7	N/A	DWS 2 Full Width?	N/A
N/A	Road 2 X Slope (%)	3.1	N/A	DWS 2 Offset (In)	N/A
N/A	Refuge 3 Length (in)	N/A	N/A	Gutter 3 Ponding?	N/A
N/A	Refuge 3 Width (in)	N/A	N/A	Gutter 3 Lip Ht (in)	N/A
N/A	Refuge 3 Slope (%)	N/A	N/A	Gutter 3 Slope (%)	N/A
N/A	Refuge 3 XSlope (%)	N/A	N/A	Gutter 3 XSlope (%)	N/A
N/A	Painted X Walk3?	N/A	N/A	DWS 3 Provided?	N/A
N/A	X Walk 3 Direction	N/A	N/A	DWS 3 Contrast?	N/A
N/A	X Walk 3 Width (in)	N/A	N/A	DWS 3 Length (in)	N/A
N/A	Road 3 Slope (%)	N/A	N/A	DWS 3 Full Width?	N/A
N/A	Road 3 XSlope (%)	N/A	N/A	DWS 3 Offset (in)	N/A
Yes	Any Obstructions?	N/A	N/A	Storm Grate/Utility Hazard?	N/A
N/A	Obstruction Type		N/A	Storm Grate/Utility Type	
		N/A			N/A
N/A	Surface Condition	Good

Remove & Replace Entire Refuge.
