Access Compliance Report

Public Rights-of-Way

(Island Curb Cuts)

Intersection ID: 11256	Main Street: N_IRWIN_AV	Cross Street: W_5TH_ST	Location: W
ADA ID: A1379A94029C	Curb Cut Type: MedianRefuge2	Initial Pass/Fail: Fail	Overall Compliance: No
Severity Score: 1.25			
Codes/Mitigation Info/Possible Solution		Field Measurements/Component Compliance

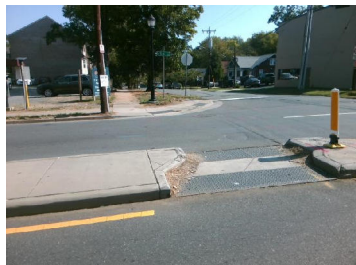
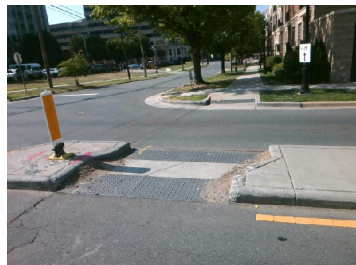
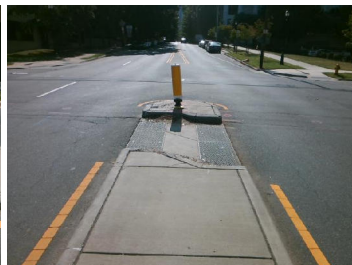
Compliance	Description	Data	Compliance	Description	Data
Yes	Refuge 1 Length (In)	37.0	N/A	Gutter 1 Ponding?	N/A
Yes	Refuge 1 Width (In)	90.0	N/A	Gutter 1 Lip Ht (In)	N/A
Yes	Refuge 1 Slope (%)	2.2	N/A	Gutter 1 Slope (%)	N/A
Yes	Refuge 1 X Slope (%)	3.5	N/A	Gutter 1 X Slope (%)	N/A
N/A	Painted X Walk1?	No	N/A	DWS 1 Provided?	N/A
N/A	X Walk 1 Direction	To N	N/A	DWS 1 Contrast?	N/A
N/A	X Walk 1 Width (In)	N/A	N/A	DWS 1 Length (In)	N/A
N/A	Road 1 Slope (%)	2.7	N/A	DWS 1 Full Width?	N/A
N/A	Road 1 X Slope (%)	1.1	N/A	DWS 1 Offset (In)	N/A
Yes	Refuge 2 Length (In)	37.0	N/A	Gutter 2 Ponding?	N/A
Yes	Refuge 2 Width (In)	90.0	N/A	Gutter 2 Lip Ht (In)	N/A
Yes	Refuge 2 Slope (%)	1.9	N/A	Gutter 2 Slope (%)	N/A
Yes	Refuge 2 X Slope (%)	3.6	N/A	Gutter 2 X Slope (%)	N/A
N/A	Painted X Walk2?	No	N/A	DWS 2 Provided?	N/A
N/A	X Walk 2 Direction	To S	N/A	DWS 2 Contrast?	N/A
N/A	X Walk 2 Width (In)	N/A	N/A	DWS 2 Length (In)	N/A

N/A	Road 2 Slope (%)	3.4	N/A	DWS 2 Full Width?	N/A
N/A	Road 2 X Slope (%)	4.6	N/A	DWS 2 Offset (In)	N/A
N/A	Refuge 3 Length (in)	N/A	N/A	Gutter 3 Ponding?	N/A
N/A	Refuge 3 Width (in)	N/A	N/A	Gutter 3 Lip Ht (in)	N/A
N/A	Refuge 3 Slope (%)	N/A	N/A	Gutter 3 Slope (%)	N/A
N/A	Refuge 3 XSlope (%)	N/A	N/A	Gutter 3 XSlope (%)	N/A
N/A	Painted X Walk3?	N/A	N/A	DWS 3 Provided?	N/A
N/A	X Walk 3 Direction	N/A	N/A	DWS 3 Contrast?	N/A
N/A	X Walk 3 Width (in)	N/A	N/A	DWS 3 Length (in)	N/A
N/A	Road 3 Slope (%)	N/A	N/A	DWS 3 Full Width?	N/A
N/A	Road 3 XSlope (%)	N/A	N/A	DWS 3 Offset (in)	N/A
Yes	Any Obstructions?	N/A	N/A	Storm Grate/Utility Hazard?	N/A
N/A	Obstruction Type		N/A	Storm Grate/Utility Type	
		N/A			N/A
N/A	Surface Condition	Good

Remove & Replace Entire Refuge.
