Access Compliance Report

Public Rights-of-Way

(Island Curb Cuts)

Intersection ID: 23148	Main Street: ALEXANDER_RD	Cross Street: HARRISON_RD	Location: W
ADA ID: A13EF5948E54	Curb Cut Type: MedianRefuge2	Initial Pass/Fail: Fail	Overall Compliance: No
Codes/Mitigation Info/Possible Solution		Field Measurements/Component Compliance	
Severity Score: 12.5

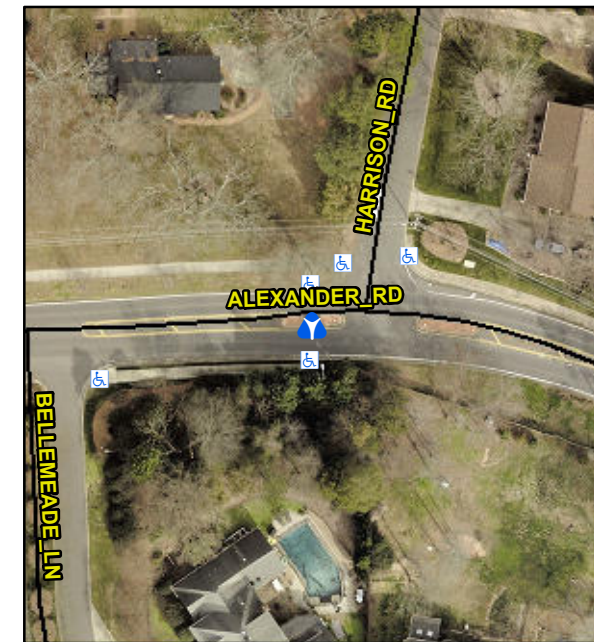
Compliance	Description	Data	Compliance	Description	Data
Yes	Refuge 1 Length (In)	36.0	N/A	Gutter 1 Ponding?	N/A
Yes	Refuge 1 Width (In)	102	N/A	Gutter 1 Lip Ht (In)	N/A
Yes	Refuge 1 Slope (%)	3.3	N/A	Gutter 1 Slope (%)	N/A
Yes	Refuge 1 X Slope (%)	0.2	N/A	Gutter 1 X Slope (%)	N/A
N/A	Painted X Walk1?	No	N/A	DWS 1 Provided?	N/A
N/A	X Walk 1 Direction	To N	N/A	DWS 1 Contrast?	N/A
N/A	X Walk 1 Width (In)	N/A	N/A	DWS 1 Length (In)	N/A
N/A	Road 1 Slope (%)	0.0	N/A	DWS 1 Full Width?	N/A
N/A	Road 1 X Slope (%)	4.1	N/A	DWS 1 Offset (In)	N/A
Yes	Refuge 2 Length (In)	36.0	N/A	Gutter 2 Ponding?	N/A
Yes	Refuge 2 Width (In)	102	N/A	Gutter 2 Lip Ht (In)	N/A
No	Refuge 2 Slope (%)	6.7	N/A	Gutter 2 Slope (%)	N/A
Yes	Refuge 2 X Slope (%)	1.2	N/A	Gutter 2 X Slope (%)	N/A
N/A	Painted X Walk2?	No	N/A	DWS 2 Provided?	N/A
N/A	X Walk 2 Direction	To S	N/A	DWS 2 Contrast?	N/A
N/A	X Walk 2 Width (In)	N/A	N/A	DWS 2 Length (In)	N/A
N/A	Road 2 Slope (%)	0.9	N/A	DWS 2 Full Width?	N/A

N/A	Road 2 X Slope (%)	5.8	N/A	DWS 2 Offset (In)	N/A
N/A	Refuge 3 Length (in)	N/A	N/A	Gutter 3 Ponding?	N/A
N/A	Refuge 3 Width (in)	N/A	N/A	Gutter 3 Lip Ht (in)	N/A
N/A	Refuge 3 Slope (%)	N/A	N/A	Gutter 3 Slope (%)	N/A
N/A	Refuge 3 XSlope (%)	N/A	N/A	Gutter 3 XSlope (%)	N/A
N/A	Painted X Walk3?	N/A	N/A	DWS 3 Provided?	N/A
N/A	X Walk 3 Direction	N/A	N/A	DWS 3 Contrast?	N/A
N/A	X Walk 3 Width (in)	N/A	N/A	DWS 3 Length (in)	N/A
N/A	Road 3 Slope (%)	N/A	N/A	DWS 3 Full Width?	N/A
N/A	Road 3 XSlope (%)	N/A	N/A	DWS 3 Offset (in)	N/A
Yes	Any Obstructions?	N/A	N/A	Storm Grate/Utility Hazard?	N/A
N/A	Obstruction Type		N/A	Storm Grate/Utility Type	
		N/A			N/A
N/A	Surface Condition	Good

Possible Solutions:

Remove & Replace Entire Refuge.
