Access Compliance Report

Public Rights-of-Way

(Island Curb Cuts)

Intersection ID: 12267	Main Street: CENTRAL_AV	Cross Street: LOUISE_AV	Location: SW
ADA ID: A3E486FCCA1B	Curb Cut Type: MedianRefuge2	Initial Pass/Fail: Pass	Overall Compliance: No
Codes/Mitigation Info/Possible Solution		Field Measurements/Component Compliance	
Severity Score: 15

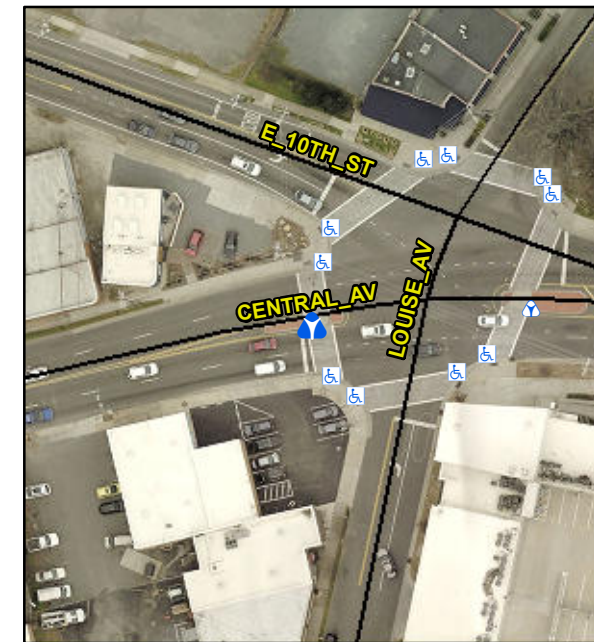
Compliance	Description	Data	Compliance	Description	Data
No	Refuge 1 Length (In)	31.0	Yes	Gutter 1 Ponding?	No
Yes	Refuge 1 Width (In)	95.5	Yes	Gutter 1 Lip Ht (In)	0.0
Yes	Refuge 1 Slope (%)	0.4	Yes	Gutter 1 Slope (%)	2.2
Yes	Refuge 1 X Slope (%)	0.8	Yes	Gutter 1 X Slope (%)	0.0
N/A	Painted X Walk1?	Yes	Yes	DWS 1 Provided?	No
N/A	X Walk 1 Direction	To S	N/A	DWS 1 Contrast?	No
N/A	X Walk 1 Width (In)	144.0	N/A	DWS 1 Length (In)	N/A
N/A	Road 1 Slope (%)	0.3	N/A	DWS 1 Full Width?	No
N/A	Road 1 X Slope (%)	2.8	N/A	DWS 1 Offset (In)	N/A
No	Refuge 2 Length (In)	31.0	Yes	Gutter 2 Ponding?	No
Yes	Refuge 2 Width (In)	95.5	Yes	Gutter 2 Lip Ht (In)	0.0
Yes	Refuge 2 Slope (%)	0.6	Yes	Gutter 2 Slope (%)	2.4
Yes	Refuge 2 X Slope (%)	1.0	Yes	Gutter 2 X Slope (%)	0.6
N/A	Painted X Walk2?	Yes	Yes	DWS 2 Provided?	No
N/A	X Walk 2 Direction	To N	N/A	DWS 2 Contrast?	No
N/A	X Walk 2 Width (In)	144.0	N/A	DWS 2 Length (In)	N/A
N/A	Road 2 Slope (%)	0.6	N/A	DWS 2 Full Width?	No

N/A	Road 2 X Slope (%)	2.1	N/A	DWS 2 Offset (In)	N/A
N/A	Refuge 3 Length (in)	N/A	N/A	Gutter 3 Ponding?	N/A
N/A	Refuge 3 Width (in)	N/A	N/A	Gutter 3 Lip Ht (in)	N/A
N/A	Refuge 3 Slope (%)	N/A	N/A	Gutter 3 Slope (%)	N/A
N/A	Refuge 3 XSlope (%)	N/A	N/A	Gutter 3 XSlope (%)	N/A
N/A	Painted X Walk3?	N/A	N/A	DWS 3 Provided?	N/A
N/A	X Walk 3 Direction	N/A	N/A	DWS 3 Contrast?	N/A
N/A	X Walk 3 Width (in)	N/A	N/A	DWS 3 Length (in)	N/A
N/A	Road 3 Slope (%)	N/A	N/A	DWS 3 Full Width?	N/A
N/A	Road 3 XSlope (%)	N/A	N/A	DWS 3 Offset (in)	N/A
Yes	Any Obstructions?	No	N/A	Storm Grate/Utility Hazard?	No
N/A	Obstruction Type		N/A	Storm Grate/Utility Type	
		N/A			N/A
N/A	Surface Condition	Good

Remove & Replace Entire Refuge.

Total Cost: \$ 3000.00
