# Access Compliance Report

## Public Rights-of-Way

### (Island Curb Cuts)

Intersection ID: 48600	Main Street: GRANDIFLORA_DR	Cross Street: LITTLE_GEM_LN	Location: NE
ADA ID: A47F4BFCCE2	Curb Cut Type: MedianRefuge2	Initial Pass/Fail: Fail	Overall Compliance: No
Severity Score: 0			
Codes/Mitigation Info/Possible Solution		Field Measurements/Component Compliance

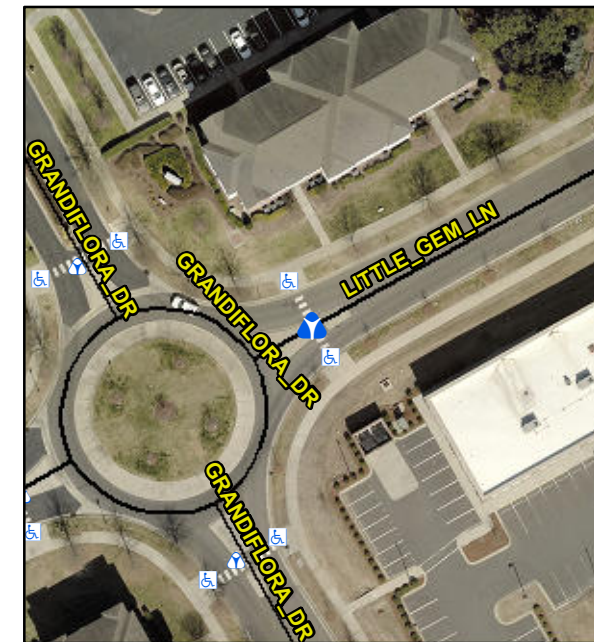
Compliance	Description	Data	Compliance	Description	Data
Yes	Refuge 1 Length (In)	48.5	N/A	Gutter 1 Ponding?	N/A
Yes	Refuge 1 Width (In)	122.0	N/A	Gutter 1 Lip Ht (In)	N/A
Yes	Refuge 1 Slope (%)	0.6	N/A	Gutter 1 Slope (%)	N/A
Yes	Refuge 1 X Slope (%)	1.7	N/A	Gutter 1 X Slope (%)	N/A
N/A	Painted X Walk1?	Yes	N/A	DWS 1 Provided?	N/A
N/A	X Walk 1 Direction	To SE	N/A	DWS 1 Contrast?	N/A
N/A	X Walk 1 Width (In)	53.0	N/A	DWS 1 Length (In)	N/A
N/A	Road 1 Slope (%)	2.2	N/A	DWS 1 Full Width?	N/A
N/A	Road 1 X Slope (%)	0.5	N/A	DWS 1 Offset (In)	N/A
Yes	Refuge 2 Length (In)	48.5	N/A	Gutter 2 Ponding?	N/A
Yes	Refuge 2 Width (In)	122.0	N/A	Gutter 2 Lip Ht (In)	N/A
Yes	Refuge 2 Slope (%)	0.2	N/A	Gutter 2 Slope (%)	N/A
Yes	Refuge 2 X Slope (%)	2.3	N/A	Gutter 2 X Slope (%)	N/A
N/A	Painted X Walk2?	Yes	N/A	DWS 2 Provided?	N/A
N/A	X Walk 2 Direction	To NW	N/A	DWS 2 Contrast?	N/A
N/A	X Walk 2 Width (In)	56.0	N/A	DWS 2 Length (In)	N/A

N/A	Road 2 Slope (%)	1.7	N/A	DWS 2 Full Width?	N/A
N/A	Road 2 X Slope (%)	1.5	N/A	DWS 2 Offset (In)	N/A
N/A	Refuge 3 Length (in)	N/A	N/A	Gutter 3 Ponding?	N/A
N/A	Refuge 3 Width (in)	N/A	N/A	Gutter 3 Lip Ht (in)	N/A
N/A	Refuge 3 Slope (%)	N/A	N/A	Gutter 3 Slope (%)	N/A
N/A	Refuge 3 XSlope (%)	N/A	N/A	Gutter 3 XSlope (%)	N/A
N/A	Painted X Walk3?	N/A	N/A	DWS 3 Provided?	N/A
N/A	X Walk 3 Direction	N/A	N/A	DWS 3 Contrast?	N/A
N/A	X Walk 3 Width (in)	N/A	N/A	DWS 3 Length (in)	N/A
N/A	Road 3 Slope (%)	N/A	N/A	DWS 3 Full Width?	N/A
N/A	Road 3 XSlope (%)	N/A	N/A	DWS 3 Offset (in)	N/A
Yes	Any Obstructions?	N/A	N/A	Storm Grate/Utility Hazard?	N/A
N/A	Obstruction Type		N/A	Storm Grate/Utility Type	
		N/A			N/A
N/A	Surface Condition	Good

Possible Solutions:

**Remove & Replace Entire Refuge.**

Total Cost: \$ 3000.00
