Access Compliance Report

Public Rights-of-Way

(Island Curb Cuts)

Intersection ID: 10040083	Main Street: TUCKASEEGEE_RD	Cross Street: N/A	Location: N
ADA ID: A55D95926746	Curb Cut Type: MedianRefuge2	Initial Pass/Fail: Fail	Overall Compliance: No
Codes/Mitigation Info/Possible Solution		Field Measurements/Component Compliance

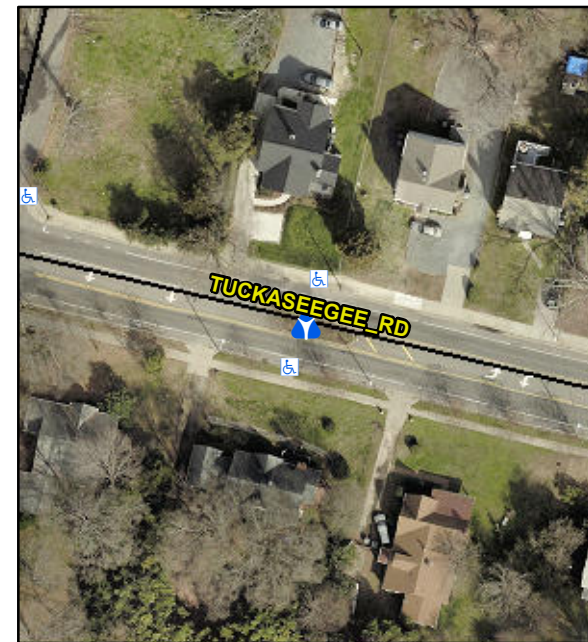
Compliance	Description	Data	Compliance	Description	Data
Yes	Refuge 1 Length (In)	50.0	N/A	Gutter 1 Ponding?	N/A
Yes	Refuge 1 Width (In)	98.0	N/A	Gutter 1 Lip Ht (In)	N/A
Yes	Refuge 1 Slope (%)	1.5	N/A	Gutter 1 Slope (%)	N/A
Yes	Refuge 1 X Slope (%)	0.1	N/A	Gutter 1 X Slope (%)	N/A
N/A	Painted X Walk1?	No	N/A	DWS 1 Provided?	N/A
N/A	X Walk 1 Direction	To N	N/A	DWS 1 Contrast?	N/A
N/A	X Walk 1 Width (In)	N/A	N/A	DWS 1 Length (In)	N/A
N/A	Road 1 Slope (%)	0.3	N/A	DWS 1 Full Width?	N/A
N/A	Road 1 X Slope (%)	6.8	N/A	DWS 1 Offset (In)	N/A
Yes	Refuge 2 Length (In)	50.0	N/A	Gutter 2 Ponding?	N/A
Yes	Refuge 2 Width (In)	98.0	N/A	Gutter 2 Lip Ht (In)	N/A
Yes	Refuge 2 Slope (%)	3.3	N/A	Gutter 2 Slope (%)	N/A
Yes	Refuge 2 X Slope (%)	2.1	N/A	Gutter 2 X Slope (%)	N/A
N/A	Painted X Walk2?	No	N/A	DWS 2 Provided?	N/A
N/A	X Walk 2 Direction	To S	N/A	DWS 2 Contrast?	N/A
N/A	X Walk 2 Width (In)	N/A	N/A	DWS 2 Length (In)	N/A

N/A	Road 2 Slope (%)	0.9	N/A	DWS 2 Full Width?	N/A
N/A	Road 2 X Slope (%)	3.3	N/A	DWS 2 Offset (In)	N/A
N/A	Refuge 3 Length (in)	N/A	N/A	Gutter 3 Ponding?	N/A
N/A	Refuge 3 Width (in)	N/A	N/A	Gutter 3 Lip Ht (in)	N/A
N/A	Refuge 3 Slope (%)	N/A	N/A	Gutter 3 Slope (%)	N/A
N/A	Refuge 3 XSlope (%)	N/A	N/A	Gutter 3 XSlope (%)	N/A
N/A	Painted X Walk3?	N/A	N/A	DWS 3 Provided?	N/A
N/A	X Walk 3 Direction	N/A	N/A	DWS 3 Contrast?	N/A
N/A	X Walk 3 Width (in)	N/A	N/A	DWS 3 Length (in)	N/A
N/A	Road 3 Slope (%)	N/A	N/A	DWS 3 Full Width?	N/A
N/A	Road 3 XSlope (%)	N/A	N/A	DWS 3 Offset (in)	N/A
Yes	Any Obstructions?	N/A	N/A	Storm Grate/Utility Hazard?	N/A
N/A	Obstruction Type		N/A	Storm Grate/Utility Type	
		N/A			N/A
N/A	Surface Condition	Good

Possible Solutions:

Remove & Replace Entire Refuge.
