# Access Compliance Report

## Public Rights-of-Way

### (Island Curb Cuts)

Intersection ID: 8113	Main Street: ORR_RD	Cross Street: GRIER_RD	Location: NW
ADA ID: A57242E8ABC3	Curb Cut Type: IslandRefuge3	Initial Pass/Fail: Fail	Overall Compliance: No
		Severity Score: 36.25

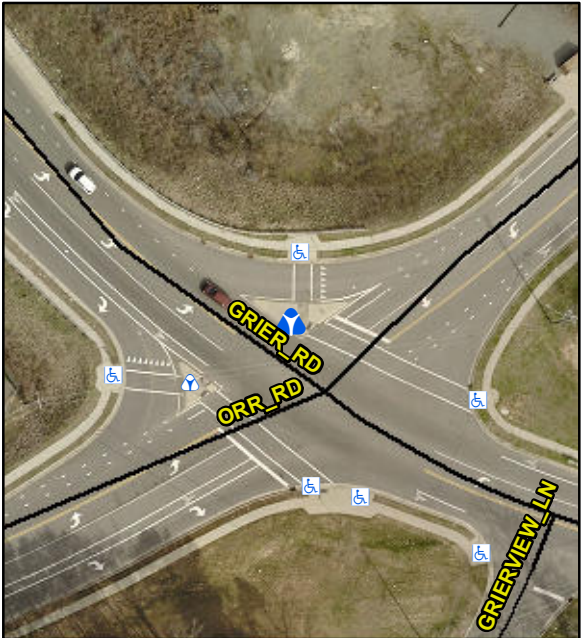
Possible Solutions:		<b>Compliance</b>	<b>Description</b>	<b>Data</b>	
	<b>Remove &amp; Replace Entire Refuge.</b>		<b>Yes</b>	Refuge 1 Length (In)	<b>73.0</b>	<b>N/A</b>
			<b>No</b>	Refuge 1 Width (In)	<b>59.0</b>	<b>N/A</b>
			<b>Yes</b>	Refuge 1 Slope (%)	<b>1.7</b>	<b>N/A</b>
			<b>Yes</b>	Refuge 1 X Slope (%)	<b>0.0</b>	<b>N/A</b>
			<b>N/A</b>	Painted X Walk1?	<b>Yes</b>	<b>N/A</b>
			<b>N/A</b>	X Walk 1 Direction	<b>To SE</b>	<b>N/A</b>
			<b>N/A</b>	X Walk 1 Width (In)	<b>117.0</b>	<b>N/A</b>
			<b>N/A</b>	Road 1 Slope (%)	<b>2.2</b>	<b>N/A</b>
			<b>N/A</b>	Road 1 X Slope (%)	<b>1.4</b>	<b>N/A</b>
<p>Surveyor Notes:</p> <p><b>N/A</b></p>			<b>Yes</b>	Refuge 2 Length (In)	<b>52.0</b>	<b>N/A</b>
			<b>Yes</b>	Refuge 2 Width (In)	<b>61.5</b>	<b>N/A</b>
			<b>Yes</b>	Refuge 2 Slope (%)	<b>2.7</b>	<b>N/A</b>
			<b>Yes</b>	Refuge 2 X Slope (%)	<b>0.1</b>	<b>N/A</b>

<b>N/A</b>	Painted X Walk2?	<b>No</b>	<b>N/A</b>
			<b>N/A</b>	X Walk 2 Direction	<b>To SW</b>	<b>N/A</b>
			<b>N/A</b>	X Walk 2 Width (In)	<b>N/A</b>	<b>N/A</b>
			<b>N/A</b>	Road 2 Slope (%)	<b>0.5</b>	<b>N/A</b>
			<b>N/A</b>	Road 2 X Slope (%)	<b>2.2</b>	<b>N/A</b>
			<b>Yes</b>	Refuge 3 Length (in)	<b>86.0</b>	<b>N/A</b>
<p>PROW/ADA:</p> <p><b>N/A</b></p>			<b>Yes</b>	Refuge 3 Width (in)	<b>60.0</b>	<b>N/A</b>
			<b>Yes</b>	Refuge 3 Slope (%)	<b>0.4</b>	<b>N/A</b>
			<b>Yes</b>	Refuge 3 XSlope (%)	<b>0.9</b>	<b>N/A</b>
			<b>N/A</b>	Painted X Walk3?	<b>Yes</b>	<b>N/A</b>
			<b>N/A</b>	X Walk 3 Direction	<b>To N</b>	<b>N/A</b>
			<b>N/A</b>	X Walk 3 Width (in)	<b>103.5</b>	<b>N/A</b>
			<b>N/A</b>	Road 3 Slope (%)	<b>1.9</b>	<b>N/A</b>
			<b>N/A</b>	Road 3 XSlope (%)	<b>2.8</b>	<b>N/A</b>
			<b>Yes</b>	Any Obstructions?	<b>N/A</b>	<b>N/A</b>
			<b>N/A</b>	Obstruction Type	<b>N/A</b>	<b>N/A</b>
<p>Total Cost:</p> <p><b>\$ 3000.00</b></p>			<b>N/A</b>	Storm Grate/Utility Hazard?	<b>N/A</b>	<b>N/A</b>

<b>N/A</b>	Storm Grate/Utility Type	<b>N/A</b>	<b>N/A</b>
			<b>N/A</b>		<b>N/A</b>	<b>N/A</b>
			<b>N/A</b>	Surface Condition	<b>Good</b>	<b>N/A</b>
