Access Compliance Report

Public Rights-of-Way

(Island Curb Cuts)

Intersection ID: 49003	Main Street: STEELE_CREEK_RD	Cross Street: STEELECROFT_PY	Location:	W
ADA ID: A689C4BA1A63	Curb Cut Type: MedianRefuge2	Initial Pass/Fail: Fail	Overall Compliance: No	Severity Score: 0
Codes/Mitigation Info/Possible Solution		Field Measurements/Component Compliance

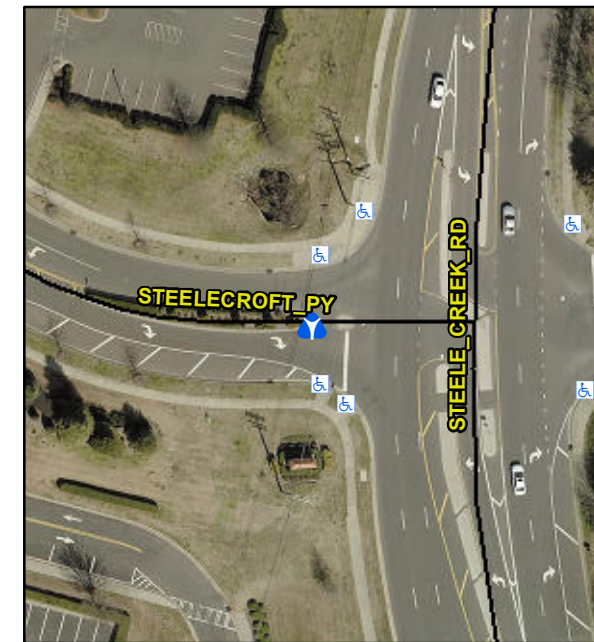
Compliance	Description	Data	Compliance	Description	Data
Yes	Refuge 1 Length (In)	45.0	N/A	Gutter 1 Ponding?	N/A
Yes	Refuge 1 Width (In)	156.0	N/A	Gutter 1 Lip Ht (In)	N/A
Yes	Refuge 1 Slope (%)	0.0	N/A	Gutter 1 Slope (%)	N/A
Yes	Refuge 1 X Slope (%)	2.3	N/A	Gutter 1 X Slope (%)	N/A
N/A	Painted X Walk1?	No	N/A	DWS 1 Provided?	N/A
N/A	X Walk 1 Direction	To N	N/A	DWS 1 Contrast?	N/A
N/A	X Walk 1 Width (In)	N/A	N/A	DWS 1 Length (In)	N/A
N/A	Road 1 Slope (%)	0.4	N/A	DWS 1 Full Width?	N/A
N/A	Road 1 X Slope (%)	2.6	N/A	DWS 1 Offset (In)	N/A
Yes	Refuge 2 Length (In)	45.0	N/A	Gutter 2 Ponding?	N/A
Yes	Refuge 2 Width (In)	156.0	N/A	Gutter 2 Lip Ht (In)	N/A
Yes	Refuge 2 Slope (%)	0.9	N/A	Gutter 2 Slope (%)	N/A
Yes	Refuge 2 X Slope (%)	1.9	N/A	Gutter 2 X Slope (%)	N/A
N/A	Painted X Walk2?	No	N/A	DWS 2 Provided?	N/A
N/A	X Walk 2 Direction	To S	N/A	DWS 2 Contrast?	N/A
N/A	X Walk 2 Width (In)	N/A	N/A	DWS 2 Length (In)	N/A

N/A	Road 2 Slope (%)	0.9	N/A	DWS 2 Full Width?	N/A
N/A	Road 2 X Slope (%)	2.2	N/A	DWS 2 Offset (In)	N/A
N/A	Refuge 3 Length (in)	N/A	N/A	Gutter 3 Ponding?	N/A
N/A	Refuge 3 Width (in)	N/A	N/A	Gutter 3 Lip Ht (in)	N/A
N/A	Refuge 3 Slope (%)	N/A	N/A	Gutter 3 Slope (%)	N/A
N/A	Refuge 3 XSlope (%)	N/A	N/A	Gutter 3 XSlope (%)	N/A
N/A	Painted X Walk3?	N/A	N/A	DWS 3 Provided?	N/A
N/A	X Walk 3 Direction	N/A	N/A	DWS 3 Contrast?	N/A
N/A	X Walk 3 Width (in)	N/A	N/A	DWS 3 Length (in)	N/A
N/A	Road 3 Slope (%)	N/A	N/A	DWS 3 Full Width?	N/A
N/A	Road 3 XSlope (%)	N/A	N/A	DWS 3 Offset (in)	N/A
Yes	Any Obstructions?	N/A	N/A	Storm Grate/Utility Hazard?	N/A
N/A	Obstruction Type		N/A	Storm Grate/Utility Type	
		N/A			N/A
N/A	Surface Condition	Good

Possible Solutions:

Remove & Replace Entire Refuge.
