Access Compliance Report

Public Rights-of-Way

(Island Curb Cuts)

Intersection ID: 28442	Main Street: IDLEWILD_RD	Cross Street: NARAYAN_ST	Location: E
ADA ID: A79343355BA9	Curb Cut Type: MedianRefuge2	Initial Pass/Fail: Fail	Overall Compliance: No
Codes/Mitigation Info/Possible Solution		Field Measurements/Component Compliance	
Severity Score: 25

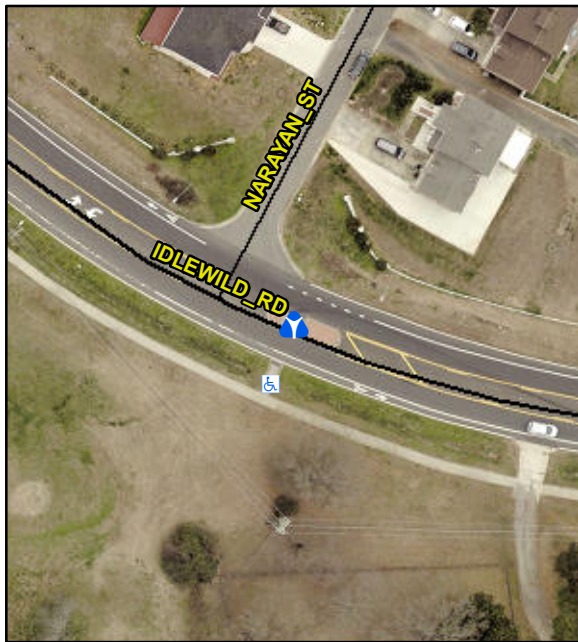
Compliance	Description	Data	Compliance	Description	Data
Yes	Refuge 1 Length (In)	66.0	N/A	Gutter 1 Ponding?	N/A
Yes	Refuge 1 Width (In)	120.0	N/A	Gutter 1 Lip Ht (In)	N/A
No	Refuge 1 Slope (%)	6.0	N/A	Gutter 1 Slope (%)	N/A
No	Refuge 1 X Slope (%)	5.4	N/A	Gutter 1 X Slope (%)	N/A
N/A	Painted X Walk1?	No	N/A	DWS 1 Provided?	N/A
N/A	X Walk 1 Direction	To N	N/A	DWS 1 Contrast?	N/A
N/A	X Walk 1 Width (In)	N/A	N/A	DWS 1 Length (In)	N/A
N/A	Road 1 Slope (%)	4.5	N/A	DWS 1 Full Width?	N/A
N/A	Road 1 X Slope (%)	8.6	N/A	DWS 1 Offset (In)	N/A
Yes	Refuge 2 Length (In)	66.0	N/A	Gutter 2 Ponding?	N/A
Yes	Refuge 2 Width (In)	120.0	N/A	Gutter 2 Lip Ht (In)	N/A
No	Refuge 2 Slope (%)	6.4	N/A	Gutter 2 Slope (%)	N/A
Yes	Refuge 2 X Slope (%)	4.7	N/A	Gutter 2 X Slope (%)	N/A
N/A	Painted X Walk2?	No	N/A	DWS 2 Provided?	N/A
N/A	X Walk 2 Direction	To S	N/A	DWS 2 Contrast?	N/A
N/A	X Walk 2 Width (In)	N/A	N/A	DWS 2 Length (In)	N/A

Remove & Replace Entire Refuge.

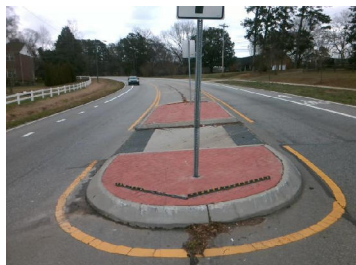
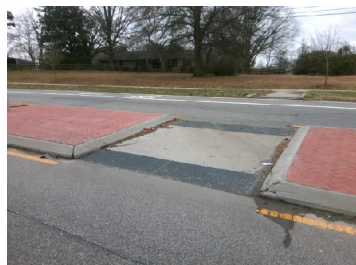
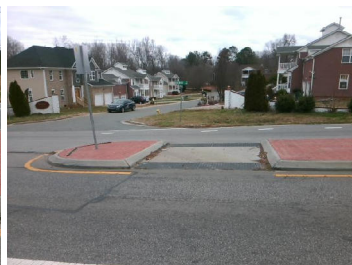
N/A	Road 2 Slope (%)	4.9	N/A	DWS 2 Full Width?	N/A
N/A	Road 2 X Slope (%)	5.5	N/A	DWS 2 Offset (In)	N/A
N/A	Refuge 3 Length (in)	N/A	N/A	Gutter 3 Ponding?	N/A
N/A	Refuge 3 Width (in)	N/A	N/A	Gutter 3 Lip Ht (in)	N/A
N/A	Refuge 3 Slope (%)	N/A	N/A	Gutter 3 Slope (%)	N/A
N/A	Refuge 3 XSlope (%)	N/A	N/A	Gutter 3 XSlope (%)	N/A
N/A	Painted X Walk3?	N/A	N/A	DWS 3 Provided?	N/A
N/A	X Walk 3 Direction	N/A	N/A	DWS 3 Contrast?	N/A
N/A	X Walk 3 Width (in)	N/A	N/A	DWS 3 Length (in)	N/A
N/A	Road 3 Slope (%)	N/A	N/A	DWS 3 Full Width?	N/A
N/A	Road 3 XSlope (%)	N/A	N/A	DWS 3 Offset (in)	N/A
Yes	Any Obstructions?	N/A	N/A	Storm Grate/Utility Hazard?	N/A
N/A	Obstruction Type		N/A	Storm Grate/Utility Type	
		N/A			N/A
N/A	Surface Condition	Good
