Access Compliance Report

Public Rights-of-Way

(Island Curb Cuts)

Intersection ID: 11693	Main Street: E_12TH_ST	Cross Street: N_COLLEGE_ST	Location: NE
ADA ID: AAFDF67DFA2D	Curb Cut Type: MedianRefuge2	Initial Pass/Fail: Fail	Overall Compliance: No
Severity Score: 33.75			
Codes/Mitigation Info/Possible Solution		Field Measurements/Component Compliance

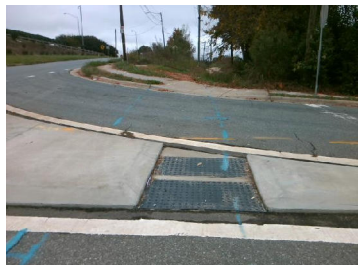
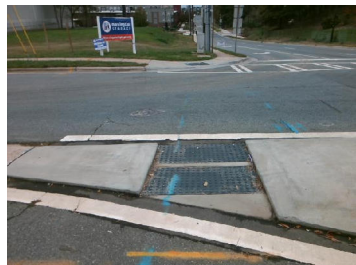
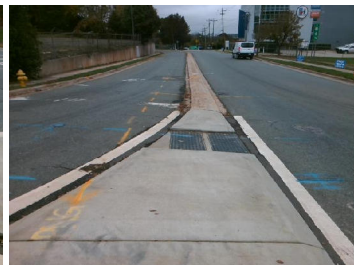
Compliance	Description	Data	Compliance	Description	Data
No	Refuge 1 Length (In)	27.0	N/A	Gutter 1 Ponding?	N/A
No	Refuge 1 Width (In)	48.0	N/A	Gutter 1 Lip Ht (In)	N/A
No	Refuge 1 Slope (%)	7.9	N/A	Gutter 1 Slope (%)	N/A
Yes	Refuge 1 X Slope (%)	3.2	N/A	Gutter 1 X Slope (%)	N/A
N/A	Painted X Walk1?	No	N/A	DWS 1 Provided?	N/A
N/A	X Walk 1 Direction	To SE	N/A	DWS 1 Contrast?	N/A
N/A	X Walk 1 Width (In)	N/A	N/A	DWS 1 Length (In)	N/A
N/A	Road 1 Slope (%)	2.1	N/A	DWS 1 Full Width?	N/A
N/A	Road 1 X Slope (%)	6.7	N/A	DWS 1 Offset (In)	N/A
No	Refuge 2 Length (In)	27.0	N/A	Gutter 2 Ponding?	N/A
No	Refuge 2 Width (In)	48.0	N/A	Gutter 2 Lip Ht (In)	N/A
No	Refuge 2 Slope (%)	9.7	N/A	Gutter 2 Slope (%)	N/A
Yes	Refuge 2 X Slope (%)	4.1	N/A	Gutter 2 X Slope (%)	N/A
N/A	Painted X Walk2?	No	N/A	DWS 2 Provided?	N/A
N/A	X Walk 2 Direction	To NW	N/A	DWS 2 Contrast?	N/A
N/A	X Walk 2 Width (In)	N/A	N/A	DWS 2 Length (In)	N/A
N/A	Road 2 Slope (%)	3.8	N/A	DWS 2 Full Width?	N/A

N/A	Road 2 X Slope (%)	10.5	N/A	DWS 2 Offset (In)	N/A
N/A	Refuge 3 Length (in)	N/A	N/A	Gutter 3 Ponding?	N/A
N/A	Refuge 3 Width (in)	N/A	N/A	Gutter 3 Lip Ht (in)	N/A
N/A	Refuge 3 Slope (%)	N/A	N/A	Gutter 3 Slope (%)	N/A
N/A	Refuge 3 XSlope (%)	N/A	N/A	Gutter 3 XSlope (%)	N/A
N/A	Painted X Walk3?	N/A	N/A	DWS 3 Provided?	N/A
N/A	X Walk 3 Direction	N/A	N/A	DWS 3 Contrast?	N/A
N/A	X Walk 3 Width (in)	N/A	N/A	DWS 3 Length (in)	N/A
N/A	Road 3 Slope (%)	N/A	N/A	DWS 3 Full Width?	N/A
N/A	Road 3 XSlope (%)	N/A	N/A	DWS 3 Offset (in)	N/A
Yes	Any Obstructions?	N/A	N/A	Storm Grate/Utility Hazard?	N/A
N/A	Obstruction Type		N/A	Storm Grate/Utility Type	
		N/A			N/A
N/A	Surface Condition	Good

Remove & Replace Entire Refuge.
