# Access Compliance Report

## Public Rights-of-Way

### (Island Curb Cuts)

Intersection ID: 10032864	Main Street: NATIONS_FORD_RD	Cross Street: N/A	Location: N
ADA ID: AC00D4FA7D7F	Curb Cut Type: MedianRefuge2	Initial Pass/Fail: Pass	Overall Compliance: Yes
Codes/Mitigation Info/Possible Solution		Field Measurements/Component Compliance

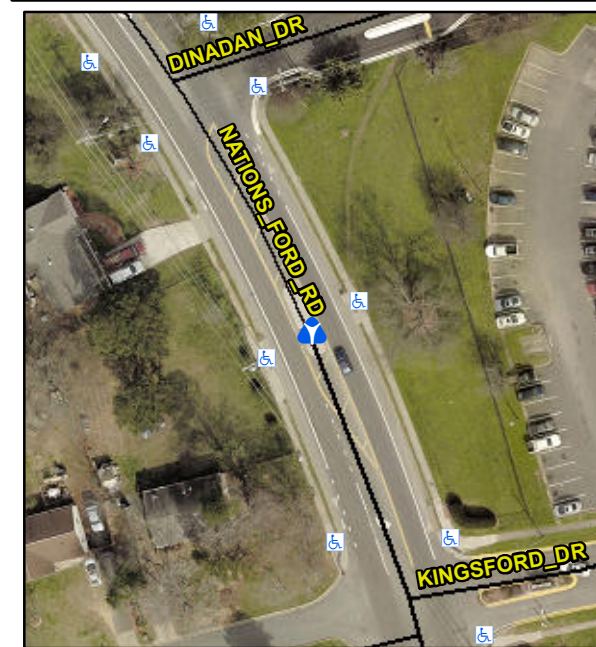
Compliance	Description	Data	Compliance	Description	Data
Yes	Refuge 1 Length (In)	54.	Yes	Gutter 1 Ponding?	No
Yes	Refuge 1 Width (In)	100.	Yes	Gutter 1 Lip Ht (In)	0.0
Yes	Refuge 1 Slope (%)	0.8	Yes	Gutter 1 Slope (%)	0.8
Yes	Refuge 1 X Slope (%)	1.1	Yes	Gutter 1 X Slope (%)	0.2
N/A	Painted X Walk1?	No	Yes	DWS 1 Provided?	Yes
N/A	X Walk 1 Direction	To W	Yes	DWS 1 Contrast?	Yes
N/A	X Walk 1 Width (In)	N/A	Yes	DWS 1 Length (In)	24.0
N/A	Road 1 Slope (%)	0.1	Yes	DWS 1 Full Width?	Yes
N/A	Road 1 X Slope (%)	0.1	Yes	DWS 1 Offset (In)	0.0
Yes	Refuge 2 Length (In)	54.0	Yes	Gutter 2 Ponding?	No
Yes	Refuge 2 Width (In)	100.	Yes	Gutter 2 Lip Ht (In)	0.0
Yes	Refuge 2 Slope (%)	4.0	Yes	Gutter 2 Slope (%)	5.0
Yes	Refuge 2 X Slope (%)	0.8	Yes	Gutter 2 X Slope (%)	0.1
N/A	Painted X Walk2?	No	Yes	DWS 2 Provided?	Yes
N/A	X Walk 2 Direction	To E	Yes	DWS 2 Contrast?	Yes
N/A	X Walk 2 Width (In)	N/A	Yes	DWS 2 Length (In)	24.0

N/A	Road 2 Slope (%)	0.2	Yes	DWS 2 Full Width?	Yes
N/A	Road 2 X Slope (%)	4.3	Yes	DWS 2 Offset (In)	0.0
N/A	Refuge 3 Length (in)	N/A	N/A	Gutter 3 Ponding?	N/A
N/A	Refuge 3 Width (in)	N/A	N/A	Gutter 3 Lip Ht (in)	N/A
N/A	Refuge 3 Slope (%)	N/A	N/A	Gutter 3 Slope (%)	N/A
N/A	Refuge 3 XSlope (%)	N/A	N/A	Gutter 3 XSlope (%)	N/A
N/A	Painted X Walk3?	N/A	N/A	DWS 3 Provided?	N/A
N/A	X Walk 3 Direction	N/A	N/A	DWS 3 Contrast?	N/A
N/A	X Walk 3 Width (in)	N/A	N/A	DWS 3 Length (in)	N/A
N/A	Road 3 Slope (%)	N/A	N/A	DWS 3 Full Width?	N/A
N/A	Road 3 XSlope (%)	N/A	N/A	DWS 3 Offset (in)	N/A
Yes	Any Obstructions?	N/A	N/A	Storm Grate/Utility Hazard?	No
N/A	Obstruction Type		N/A	Storm Grate/Utility Type	
		N/A			N/A
N/A	Surface Condition	Good

Possible Solutions:

N/A
