# Access Compliance Report

## Public Rights-of-Way

### (Island Curb Cuts)

Intersection ID: 6102	Main Street: UNIVERSITY_CITY_BV	Cross Street: UNIVERSITY_PROFESSIONAL_DR	Location: N
ADA ID: B1B8DBFF69FF	Curb Cut Type: IslandRefuge3	Initial Pass/Fail: Fail	Overall Compliance: No
		Severity Score: 36.25

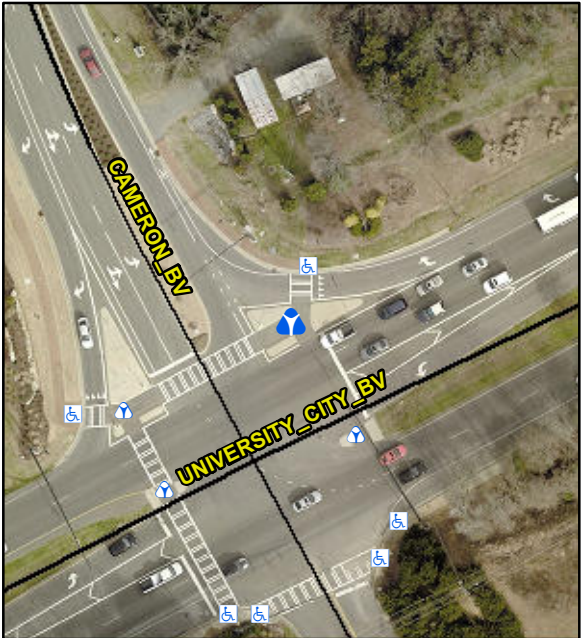
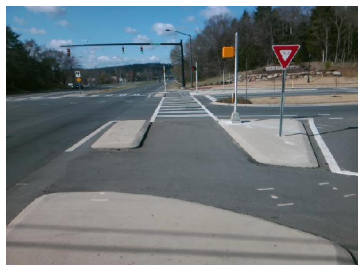
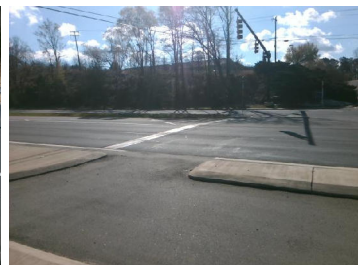
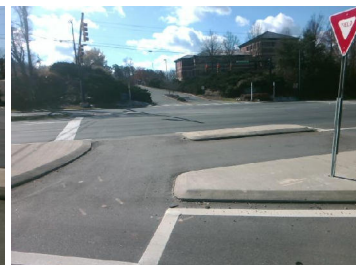
Possible Solutions:		<b>Compliance</b>	<b>Description</b>	<b>Data</b>	
	<b>Remove &amp; Replace Entire Refuge.</b>		<b>Yes</b>	Refuge 1 Length (In)	<b>93.0</b>	<b>N/A</b>
			<b>Yes</b>	Refuge 1 Width (In)	<b>121.0</b>	<b>N/A</b>
			<b>Yes</b>	Refuge 1 Slope (%)	<b>2.4</b>	<b>N/A</b>
			<b>Yes</b>	Refuge 1 X Slope (%)	<b>3.3</b>	<b>N/A</b>
			<b>N/A</b>	Painted X Walk1?	<b>Yes</b>	<b>N/A</b>
			<b>N/A</b>	X Walk 1 Direction	<b>To W</b>	<b>N/A</b>
			<b>N/A</b>	X Walk 1 Width (In)	<b>116.0</b>	<b>N/A</b>
			<b>N/A</b>	Road 1 Slope (%)	<b>3.3</b>	<b>N/A</b>
			<b>N/A</b>	Road 1 X Slope (%)	<b>2.4</b>	<b>N/A</b>
Surveyor Notes:  <b>N/A</b>			<b>Yes</b>	Refuge 2 Length (In)	<b>93.0</b>	<b>N/A</b>
			<b>Yes</b>	Refuge 2 Width (In)	<b>114.0</b>	<b>N/A</b>
			<b>Yes</b>	Refuge 2 Slope (%)	<b>3.6</b>	<b>N/A</b>
			<b>Yes</b>	Refuge 2 X Slope (%)	<b>5.0</b>	<b>N/A</b>

<b>N/A</b>	Painted X Walk2?	<b>Yes</b>	<b>N/A</b>
			<b>N/A</b>	X Walk 2 Direction	<b>To N</b>	<b>N/A</b>
			<b>N/A</b>	X Walk 2 Width (In)	<b>123.0</b>	<b>N/A</b>
			<b>N/A</b>	Road 2 Slope (%)	<b>5.0</b>	<b>N/A</b>
			<b>N/A</b>	Road 2 X Slope (%)	<b>3.6</b>	<b>N/A</b>
			<b>Yes</b>	Refuge 3 Length (in)	<b>49.0</b>	<b>N/A</b>
PROW/ADA:  <b>N/A</b>			<b>Yes</b>	Refuge 3 Width (in)	<b>121.0</b>	<b>N/A</b>
			<b>Yes</b>	Refuge 3 Slope (%)	<b>2.8</b>	<b>N/A</b>
			<b>Yes</b>	Refuge 3 XSlope (%)	<b>3.2</b>	<b>N/A</b>
			<b>N/A</b>	Painted X Walk3?	<b>No</b>	<b>N/A</b>
			<b>N/A</b>	X Walk 3 Direction	<b>To S</b>	<b>N/A</b>
			<b>N/A</b>	X Walk 3 Width (in)	<b>N/A</b>	<b>N/A</b>
			<b>N/A</b>	Road 3 Slope (%)	<b>1.6</b>	<b>N/A</b>
			<b>N/A</b>	Road 3 XSlope (%)	<b>2.9</b>	<b>N/A</b>
			<b>Yes</b>	Any Obstructions?	<b>N/A</b>	<b>N/A</b>
			<b>N/A</b>	Obstruction Type	<b>N/A</b>	<b>N/A</b>
Total Cost: <div>             \$             3000.00           </div>			<b>N/A</b>	Surface Condition	<b>Good</b>	<b>N/A</b>
