# Access Compliance Report

## Public Rights-of-Way

### (Island Curb Cuts)

Intersection ID: 8157	Main Street: N_TRYON_ST	Cross Street: ORR_RD	Location: SW
ADA ID: B2A5BD5BC085	Curb Cut Type: MedianRefuge2	Initial Pass/Fail: Pass	Overall Compliance: No
Severity Score: 0.25			
Codes/Mitigation Info/Possible Solution		Field Measurements/Component Compliance

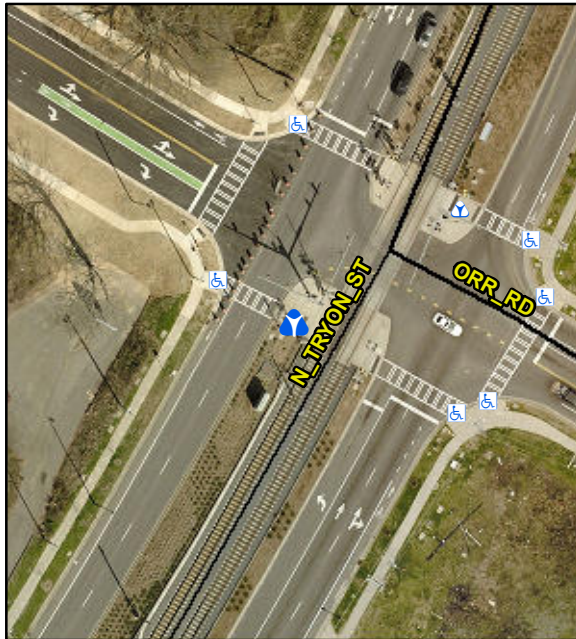
Compliance	Description	Data	Compliance	Description	Data
Yes	Refuge 1 Length (In)	122.5	Yes	Gutter 1 Ponding?	No
Yes	Refuge 1 Width (In)	121.0	Yes	Gutter 1 Lip Ht (In)	0.0
Yes	Refuge 1 Slope (%)	2.2	Yes	Gutter 1 Slope (%)	1.6
Yes	Refuge 1 X Slope (%)	0.9	Yes	Gutter 1 X Slope (%)	0.5
N/A	Painted X Walk1?	No	Yes	DWS 1 Provided?	Yes
N/A	X Walk 1 Direction	To E	Yes	DWS 1 Contrast?	Yes
N/A	X Walk 1 Width (In)	N/A	Yes	DWS 1 Length (In)	24.0
N/A	Road 1 Slope (%)	0.6	Yes	DWS 1 Full Width?	Yes
N/A	Road 1 X Slope (%)	1.1	No	DWS 1 Offset (In)	42.0
Yes	Refuge 2 Length (In)	122.5	No	Gutter 2 Ponding?	Yes
Yes	Refuge 2 Width (In)	121.0	Yes	Gutter 2 Lip Ht (In)	0.0
Yes	Refuge 2 Slope (%)	1.8	Yes	Gutter 2 Slope (%)	1.4
Yes	Refuge 2 X Slope (%)	1.9	No	Gutter 2 X Slope (%)	2.2
N/A	Painted X Walk2?	Yes	Yes	DWS 2 Provided?	Yes
N/A	X Walk 2 Direction	To W	Yes	DWS 2 Contrast?	Yes
N/A	X Walk 2 Width (In)	102.0	Yes	DWS 2 Length (In)	24.0

N/A	Road 2 Slope (%)	0.5	Yes	DWS 2 Full Width?	Yes
N/A	Road 2 X Slope (%)	2.0	Yes	DWS 2 Offset (In)	0.0
N/A	Refuge 3 Length (in)	N/A	N/A	Gutter 3 Ponding?	N/A
N/A	Refuge 3 Width (in)	N/A	N/A	Gutter 3 Lip Ht (in)	N/A
N/A	Refuge 3 Slope (%)	N/A	N/A	Gutter 3 Slope (%)	N/A
N/A	Refuge 3 XSlope (%)	N/A	N/A	Gutter 3 XSlope (%)	N/A
N/A	Painted X Walk3?	N/A	N/A	DWS 3 Provided?	N/A
N/A	X Walk 3 Direction	N/A	N/A	DWS 3 Contrast?	N/A
N/A	X Walk 3 Width (in)	N/A	N/A	DWS 3 Length (in)	N/A
N/A	Road 3 Slope (%)	N/A	N/A	DWS 3 Full Width?	N/A
N/A	Road 3 XSlope (%)	N/A	N/A	DWS 3 Offset (in)	N/A
Yes	Any Obstructions?	N/A	N/A	Storm Grate/Utility Hazard?	No
N/A	Obstruction Type		N/A	Storm Grate/Utility Type	
		N/A			N/A
N/A	Surface Condition	Good

Possible Solutions:

**Remove & Replace Detectable Warning System. Remove & Replace Gutter.**

Total Cost: \$ 1550.00
