# Access Compliance Report

## Public Rights-of-Way

### (Island Curb Cuts)

Intersection ID: 15584	Main Street: BONLYN_DR	Cross Street: E_W_T_HARRIS_BV	Location: N
ADA ID: B31AA87409C1	Curb Cut Type: MedianRefuge2	Initial Pass/Fail: Fail	Overall Compliance: No
Severity Score: 1.25			
Codes/Mitigation Info/Possible Solution		Field Measurements/Component Compliance

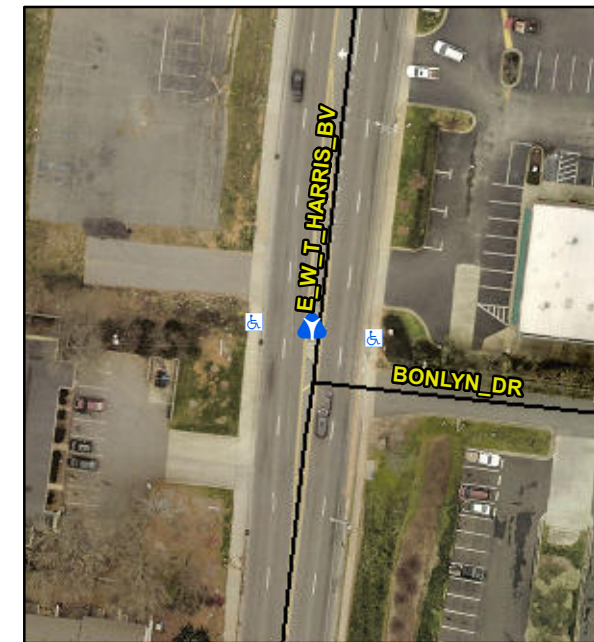
Compliance	Description	Data	Compliance	Description	Data
Yes	Refuge 1 Length (In)	36.25	N/A	Gutter 1 Ponding?	N/A
Yes	Refuge 1 Width (In)	100.0	N/A	Gutter 1 Lip Ht (In)	N/A
Yes	Refuge 1 Slope (%)	4.1	N/A	Gutter 1 Slope (%)	N/A
Yes	Refuge 1 X Slope (%)	2.2	N/A	Gutter 1 X Slope (%)	N/A
N/A	Painted X Walk1?	No	N/A	DWS 1 Provided?	N/A
N/A	X Walk 1 Direction	To W	N/A	DWS 1 Contrast?	N/A
N/A	X Walk 1 Width (In)	N/A	N/A	DWS 1 Length (In)	N/A
N/A	Road 1 Slope (%)	2.2	N/A	DWS 1 Full Width?	N/A
N/A	Road 1 X Slope (%)	3.6	N/A	DWS 1 Offset (In)	N/A
Yes	Refuge 2 Length (In)	36.25	N/A	Gutter 2 Ponding?	N/A
Yes	Refuge 2 Width (In)	100.0	N/A	Gutter 2 Lip Ht (In)	N/A
Yes	Refuge 2 Slope (%)	1.4	N/A	Gutter 2 Slope (%)	N/A
Yes	Refuge 2 X Slope (%)	1.7	N/A	Gutter 2 X Slope (%)	N/A
N/A	Painted X Walk2?	No	N/A	DWS 2 Provided?	N/A
N/A	X Walk 2 Direction	To E	N/A	DWS 2 Contrast?	N/A
N/A	X Walk 2 Width (In)	N/A	N/A	DWS 2 Length (In)	N/A

N/A	Road 2 Slope (%)	1.9	N/A	DWS 2 Full Width?	N/A
N/A	Road 2 X Slope (%)	5.3	N/A	DWS 2 Offset (In)	N/A
N/A	Refuge 3 Length (in)	N/A	N/A	Gutter 3 Ponding?	N/A
N/A	Refuge 3 Width (in)	N/A	N/A	Gutter 3 Lip Ht (in)	N/A
N/A	Refuge 3 Slope (%)	N/A	N/A	Gutter 3 Slope (%)	N/A
N/A	Refuge 3 XSlope (%)	N/A	N/A	Gutter 3 XSlope (%)	N/A
N/A	Painted X Walk3?	N/A	N/A	DWS 3 Provided?	N/A
N/A	X Walk 3 Direction	N/A	N/A	DWS 3 Contrast?	N/A
N/A	X Walk 3 Width (in)	N/A	N/A	DWS 3 Length (in)	N/A
N/A	Road 3 Slope (%)	N/A	N/A	DWS 3 Full Width?	N/A
N/A	Road 3 XSlope (%)	N/A	N/A	DWS 3 Offset (in)	N/A
Yes	Any Obstructions?	N/A	N/A	Storm Grate/Utility Hazard?	N/A
N/A	Obstruction Type		N/A	Storm Grate/Utility Type	
		N/A			N/A
N/A	Surface Condition	Good

**Remove & Replace Entire Refuge.**

**\$ 3000.00**
