Access Compliance Report

Public Rights-of-Way

(Island Curb Cuts)

Intersection ID: 14455	Main Street: EAST_BV	Cross Street: WINTHROP_AV	Location: NW
ADA ID: B665F3E6A336	Curb Cut Type: MedianRefuge2	Initial Pass/Fail: Fail	Overall Compliance: No
Severity Score: 1.25			
Codes/Mitigation Info/Possible Solution		Field Measurements/Component Compliance

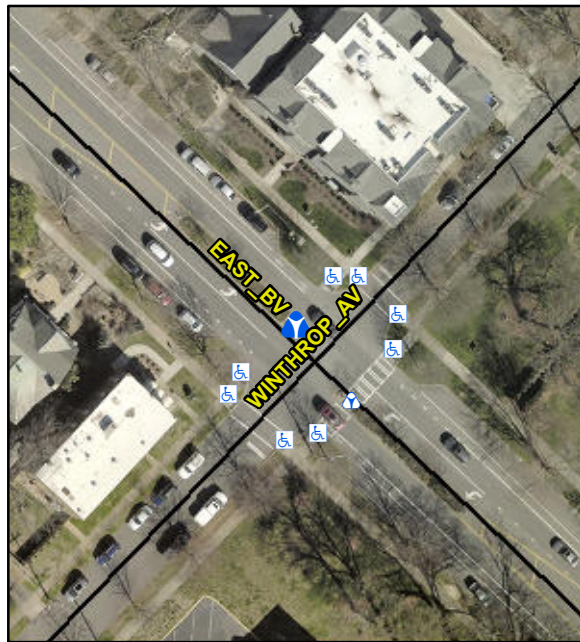
Compliance	Description	Data	Compliance	Description	Data
Yes	Refuge 1 Length (In)	41.5	N/A	Gutter 1 Ponding?	N/A
Yes	Refuge 1 Width (In)	98.0	N/A	Gutter 1 Lip Ht (In)	N/A
Yes	Refuge 1 Slope (%)	0.4	N/A	Gutter 1 Slope (%)	N/A
Yes	Refuge 1 X Slope (%)	2.5	N/A	Gutter 1 X Slope (%)	N/A
N/A	Painted X Walk1?	No	N/A	DWS 1 Provided?	N/A
N/A	X Walk 1 Direction	To SW	N/A	DWS 1 Contrast?	N/A
N/A	X Walk 1 Width (In)	N/A	N/A	DWS 1 Length (In)	N/A
N/A	Road 1 Slope (%)	1.4	N/A	DWS 1 Full Width?	N/A
N/A	Road 1 X Slope (%)	1.5	N/A	DWS 1 Offset (In)	N/A
Yes	Refuge 2 Length (In)	41.5	N/A	Gutter 2 Ponding?	N/A
Yes	Refuge 2 Width (In)	98.0	N/A	Gutter 2 Lip Ht (In)	N/A
Yes	Refuge 2 Slope (%)	2.5	N/A	Gutter 2 Slope (%)	N/A
Yes	Refuge 2 X Slope (%)	1.9	N/A	Gutter 2 X Slope (%)	N/A
N/A	Painted X Walk2?	No	N/A	DWS 2 Provided?	N/A
N/A	X Walk 2 Direction	To NE	N/A	DWS 2 Contrast?	N/A
N/A	X Walk 2 Width (In)	N/A	N/A	DWS 2 Length (In)	N/A

N/A	Road 2 Slope (%)	0.8	N/A	DWS 2 Full Width?	N/A
N/A	Road 2 X Slope (%)	2.6	N/A	DWS 2 Offset (In)	N/A
N/A	Refuge 3 Length (in)	N/A	N/A	Gutter 3 Ponding?	N/A
N/A	Refuge 3 Width (in)	N/A	N/A	Gutter 3 Lip Ht (in)	N/A
N/A	Refuge 3 Slope (%)	N/A	N/A	Gutter 3 Slope (%)	N/A
N/A	Refuge 3 XSlope (%)	N/A	N/A	Gutter 3 XSlope (%)	N/A
N/A	Painted X Walk3?	N/A	N/A	DWS 3 Provided?	N/A
N/A	X Walk 3 Direction	N/A	N/A	DWS 3 Contrast?	N/A
N/A	X Walk 3 Width (in)	N/A	N/A	DWS 3 Length (in)	N/A
N/A	Road 3 Slope (%)	N/A	N/A	DWS 3 Full Width?	N/A
N/A	Road 3 XSlope (%)	N/A	N/A	DWS 3 Offset (in)	N/A
Yes	Any Obstructions?	N/A	N/A	Storm Grate/Utility Hazard?	N/A
N/A	Obstruction Type		N/A	Storm Grate/Utility Type	
			N/A		N/A
N/A	Surface Condition	Good

Possible Solutions:

Remove & Replace Entire Refuge.

Total Cost: \$ 3000.00
