Access Compliance Report

Public Rights-of-Way

(Island Curb Cuts)

Intersection ID: 3494	Main Street: REAMES_RD	Cross Street: W_W_T_HARRIS_BV	Location: SW
ADA ID: B6EFC0E83F86	Curb Cut Type: IslandRefuge3	Initial Pass/Fail: Fail	Overall Compliance: No
Severity Score: 47.5			
Codes/Mitigation Info/Possible Solution		Field Measurements/Component Compliance

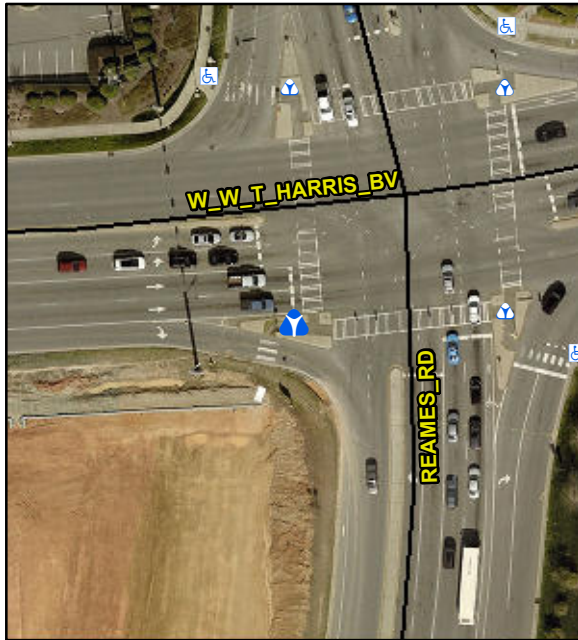
Compliance	Description	Data	Compliance	Description	Data
Yes	Refuge 1 Length (In)	36.0	N/A	Gutter 1 Ponding?	N/A
Yes	Refuge 1 Width (In)	78.0	N/A	Gutter 1 Lip Ht (In)	N/A
Yes	Refuge 1 Slope (%)	0.8	N/A	Gutter 1 Slope (%)	N/A
Yes	Refuge 1 X Slope (%)	1.6	N/A	Gutter 1 X Slope (%)	N/A
N/A	Painted X Walk1?	Yes	N/A	DWS 1 Provided?	N/A
N/A	X Walk 1 Direction	To S	N/A	DWS 1 Contrast?	N/A
N/A	X Walk 1 Width (In)	124.0	N/A	DWS 1 Length (In)	N/A
N/A	Road 1 Slope (%)	2.5	N/A	DWS 1 Full Width?	N/A
N/A	Road 1 X Slope (%)	3.8	N/A	DWS 1 Offset (In)	N/A
Yes	Refuge 2 Length (In)	54.0	N/A	Gutter 2 Ponding?	N/A
Yes	Refuge 2 Width (In)	73.0	N/A	Gutter 2 Lip Ht (In)	N/A
Yes	Refuge 2 Slope (%)	2.3	N/A	Gutter 2 Slope (%)	N/A
Yes	Refuge 2 X Slope (%)	2.2	N/A	Gutter 2 X Slope (%)	N/A
N/A	Painted X Walk2?	Yes	N/A	DWS 2 Provided?	N/A
N/A	X Walk 2 Direction	To N	N/A	DWS 2 Contrast?	N/A
N/A	X Walk 2 Width (In)	109.0	N/A	DWS 2 Length (In)	N/A

N/A	Road 2 Slope (%)	3.5	N/A	DWS 2 Full Width?	N/A
N/A	Road 2 X Slope (%)	6.2	N/A	DWS 2 Offset (In)	N/A
Yes	Refuge 3 Length (in)	75.0	N/A	Gutter 3 Ponding?	N/A
Yes	Refuge 3 Width (in)	71.0	N/A	Gutter 3 Lip Ht (in)	N/A
No	Refuge 3 Slope (%)	5.1	N/A	Gutter 3 Slope (%)	N/A
Yes	Refuge 3 XSlope (%)	2.1	N/A	Gutter 3 XSlope (%)	N/A
N/A	Painted X Walk3?	Yes	N/A	DWS 3 Provided?	N/A
N/A	X Walk 3 Direction	To E	N/A	DWS 3 Contrast?	N/A
N/A	X Walk 3 Width (in)	112.0	N/A	DWS 3 Length (in)	N/A
N/A	Road 3 Slope (%)	1.7	N/A	DWS 3 Full Width?	N/A
N/A	Road 3 XSlope (%)	1.6	N/A	DWS 3 Offset (in)	N/A
Yes	Any Obstructions?	N/A	N/A	Storm Grate/Utility Hazard?	N/A
N/A	Obstruction Type		N/A	Storm Grate/Utility Type	
		N/A			N/A
N/A	Surface Condition	Good

Remove & Replace Entire Refuge.
