Access Compliance Report

Public Rights-of-Way

(Island Curb Cuts)

Intersection ID: 23288	Main Street: ALEXANDER_RD	Cross Street: SHAFTESBURY_RD	Location: SW
ADA ID: B8D3786C4458	Curb Cut Type: MedianRefuge2	Initial Pass/Fail: Pass	Overall Compliance: No
Codes/Mitigation Info/Possible Solution		Field Measurements/Component Compliance

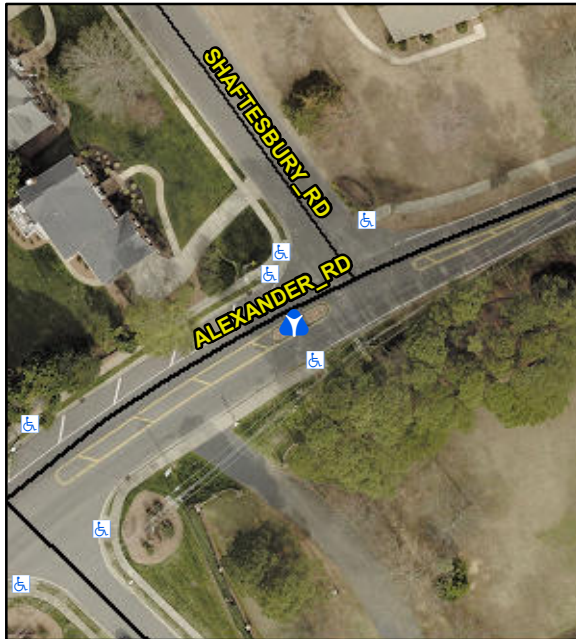
Compliance	Description	Data	Compliance	Description	Data
Yes	Refuge 1 Length (In)	36.0	Yes	Gutter 1 Ponding?	No
Yes	Refuge 1 Width (In)	99.0	Yes	Gutter 1 Lip Ht (In)	0.0
Yes	Refuge 1 Slope (%)	1.9	Yes	Gutter 1 Slope (%)	5.0
Yes	Refuge 1 X Slope (%)	0.1	Yes	Gutter 1 X Slope (%)	1.3
N/A	Painted X Walk1?	No	Yes	DWS 1 Provided?	Yes
N/A	X Walk 1 Direction	To NW	Yes	DWS 1 Contrast?	Yes
N/A	X Walk 1 Width (In)	N/A	Yes	DWS 1 Length (In)	24.5
N/A	Road 1 Slope (%)	0.6	Yes	DWS 1 Full Width?	Yes
N/A	Road 1 X Slope (%)	1.5	No	DWS 1 Offset (In)	3.0
Yes	Refuge 2 Length (In)	36.0	Yes	Gutter 2 Ponding?	No
Yes	Refuge 2 Width (In)	99.0	Yes	Gutter 2 Lip Ht (In)	0.0
Yes	Refuge 2 Slope (%)	2.3	Yes	Gutter 2 Slope (%)	1.8
Yes	Refuge 2 X Slope (%)	1.1	Yes	Gutter 2 X Slope (%)	0.5
N/A	Painted X Walk2?	No	Yes	DWS 2 Provided?	Yes
N/A	X Walk 2 Direction	To SE	Yes	DWS 2 Contrast?	Yes
N/A	X Walk 2 Width (In)	N/A	Yes	DWS 2 Length (In)	24.5

N/A	Road 2 Slope (%)	0.6	Yes	DWS 2 Full Width?	Yes
N/A	Road 2 X Slope (%)	5.2	No	DWS 2 Offset (In)	3.0
N/A	Refuge 3 Length (in)	N/A	N/A	Gutter 3 Ponding?	N/A
N/A	Refuge 3 Width (in)	N/A	N/A	Gutter 3 Lip Ht (in)	N/A
N/A	Refuge 3 Slope (%)	N/A	N/A	Gutter 3 Slope (%)	N/A
N/A	Refuge 3 XSlope (%)	N/A	N/A	Gutter 3 XSlope (%)	N/A
N/A	Painted X Walk3?	N/A	N/A	DWS 3 Provided?	N/A
N/A	X Walk 3 Direction	N/A	N/A	DWS 3 Contrast?	N/A
N/A	X Walk 3 Width (in)	N/A	N/A	DWS 3 Length (in)	N/A
N/A	Road 3 Slope (%)	N/A	N/A	DWS 3 Full Width?	N/A
N/A	Road 3 XSlope (%)	N/A	N/A	DWS 3 Offset (in)	N/A
Yes	Any Obstructions?	No	N/A	Storm Grate/Utility Hazard?	No
N/A	Obstruction Type		N/A	Storm Grate/Utility Type	
N/A	Surface Condition	Good	N/A		N/A

Possible Solutions:

Remove & Replace Detectable Warning System.
