Access Compliance Report

Public Rights-of-Way

(Island Curb Cuts)

Intersection ID: 18756	Main Street: RIGSBY_RD	Cross Street: STEELE_CREEK_RD	Location: NW
ADA ID: B965BF34B3FE	Curb Cut Type: MedianRefuge2	Initial Pass/Fail: Fail	Overall Compliance: No
Severity Score: 12.5			
Codes/Mitigation Info/Possible Solution		Field Measurements/Component Compliance

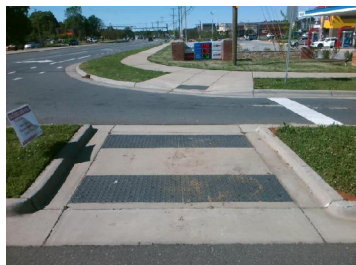
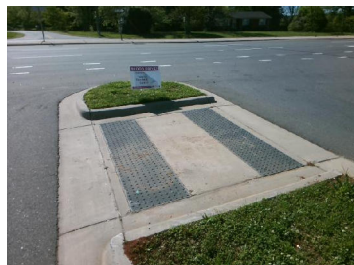
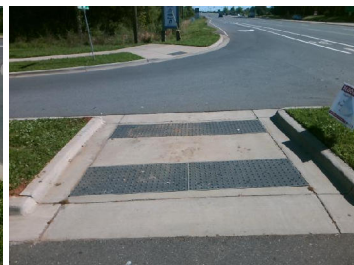
Compliance	Description	Data	Compliance	Description	Data
Yes	Refuge 1 Length (In)	45.5	N/A	Gutter 1 Ponding?	N/A
Yes	Refuge 1 Width (In)	120.0	N/A	Gutter 1 Lip Ht (In)	N/A
Yes	Refuge 1 Slope (%)	0.5	N/A	Gutter 1 Slope (%)	N/A
No	Refuge 1 X Slope (%)	6.6	N/A	Gutter 1 X Slope (%)	N/A
N/A	Painted X Walk1?	No	N/A	DWS 1 Provided?	N/A
N/A	X Walk 1 Direction	To SW	N/A	DWS 1 Contrast?	N/A
N/A	X Walk 1 Width (In)	N/A	N/A	DWS 1 Length (In)	N/A
N/A	Road 1 Slope (%)	4.3	N/A	DWS 1 Full Width?	N/A
N/A	Road 1 X Slope (%)	5.2	N/A	DWS 1 Offset (In)	N/A
Yes	Refuge 2 Length (In)	45.5	N/A	Gutter 2 Ponding?	N/A
Yes	Refuge 2 Width (In)	120.0	N/A	Gutter 2 Lip Ht (In)	N/A
Yes	Refuge 2 Slope (%)	1.9	N/A	Gutter 2 Slope (%)	N/A
No	Refuge 2 X Slope (%)	5.9	N/A	Gutter 2 X Slope (%)	N/A
N/A	Painted X Walk2?	No	N/A	DWS 2 Provided?	N/A
N/A	X Walk 2 Direction	To NE	N/A	DWS 2 Contrast?	N/A
N/A	X Walk 2 Width (In)	N/A	N/A	DWS 2 Length (In)	N/A

Remove & Replace Entire Refuge.
