# Access Compliance Report

## Public Rights-of-Way

### (Island Curb Cuts)

Intersection ID: 51510	Main Street: KENILWORTH_AV	Cross Street: PEARL_PARK_WY	Location: NE
ADA ID: BAEA0600BA68	Curb Cut Type: MedianRefuge2	Initial Pass/Fail: Fail	Overall Compliance: No
			Severity Score: 0

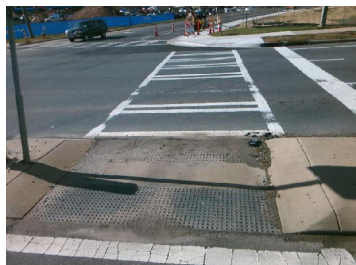
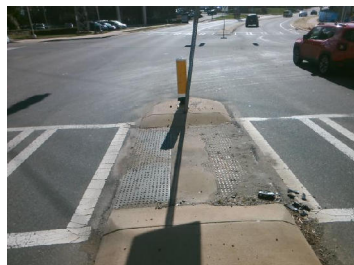
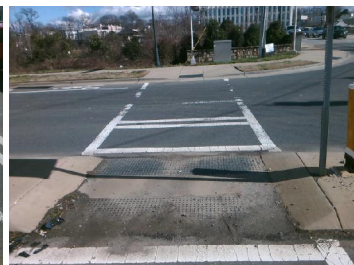
Compliance	Description	Data	Compliance	Description	Data
Yes	Refuge 1 Length (In)	38.0	N/A	Gutter 1 Ponding?	N/A
Yes	Refuge 1 Width (In)	97.0	N/A	Gutter 1 Lip Ht (In)	N/A
Yes	Refuge 1 Slope (%)	0.7	N/A	Gutter 1 Slope (%)	N/A
Yes	Refuge 1 X Slope (%)	2.7	N/A	Gutter 1 X Slope (%)	N/A
N/A	Painted X Walk1?	Yes	N/A	DWS 1 Provided?	N/A
N/A	X Walk 1 Direction	To W	N/A	DWS 1 Contrast?	N/A
N/A	X Walk 1 Width (In)	110.0	N/A	DWS 1 Length (In)	N/A
N/A	Road 1 Slope (%)	1.2	N/A	DWS 1 Full Width?	N/A
N/A	Road 1 X Slope (%)	5.0	N/A	DWS 1 Offset (In)	N/A
Yes	Refuge 2 Length (In)	38.0	N/A	Gutter 2 Ponding?	N/A
Yes	Refuge 2 Width (In)	97.0	N/A	Gutter 2 Lip Ht (In)	N/A
Yes	Refuge 2 Slope (%)	0.5	N/A	Gutter 2 Slope (%)	N/A
Yes	Refuge 2 X Slope (%)	1.9	N/A	Gutter 2 X Slope (%)	N/A
N/A	Painted X Walk2?	Yes	N/A	DWS 2 Provided?	N/A
N/A	X Walk 2 Direction	To E	N/A	DWS 2 Contrast?	N/A
N/A	X Walk 2 Width (In)	112.0	N/A	DWS 2 Length (In)	N/A

N/A	Road 2 Slope (%)	0.1	N/A	DWS 2 Full Width?	N/A
N/A	Road 2 X Slope (%)	0.9	N/A	DWS 2 Offset (In)	N/A
N/A	Refuge 3 Length (in)	N/A	N/A	Gutter 3 Ponding?	N/A
N/A	Refuge 3 Width (in)	N/A	N/A	Gutter 3 Lip Ht (in)	N/A
N/A	Refuge 3 Slope (%)	N/A	N/A	Gutter 3 Slope (%)	N/A
N/A	Refuge 3 XSlope (%)	N/A	N/A	Gutter 3 XSlope (%)	N/A
N/A	Painted X Walk3?	N/A	N/A	DWS 3 Provided?	N/A
N/A	X Walk 3 Direction	N/A	N/A	DWS 3 Contrast?	N/A
N/A	X Walk 3 Width (in)	N/A	N/A	DWS 3 Length (in)	N/A
N/A	Road 3 Slope (%)	N/A	N/A	DWS 3 Full Width?	N/A
N/A	Road 3 XSlope (%)	N/A	N/A	DWS 3 Offset (in)	N/A
Yes	Any Obstructions?	N/A	N/A	Storm Grate/Utility Hazard?	N/A
N/A	Obstruction Type		N/A	Storm Grate/Utility Type	
		N/A			N/A
N/A	Surface Condition	Good

**Remove & Replace Entire Refuge.**
