# Access Compliance Report

## Public Rights-of-Way

### (Island Curb Cuts)

Intersection ID: N/A	Main Street: S CALDWELL ST	Cross Street: E 3RD ST	Location: SW
ADA ID: BBB989EB0C92	Curb Cut Type: MedianRefuge2	Initial Pass/Fail: Pass	Overall Compliance: No
Codes/Mitigation Info/Possible Solution		Field Measurements/Component Compliance

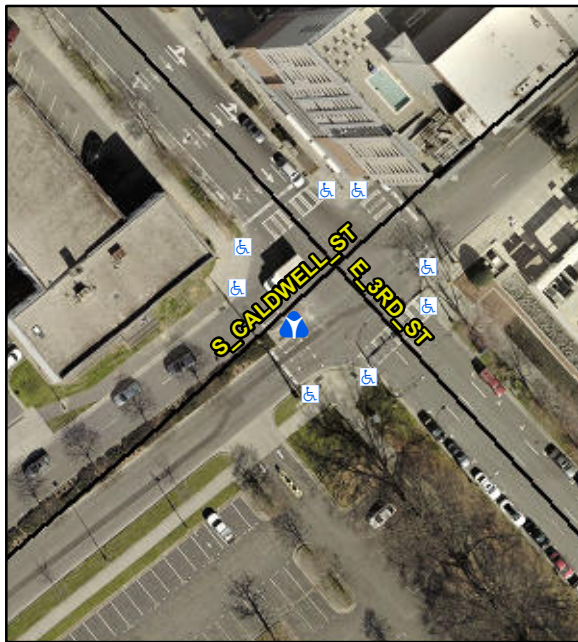
Compliance	Description	Data	Compliance	Description	Data
Yes	Refuge 1 Length (In)	54.0	Yes	Gutter 1 Ponding?	No
Yes	Refuge 1 Width (In)	110.0	Yes	Gutter 1 Lip Ht (In)	0.0
Yes	Refuge 1 Slope (%)	3.6	Yes	Gutter 1 Slope (%)	1.0
Yes	Refuge 1 X Slope (%)	0.3	Yes	Gutter 1 X Slope (%)	0.5
N/A	Painted X Walk1?	Yes	Yes	DWS 1 Provided?	Yes
N/A	X Walk 1 Direction	To SE	Yes	DWS 1 Contrast?	Yes
N/A	X Walk 1 Width (In)	121.0	Yes	DWS 1 Length (In)	24.5
N/A	Road 1 Slope (%)	0.1	No	DWS 1 Full Width?	No
N/A	Road 1 X Slope (%)	4.6	Yes	DWS 1 Offset (In)	0.0
Yes	Refuge 2 Length (In)	54.0	Yes	Gutter 2 Ponding?	No
Yes	Refuge 2 Width (In)	110.0	Yes	Gutter 2 Lip Ht (In)	0.0
Yes	Refuge 2 Slope (%)	0.6	Yes	Gutter 2 Slope (%)	1.2
Yes	Refuge 2 X Slope (%)	0.6	Yes	Gutter 2 X Slope (%)	1.0
N/A	Painted X Walk2?	Yes	Yes	DWS 2 Provided?	Yes
N/A	X Walk 2 Direction	To NW	Yes	DWS 2 Contrast?	Yes
N/A	X Walk 2 Width (In)	119.0	Yes	DWS 2 Length (In)	24.5

N/A	Road 2 Slope (%)	0.2	No	DWS 2 Full Width?	No
N/A	Road 2 X Slope (%)	0.1	Yes	DWS 2 Offset (In)	0.0
N/A	Refuge 3 Length (in)	N/A	N/A	Gutter 3 Ponding?	N/A
N/A	Refuge 3 Width (in)	N/A	N/A	Gutter 3 Lip Ht (in)	N/A
N/A	Refuge 3 Slope (%)	N/A	N/A	Gutter 3 Slope (%)	N/A
N/A	Refuge 3 XSlope (%)	N/A	N/A	Gutter 3 XSlope (%)	N/A
N/A	Painted X Walk3?	N/A	N/A	DWS 3 Provided?	N/A
N/A	X Walk 3 Direction	N/A	N/A	DWS 3 Contrast?	N/A
N/A	X Walk 3 Width (in)	N/A	N/A	DWS 3 Length (in)	N/A
N/A	Road 3 Slope (%)	N/A	N/A	DWS 3 Full Width?	N/A
N/A	Road 3 XSlope (%)	N/A	N/A	DWS 3 Offset (in)	N/A
Yes	Any Obstructions?	N/A	N/A	Storm Grate/Utility Hazard?	No
N/A	Obstruction Type		N/A	Storm Grate/Utility Type	
		N/A			N/A
N/A	Surface Condition	Good

Possible Solutions:

**Remove & Replace Detectable Warning System.**

Total Cost: \$ 1600.00
