# Access Compliance Report

## Public Rights-of-Way

### (Island Curb Cuts)

Intersection ID: 24251	Main Street: PINEVILLE-MATTHEWS_RD	Cross Street: PROVIDENCE_COURT_LN	Location: NW
ADA ID: BBBDE9D4F597	Curb Cut Type: MedianRefuge2	Initial Pass/Fail: Fail	Overall Compliance: No
Severity Score: 0			
Codes/Mitigation Info/Possible Solution		Field Measurements/Component Compliance

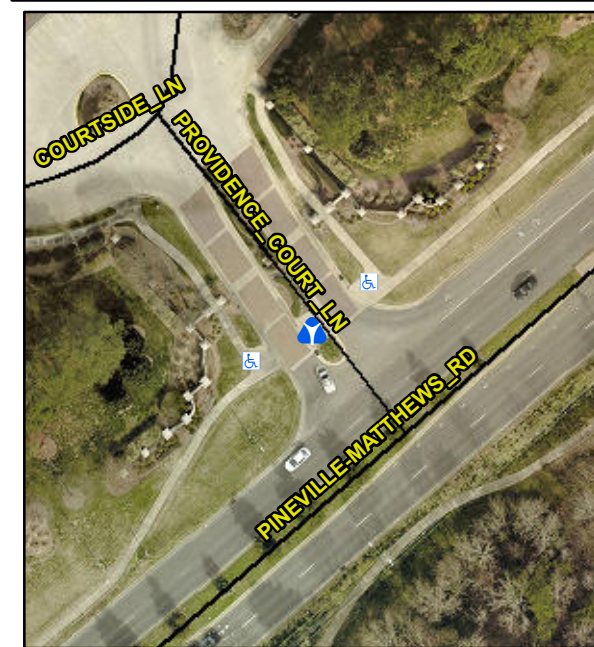
Compliance	Description	Data	Compliance	Description	Data
Yes	Refuge 1 Length (In)	64.5	N/A	Gutter 1 Ponding?	N/A
Yes	Refuge 1 Width (In)	64.0	N/A	Gutter 1 Lip Ht (In)	N/A
Yes	Refuge 1 Slope (%)	0.0	N/A	Gutter 1 Slope (%)	N/A
Yes	Refuge 1 X Slope (%)	2.2	N/A	Gutter 1 X Slope (%)	N/A
N/A	Painted X Walk1?	No	N/A	DWS 1 Provided?	N/A
N/A	X Walk 1 Direction	To NE	N/A	DWS 1 Contrast?	N/A
N/A	X Walk 1 Width (In)	N/A	N/A	DWS 1 Length (In)	N/A
N/A	Road 1 Slope (%)	1.9	N/A	DWS 1 Full Width?	N/A
N/A	Road 1 X Slope (%)	0.7	N/A	DWS 1 Offset (In)	N/A
Yes	Refuge 2 Length (In)	64.5	N/A	Gutter 2 Ponding?	N/A
Yes	Refuge 2 Width (In)	64.0	N/A	Gutter 2 Lip Ht (In)	N/A
Yes	Refuge 2 Slope (%)	0.0	N/A	Gutter 2 Slope (%)	N/A
Yes	Refuge 2 X Slope (%)	4.3	N/A	Gutter 2 X Slope (%)	N/A
N/A	Painted X Walk2?	No	N/A	DWS 2 Provided?	N/A
N/A	X Walk 2 Direction	To SW	N/A	DWS 2 Contrast?	N/A
N/A	X Walk 2 Width (In)	N/A	N/A	DWS 2 Length (In)	N/A

N/A	Road 2 Slope (%)	2.5	N/A	DWS 2 Full Width?	N/A
N/A	Road 2 X Slope (%)	0.5	N/A	DWS 2 Offset (In)	N/A
N/A	Refuge 3 Length (in)	N/A	N/A	Gutter 3 Ponding?	N/A
N/A	Refuge 3 Width (in)	N/A	N/A	Gutter 3 Lip Ht (in)	N/A
N/A	Refuge 3 Slope (%)	N/A	N/A	Gutter 3 Slope (%)	N/A
N/A	Refuge 3 XSlope (%)	N/A	N/A	Gutter 3 XSlope (%)	N/A
N/A	Painted X Walk3?	N/A	N/A	DWS 3 Provided?	N/A
N/A	X Walk 3 Direction	N/A	N/A	DWS 3 Contrast?	N/A
N/A	X Walk 3 Width (in)	N/A	N/A	DWS 3 Length (in)	N/A
N/A	Road 3 Slope (%)	N/A	N/A	DWS 3 Full Width?	N/A
N/A	Road 3 XSlope (%)	N/A	N/A	DWS 3 Offset (in)	N/A
Yes	Any Obstructions?	N/A	N/A	Storm Grate/Utility Hazard?	N/A
N/A	Obstruction Type		N/A	Storm Grate/Utility Type	
		N/A			N/A
N/A	Surface Condition	Good

**Remove & Replace Entire Refuge.**

**\$ 3000.00**
