Access Compliance Report

Public Rights-of-Way

(Island Curb Cuts)

Intersection ID: 52081	Main Street: LAWYERS_RD	Cross Street: E_W_T_HARRIS_BV	Location: SE
ADA ID: C0154FADF593	Curb Cut Type: MedianRefuge2	Initial Pass/Fail: Fail	Overall Compliance: No
Severity Score: 0			
Codes/Mitigation Info/Possible Solution		Field Measurements/Component Compliance

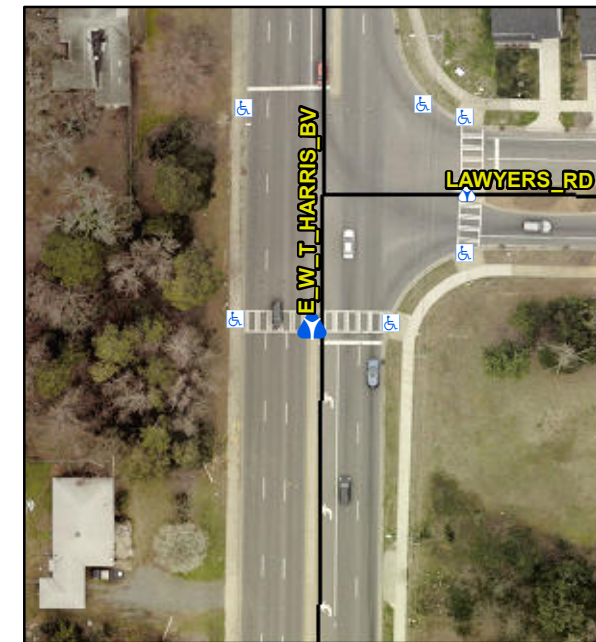
Compliance	Description	Data	Compliance	Description	Data
No	Refuge 1 Length (In)	25.0	N/A	Gutter 1 Ponding?	N/A
Yes	Refuge 1 Width (In)	116.0	N/A	Gutter 1 Lip Ht (In)	N/A
Yes	Refuge 1 Slope (%)	1.2	N/A	Gutter 1 Slope (%)	N/A
Yes	Refuge 1 X Slope (%)	1.8	N/A	Gutter 1 X Slope (%)	N/A
N/A	Painted X Walk1?	Yes	N/A	DWS 1 Provided?	N/A
N/A	X Walk 1 Direction	To W	N/A	DWS 1 Contrast?	N/A
N/A	X Walk 1 Width (In)	115.0	N/A	DWS 1 Length (In)	N/A
N/A	Road 1 Slope (%)	1.7	N/A	DWS 1 Full Width?	N/A
N/A	Road 1 X Slope (%)	2.3	N/A	DWS 1 Offset (In)	N/A
No	Refuge 2 Length (In)	25.0	N/A	Gutter 2 Ponding?	N/A
Yes	Refuge 2 Width (In)	116.0	N/A	Gutter 2 Lip Ht (In)	N/A
Yes	Refuge 2 Slope (%)	0.3	N/A	Gutter 2 Slope (%)	N/A
Yes	Refuge 2 X Slope (%)	1.8	N/A	Gutter 2 X Slope (%)	N/A
N/A	Painted X Walk2?	Yes	N/A	DWS 2 Provided?	N/A
N/A	X Walk 2 Direction	To E	N/A	DWS 2 Contrast?	N/A
N/A	X Walk 2 Width (In)	114.0	N/A	DWS 2 Length (In)	N/A

Possible Solutions:

Remove & Replace Entire Refuge.
