Access Compliance Report

Public Rights-of-Way

(Island Curb Cuts)

Intersection ID: 10036505	Main Street: ROZZELLES_FERRY_RD	Cross Street: N/A	Location:	N/A
ADA ID: C3BDEF8E835D	Curb Cut Type: MedianRefuge2	Initial Pass/Fail: Fail	Overall Compliance: No	Severity Score: 30
Codes/Mitigation Info/Possible Solution		Field Measurements/Component Compliance

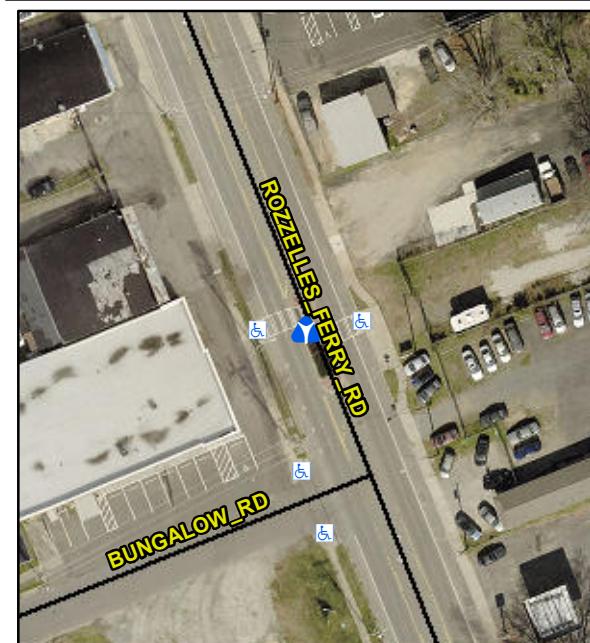
Compliance	Description	Data	Compliance	Description	Data
Yes	Refuge 1 Length (In)	56.5	N/A	Gutter 1 Ponding?	N/A
No	Refuge 1 Width (In)	44.0	N/A	Gutter 1 Lip Ht (In)	N/A
No	Refuge 1 Slope (%)	5.3	N/A	Gutter 1 Slope (%)	N/A
Yes	Refuge 1 X Slope (%)	2.0	N/A	Gutter 1 X Slope (%)	N/A
N/A	Painted X Walk1?	Yes	N/A	DWS 1 Provided?	N/A
N/A	X Walk 1 Direction	To W	N/A	DWS 1 Contrast?	N/A
N/A	X Walk 1 Width (In)	109.5	N/A	DWS 1 Length (In)	N/A
N/A	Road 1 Slope (%)	2.1	N/A	DWS 1 Full Width?	N/A
N/A	Road 1 X Slope (%)	3.1	N/A	DWS 1 Offset (In)	N/A
Yes	Refuge 2 Length (In)	56.5	N/A	Gutter 2 Ponding?	N/A
No	Refuge 2 Width (In)	44.0	N/A	Gutter 2 Lip Ht (In)	N/A
Yes	Refuge 2 Slope (%)	2.0	N/A	Gutter 2 Slope (%)	N/A
Yes	Refuge 2 X Slope (%)	2.1	N/A	Gutter 2 X Slope (%)	N/A
N/A	Painted X Walk2?	Yes	N/A	DWS 2 Provided?	N/A
N/A	X Walk 2 Direction	To E	N/A	DWS 2 Contrast?	N/A
N/A	X Walk 2 Width (In)	110.5	N/A	DWS 2 Length (In)	N/A

N/A	Road 2 Slope (%)	3.0	N/A	DWS 2 Full Width?	N/A
N/A	Road 2 X Slope (%)	2.9	N/A	DWS 2 Offset (In)	N/A
N/A	Refuge 3 Length (in)	N/A	N/A	Gutter 3 Ponding?	N/A
N/A	Refuge 3 Width (in)	N/A	N/A	Gutter 3 Lip Ht (in)	N/A
N/A	Refuge 3 Slope (%)	N/A	N/A	Gutter 3 Slope (%)	N/A
N/A	Refuge 3 XSlope (%)	N/A	N/A	Gutter 3 XSlope (%)	N/A
N/A	Painted X Walk3?	N/A	N/A	DWS 3 Provided?	N/A
N/A	X Walk 3 Direction	N/A	N/A	DWS 3 Contrast?	N/A
N/A	X Walk 3 Width (in)	N/A	N/A	DWS 3 Length (in)	N/A
N/A	Road 3 Slope (%)	N/A	N/A	DWS 3 Full Width?	N/A
N/A	Road 3 XSlope (%)	N/A	N/A	DWS 3 Offset (in)	N/A
Yes	Any Obstructions?	N/A	N/A	Storm Grate/Utility Hazard?	N/A
N/A	Obstruction Type		N/A	Storm Grate/Utility Type	
		N/A			N/A
N/A	Surface Condition	Good

Possible Solutions:

Remove & Replace Entire Refuge.
