# Access Compliance Report

## Public Rights-of-Way

### (Island Curb Cuts)

Intersection ID: N/A	Main Street: JOHN BELK RA	Cross Street: S CALDWELL ST	Location: N
ADA ID: C6F6DFCFF526	Curb Cut Type: MedianRefuge2	Initial Pass/Fail: Fail	Overall Compliance: No
Codes/Mitigation Info/Possible Solution		Field Measurements/Component Compliance

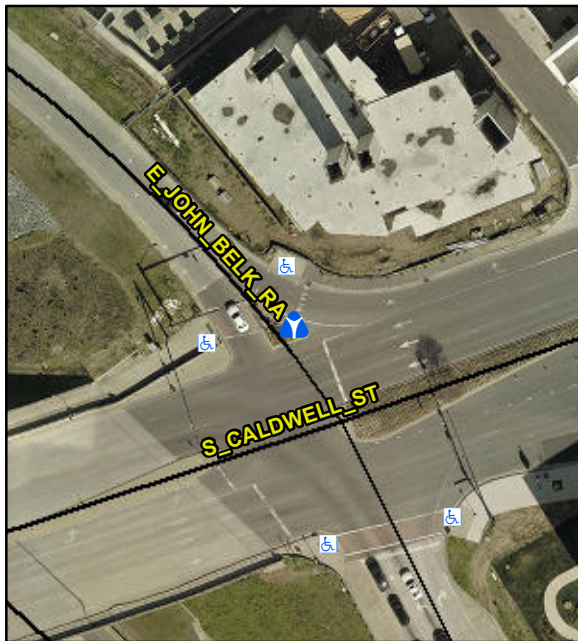
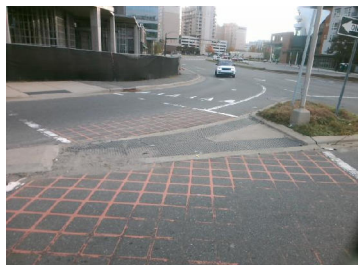
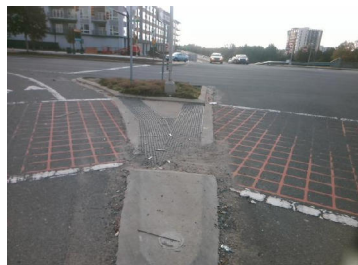
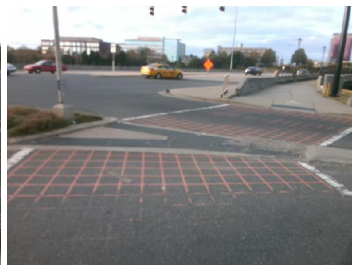
Compliance	Description	Data	Compliance	Description	Data
No	Refuge 1 Length (In)	23.0	N/A	Gutter 1 Ponding?	N/A
Yes	Refuge 1 Width (In)	192.0	N/A	Gutter 1 Lip Ht (In)	N/A
Yes	Refuge 1 Slope (%)	1.2	N/A	Gutter 1 Slope (%)	N/A
Yes	Refuge 1 X Slope (%)	2.6	N/A	Gutter 1 X Slope (%)	N/A
N/A	Painted X Walk1?	Yes	N/A	DWS 1 Provided?	N/A
N/A	X Walk 1 Direction	To NE	N/A	DWS 1 Contrast?	N/A
N/A	X Walk 1 Width (In)	188.0	N/A	DWS 1 Length (In)	N/A
N/A	Road 1 Slope (%)	1.8	N/A	DWS 1 Full Width?	N/A
N/A	Road 1 X Slope (%)	1.4	N/A	DWS 1 Offset (In)	N/A
No	Refuge 2 Length (In)	23.0	N/A	Gutter 2 Ponding?	N/A
Yes	Refuge 2 Width (In)	192.0	N/A	Gutter 2 Lip Ht (In)	N/A
Yes	Refuge 2 Slope (%)	2.5	N/A	Gutter 2 Slope (%)	N/A
Yes	Refuge 2 X Slope (%)	0.7	N/A	Gutter 2 X Slope (%)	N/A
N/A	Painted X Walk2?	Yes	N/A	DWS 2 Provided?	N/A
N/A	X Walk 2 Direction	To NW	N/A	DWS 2 Contrast?	N/A
N/A	X Walk 2 Width (In)	188.0	N/A	DWS 2 Length (In)	N/A

N/A	Road 2 Slope (%)	1.4	N/A	DWS 2 Full Width?	N/A
N/A	Road 2 X Slope (%)	2.4	N/A	DWS 2 Offset (In)	N/A
N/A	Refuge 3 Length (in)	N/A	N/A	Gutter 3 Ponding?	N/A
N/A	Refuge 3 Width (in)	N/A	N/A	Gutter 3 Lip Ht (in)	N/A
N/A	Refuge 3 Slope (%)	N/A	N/A	Gutter 3 Slope (%)	N/A
N/A	Refuge 3 XSlope (%)	N/A	N/A	Gutter 3 XSlope (%)	N/A
N/A	Painted X Walk3?	N/A	N/A	DWS 3 Provided?	N/A
N/A	X Walk 3 Direction	N/A	N/A	DWS 3 Contrast?	N/A
N/A	X Walk 3 Width (in)	N/A	N/A	DWS 3 Length (in)	N/A
N/A	Road 3 Slope (%)	N/A	N/A	DWS 3 Full Width?	N/A
N/A	Road 3 XSlope (%)	N/A	N/A	DWS 3 Offset (in)	N/A
Yes	Any Obstructions?	N/A	N/A	Storm Grate/Utility Hazard?	N/A
N/A	Obstruction Type		N/A	Storm Grate/Utility Type	
		N/A			N/A
N/A	Surface Condition	Good

**Remove & Replace Entire Refuge.**

**\$ 3000.00**
