Access Compliance Report

Public Rights-of-Way

(Island Curb Cuts)

Intersection ID: 6998	Main Street: NEVIN_RD	Cross Street: STATESVILLE_RD	Location: N
ADA ID: CA101DCFD78D	Curb Cut Type: MedianRefuge2	Initial Pass/Fail: Fail	Overall Compliance: No
Codes/Mitigation Info/Possible Solution		Field Measurements/Component Compliance

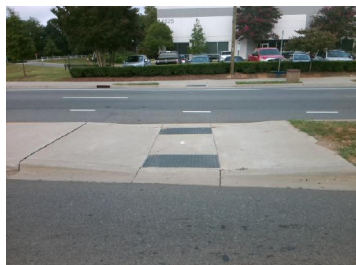
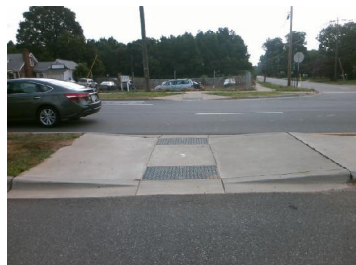
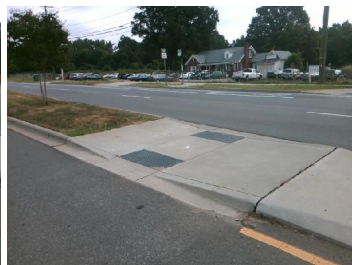
Compliance	Description	Data	Compliance	Description	Data
Yes	Refuge 1 Length (In)	53.0	N/A	Gutter 1 Ponding?	N/A
No	Refuge 1 Width (In)	47.5	N/A	Gutter 1 Lip Ht (In)	N/A
Yes	Refuge 1 Slope (%)	1.8	N/A	Gutter 1 Slope (%)	N/A
Yes	Refuge 1 X Slope (%)	0.4	N/A	Gutter 1 X Slope (%)	N/A
N/A	Painted X Walk1?	No	N/A	DWS 1 Provided?	N/A
N/A	X Walk 1 Direction	To E	N/A	DWS 1 Contrast?	N/A
N/A	X Walk 1 Width (In)	N/A	N/A	DWS 1 Length (In)	N/A
N/A	Road 1 Slope (%)	0.4	N/A	DWS 1 Full Width?	N/A
N/A	Road 1 X Slope (%)	1.2	N/A	DWS 1 Offset (In)	N/A
Yes	Refuge 2 Length (In)	53.0	N/A	Gutter 2 Ponding?	N/A
No	Refuge 2 Width (In)	47.5	N/A	Gutter 2 Lip Ht (In)	N/A
Yes	Refuge 2 Slope (%)	1.9	N/A	Gutter 2 Slope (%)	N/A
Yes	Refuge 2 X Slope (%)	1.5	N/A	Gutter 2 X Slope (%)	N/A
N/A	Painted X Walk2?	No	N/A	DWS 2 Provided?	N/A
N/A	X Walk 2 Direction	To SE	N/A	DWS 2 Contrast?	N/A
N/A	X Walk 2 Width (In)	N/A	N/A	DWS 2 Length (In)	N/A

N/A	Road 2 Slope (%)	0.4	N/A	DWS 2 Full Width?	N/A
N/A	Road 2 X Slope (%)	1.1	N/A	DWS 2 Offset (In)	N/A
N/A	Refuge 3 Length (in)	N/A	N/A	Gutter 3 Ponding?	N/A
N/A	Refuge 3 Width (in)	N/A	N/A	Gutter 3 Lip Ht (in)	N/A
N/A	Refuge 3 Slope (%)	N/A	N/A	Gutter 3 Slope (%)	N/A
N/A	Refuge 3 XSlope (%)	N/A	N/A	Gutter 3 XSlope (%)	N/A
N/A	Painted X Walk3?	No	N/A	DWS 3 Provided?	N/A
N/A	X Walk 3 Direction	N/A	N/A	DWS 3 Contrast?	N/A
N/A	X Walk 3 Width (in)	N/A	N/A	DWS 3 Length (in)	N/A
N/A	Road 3 Slope (%)	N/A	N/A	DWS 3 Full Width?	N/A
N/A	Road 3 XSlope (%)	N/A	N/A	DWS 3 Offset (in)	N/A
Yes	Any Obstructions?	N/A	N/A	Storm Grate/Utility Hazard?	N/A
N/A	Obstruction Type		N/A	Storm Grate/Utility Type	
		N/A			N/A
N/A	Surface Condition	Good

Remove & Replace Entire Refuge.
