Access Compliance Report

Public Rights-of-Way

(Island Curb Cuts)

Intersection ID: 3494	Main Street: REAMES_RD	Cross Street: W_W_T_HARRIS_BV	Location: SE
ADA ID: CAAF8A18409B	Curb Cut Type: IslandRefuge3	Initial Pass/Fail: Fail	Overall Compliance: No
Severity Score: 36.25			
Codes/Mitigation Info/Possible Solution		Field Measurements/Component Compliance

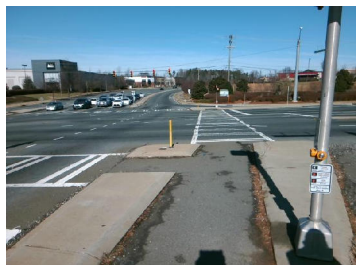
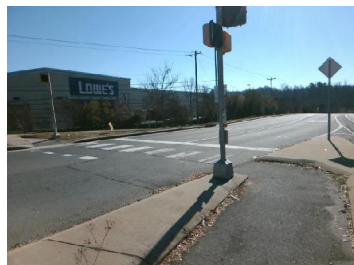
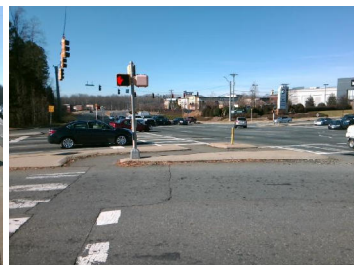
Compliance	Description	Data	Compliance	Description	Data
Yes	Refuge 1 Length (In)	68.0	N/A	Gutter 1 Ponding?	N/A
Yes	Refuge 1 Width (In)	71.0	N/A	Gutter 1 Lip Ht (In)	N/A
Yes	Refuge 1 Slope (%)	2.9	N/A	Gutter 1 Slope (%)	N/A
Yes	Refuge 1 X Slope (%)	1.9	N/A	Gutter 1 X Slope (%)	N/A
N/A	Painted X Walk1?	Yes	N/A	DWS 1 Provided?	N/A
N/A	X Walk 1 Direction	To W	N/A	DWS 1 Contrast?	N/A
N/A	X Walk 1 Width (In)	120.0	N/A	DWS 1 Length (In)	N/A
N/A	Road 1 Slope (%)	2.3	N/A	DWS 1 Full Width?	N/A
N/A	Road 1 X Slope (%)	4.8	N/A	DWS 1 Offset (In)	N/A
Yes	Refuge 2 Length (In)	72.0	N/A	Gutter 2 Ponding?	N/A
Yes	Refuge 2 Width (In)	72.0	N/A	Gutter 2 Lip Ht (In)	N/A
Yes	Refuge 2 Slope (%)	4.3	N/A	Gutter 2 Slope (%)	N/A
Yes	Refuge 2 X Slope (%)	4.0	N/A	Gutter 2 X Slope (%)	N/A
N/A	Painted X Walk2?	Yes	N/A	DWS 2 Provided?	N/A
N/A	X Walk 2 Direction	To N	N/A	DWS 2 Contrast?	N/A
N/A	X Walk 2 Width (In)	120.0	N/A	DWS 2 Length (In)	N/A

N/A	Road 2 Slope (%)	2.1	N/A	DWS 2 Full Width?	N/A
N/A	Road 2 X Slope (%)	4.3	N/A	DWS 2 Offset (In)	N/A
Yes	Refuge 3 Length (in)	31.0	N/A	Gutter 3 Ponding?	N/A
Yes	Refuge 3 Width (in)	73.0	N/A	Gutter 3 Lip Ht (in)	N/A
Yes	Refuge 3 Slope (%)	0.4	N/A	Gutter 3 Slope (%)	N/A
Yes	Refuge 3 XSlope (%)	0.7	N/A	Gutter 3 XSlope (%)	N/A
N/A	Painted X Walk3?	Yes	N/A	DWS 3 Provided?	N/A
N/A	X Walk 3 Direction	To SE	N/A	DWS 3 Contrast?	N/A
N/A	X Walk 3 Width (in)	63.0	N/A	DWS 3 Length (in)	N/A
N/A	Road 3 Slope (%)	0.7	N/A	DWS 3 Full Width?	N/A
N/A	Road 3 XSlope (%)	0.9	N/A	DWS 3 Offset (in)	N/A
Yes	Any Obstructions?	N/A	N/A	Storm Grate/Utility Hazard?	N/A
N/A	Obstruction Type		N/A	Storm Grate/Utility Type	
N/A	Surface Condition	Good	N/A		N/A

Remove & Replace Entire Refuge.
