# Access Compliance Report

## Public Rights-of-Way

### (Island Curb Cuts)

Intersection ID: 1002095	Main Street: J_W_CLAY_BV	Cross Street: N/A	Location: W
ADA ID: CCB4C1BE5053	Curb Cut Type: MedianRefuge2	Initial Pass/Fail: Fail	Overall Compliance: No
Codes/Mitigation Info/Possible Solution		Field Measurements/Component Compliance

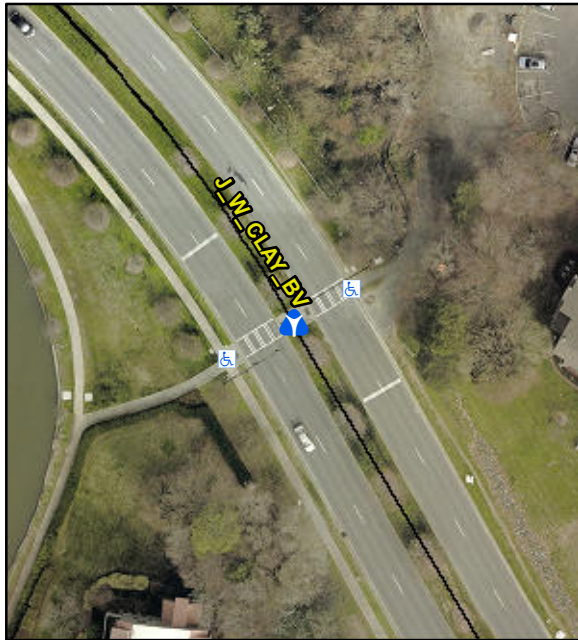
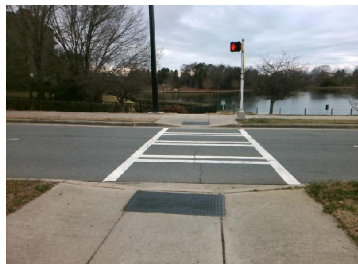
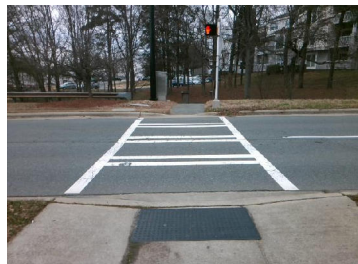
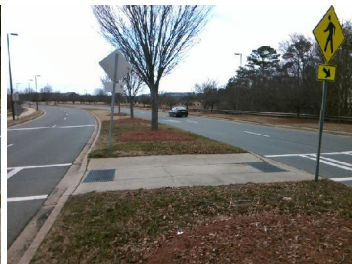
**RD1 SL 1.9%, XSL 0.7%, RD2 SL 1.7%, XSL 3.6%**

Compliance	Description	Data	Compliance	Description	Data
Yes	Refuge 1 Length (In)	100.0	N/A	Gutter 1 Ponding?	N/A
No	Refuge 1 Width (In)	46.0	N/A	Gutter 1 Lip Ht (In)	N/A
Yes	Refuge 1 Slope (%)	1.3	N/A	Gutter 1 Slope (%)	N/A
Yes	Refuge 1 X Slope (%)	3.3	N/A	Gutter 1 X Slope (%)	N/A
N/A	Painted X Walk1?	Yes	N/A	DWS 1 Provided?	N/A
N/A	X Walk 1 Direction	To W	N/A	DWS 1 Contrast?	N/A
N/A	X Walk 1 Width (In)	110.0	N/A	DWS 1 Length (In)	N/A
N/A	Road 1 Slope (%)	1.8	N/A	DWS 1 Full Width?	N/A
N/A	Road 1 X Slope (%)	1.9	N/A	DWS 1 Offset (In)	N/A
Yes	Refuge 2 Length (In)	100.0	N/A	Gutter 2 Ponding?	N/A
No	Refuge 2 Width (In)	46.0	N/A	Gutter 2 Lip Ht (In)	N/A
Yes	Refuge 2 Slope (%)	0.3	N/A	Gutter 2 Slope (%)	N/A
Yes	Refuge 2 X Slope (%)	2.8	N/A	Gutter 2 X Slope (%)	N/A
N/A	Painted X Walk2?	Yes	N/A	DWS 2 Provided?	N/A
N/A	X Walk 2 Direction	To E	N/A	DWS 2 Contrast?	N/A
N/A	X Walk 2 Width (In)	110.0	N/A	DWS 2 Length (In)	N/A

**Remove & Replace Entire Refuge.**
