Access Compliance Report

Public Rights-of-Way

(Island Curb Cuts)

Intersection ID: 52774	Main Street: PROSPERITY_CHURCH_RD	Cross Street: N/A	Location: S
ADA ID: CE1DDD7A35AF	Curb Cut Type: MedianRefuge2	Initial Pass/Fail: Pass	Overall Compliance: No
			Severity Score: 15

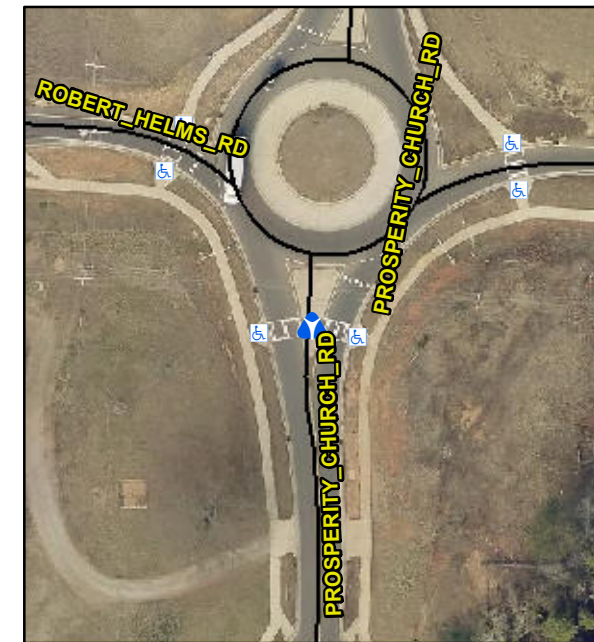
Compliance	Description	Data	Compliance	Description	Data
Yes	Refuge 1 Length (In)	36.0	Yes	Gutter 1 Ponding?	No
Yes	Refuge 1 Width (In)	118.0	Yes	Gutter 1 Lip Ht (In)	0.0
Yes	Refuge 1 Slope (%)	1.2	Yes	Gutter 1 Slope (%)	2.2
Yes	Refuge 1 X Slope (%)	1.0	Yes	Gutter 1 X Slope (%)	1.2
N/A	Painted X Walk1?	Yes	No	DWS 1 Provided?	No
N/A	X Walk 1 Direction	To E	N/A	DWS 1 Contrast?	No
N/A	X Walk 1 Width (In)	104.0	N/A	DWS 1 Length (In)	N/A
N/A	Road 1 Slope (%)	1.7	N/A	DWS 1 Full Width?	No
N/A	Road 1 X Slope (%)	2.1	N/A	DWS 1 Offset (In)	N/A
Yes	Refuge 2 Length (In)	36.0	Yes	Gutter 2 Ponding?	No
Yes	Refuge 2 Width (In)	118.0	Yes	Gutter 2 Lip Ht (In)	0.0
Yes	Refuge 2 Slope (%)	0.5	Yes	Gutter 2 Slope (%)	2.0
Yes	Refuge 2 X Slope (%)	0.2	Yes	Gutter 2 X Slope (%)	0.6
N/A	Painted X Walk2?	Yes	No	DWS 2 Provided?	No
N/A	X Walk 2 Direction	To W	N/A	DWS 2 Contrast?	No
N/A	X Walk 2 Width (In)	105.0	N/A	DWS 2 Length (In)	N/A

N/A	Road 2 Slope (%)	0.3	N/A	DWS 2 Full Width?	No
N/A	Road 2 X Slope (%)	2.2	N/A	DWS 2 Offset (In)	N/A
N/A	Refuge 3 Length (in)	N/A	N/A	Gutter 3 Ponding?	N/A
N/A	Refuge 3 Width (in)	N/A	N/A	Gutter 3 Lip Ht (in)	N/A
N/A	Refuge 3 Slope (%)	N/A	N/A	Gutter 3 Slope (%)	N/A
N/A	Refuge 3 XSlope (%)	N/A	N/A	Gutter 3 XSlope (%)	N/A
N/A	Painted X Walk3?	No	N/A	DWS 3 Provided?	N/A
N/A	X Walk 3 Direction	N/A	N/A	DWS 3 Contrast?	N/A
N/A	X Walk 3 Width (in)	N/A	N/A	DWS 3 Length (in)	N/A
N/A	Road 3 Slope (%)	N/A	N/A	DWS 3 Full Width?	N/A
N/A	Road 3 XSlope (%)	N/A	N/A	DWS 3 Offset (in)	N/A
Yes	Any Obstructions?	No	N/A	Storm Grate/Utility Hazard?	No
N/A	Obstruction Type		N/A	Storm Grate/Utility Type	
		N/A			N/A
N/A	Surface Condition	Good

Possible Solutions:

Install Detectable Warning System.

Total Cost:

\$ 470.00
