# Access Compliance Report

## Public Rights-of-Way

### (Island Curb Cuts)

Intersection ID: 10630	Main Street: E_SUGAR_CREEK_RD	Cross Street: EASTWAY_DR	Location: NW
ADA ID: CF46AE737845	Curb Cut Type: IslandRefuge3	Initial Pass/Fail: Fail	Overall Compliance: No
Codes/Mitigation Info/Possible Solution		Field Measurements/Component Compliance	
Severity Score: 35

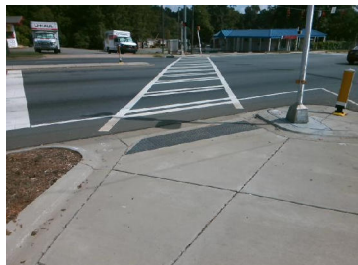
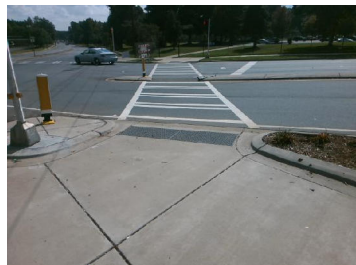
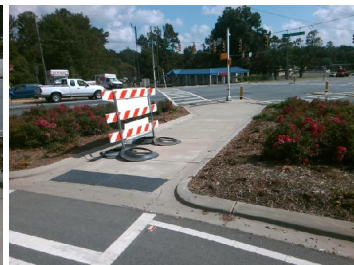
Compliance	Description	Data	Compliance	Description	Data
Yes	Refuge 1 Length (In)	36.5	N/A	Gutter 1 Ponding?	N/A
Yes	Refuge 1 Width (In)	103.0	N/A	Gutter 1 Lip Ht (In)	N/A
Yes	Refuge 1 Slope (%)	1.6	N/A	Gutter 1 Slope (%)	N/A
Yes	Refuge 1 X Slope (%)	1.5	N/A	Gutter 1 X Slope (%)	N/A
N/A	Painted X Walk1?	Yes	N/A	DWS 1 Provided?	N/A
N/A	X Walk 1 Direction	To SE	N/A	DWS 1 Contrast?	N/A
N/A	X Walk 1 Width (In)	127.5	N/A	DWS 1 Length (In)	N/A
N/A	Road 1 Slope (%)	2.4	N/A	DWS 1 Full Width?	N/A
N/A	Road 1 X Slope (%)	0.7	N/A	DWS 1 Offset (In)	N/A
Yes	Refuge 2 Length (In)	89.0	N/A	Gutter 2 Ponding?	N/A
Yes	Refuge 2 Width (In)	96.0	N/A	Gutter 2 Lip Ht (In)	N/A
Yes	Refuge 2 Slope (%)	0.8	N/A	Gutter 2 Slope (%)	N/A
Yes	Refuge 2 X Slope (%)	5.0	N/A	Gutter 2 X Slope (%)	N/A
N/A	Painted X Walk2?	Yes	N/A	DWS 2 Provided?	N/A
N/A	X Walk 2 Direction	To S	N/A	DWS 2 Contrast?	N/A
N/A	X Walk 2 Width (In)	116.0	N/A	DWS 2 Length (In)	N/A

N/A	Road 2 Slope (%)	5.6	N/A	DWS 2 Full Width?	N/A
N/A	Road 2 X Slope (%)	3.4	N/A	DWS 2 Offset (In)	N/A
Yes	Refuge 3 Length (in)	461.0	N/A	Gutter 3 Ponding?	N/A
Yes	Refuge 3 Width (in)	95.5	N/A	Gutter 3 Lip Ht (in)	N/A
Yes	Refuge 3 Slope (%)	1.8	N/A	Gutter 3 Slope (%)	N/A
Yes	Refuge 3 XSlope (%)	4.1	N/A	Gutter 3 XSlope (%)	N/A
N/A	Painted X Walk3?	Yes	N/A	DWS 3 Provided?	N/A
N/A	X Walk 3 Direction	To NW	N/A	DWS 3 Contrast?	N/A
N/A	X Walk 3 Width (in)	111.5	N/A	DWS 3 Length (in)	N/A
N/A	Road 3 Slope (%)	3.5	N/A	DWS 3 Full Width?	N/A
N/A	Road 3 XSlope (%)	2.7	N/A	DWS 3 Offset (in)	N/A
Yes	Any Obstructions?	N/A	N/A	Storm Grate/Utility Hazard?	N/A
N/A	Obstruction Type		N/A	Storm Grate/Utility Type	
		N/A			N/A
N/A	Surface Condition	Good

**Remove & Replace Entire Refuge.**
