# Access Compliance Report

## Public Rights-of-Way

### (Island Curb Cuts)

Intersection ID: 12110	Main Street: S_MINT_ST	Cross Street: W_4TH_ST	Location: W
ADA ID: CF96693867C4	Curb Cut Type: IslandRefuge3	Initial Pass/Fail: Fail	Overall Compliance: No
Codes/Mitigation Info/Possible Solution		Field Measurements/Component Compliance	
Severity Score: 72.5

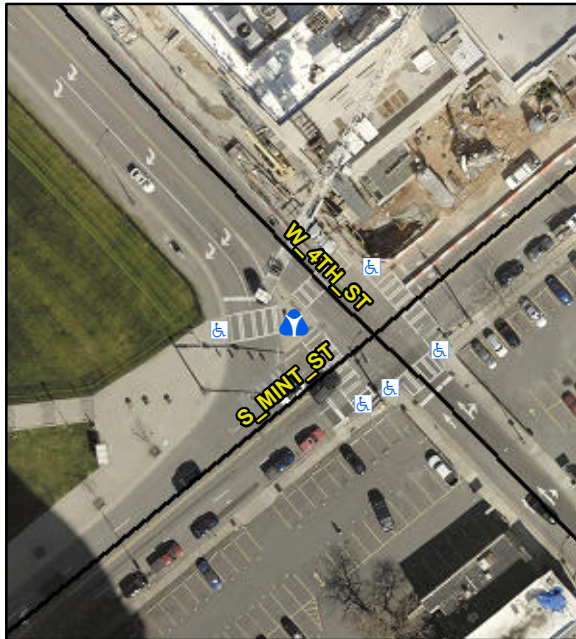
Compliance	Description	Data	Compliance	Description	Data
No	Refuge 1 Length (In)	49.0	N/A	Gutter 1 Ponding?	N/A
Yes	Refuge 1 Width (In)	89.0	N/A	Gutter 1 Lip Ht (In)	N/A
Yes	Refuge 1 Slope (%)	2.5	N/A	Gutter 1 Slope (%)	N/A
No	Refuge 1 X Slope (%)	7.5	N/A	Gutter 1 X Slope (%)	N/A
N/A	Painted X Walk1?	Yes	N/A	DWS 1 Provided?	N/A
N/A	X Walk 1 Direction	To SE	N/A	DWS 1 Contrast?	N/A
N/A	X Walk 1 Width (In)	131.0	N/A	DWS 1 Length (In)	N/A
N/A	Road 1 Slope (%)	0.4	N/A	DWS 1 Full Width?	N/A
N/A	Road 1 X Slope (%)	3.6	N/A	DWS 1 Offset (In)	N/A
No	Refuge 2 Length (In)	20.0	N/A	Gutter 2 Ponding?	N/A
Yes	Refuge 2 Width (In)	91.0	N/A	Gutter 2 Lip Ht (In)	N/A
No	Refuge 2 Slope (%)	6.9	N/A	Gutter 2 Slope (%)	N/A
Yes	Refuge 2 X Slope (%)	1.7	N/A	Gutter 2 X Slope (%)	N/A
N/A	Painted X Walk2?	Yes	N/A	DWS 2 Provided?	N/A
N/A	X Walk 2 Direction	To NE	N/A	DWS 2 Contrast?	N/A
N/A	X Walk 2 Width (In)	111.0	N/A	DWS 2 Length (In)	N/A

N/A	Road 2 Slope (%)	1.9	N/A	DWS 2 Full Width?	N/A
N/A	Road 2 X Slope (%)	5.2	N/A	DWS 2 Offset (In)	N/A
No	Refuge 3 Length (in)	38.0	N/A	Gutter 3 Ponding?	N/A
Yes	Refuge 3 Width (in)	140.0	N/A	Gutter 3 Lip Ht (in)	N/A
No	Refuge 3 Slope (%)	10.0	N/A	Gutter 3 Slope (%)	N/A
Yes	Refuge 3 XSlope (%)	3.6	N/A	Gutter 3 XSlope (%)	N/A
N/A	Painted X Walk3?	Yes	N/A	DWS 3 Provided?	N/A
N/A	X Walk 3 Direction	To W	N/A	DWS 3 Contrast?	N/A
N/A	X Walk 3 Width (in)	156.0	N/A	DWS 3 Length (in)	N/A
N/A	Road 3 Slope (%)	1.9	N/A	DWS 3 Full Width?	N/A
N/A	Road 3 XSlope (%)	8.2	N/A	DWS 3 Offset (in)	N/A
Yes	Any Obstructions?	N/A	N/A	Storm Grate/Utility Hazard?	N/A
N/A	Obstruction Type		N/A	Storm Grate/Utility Type	
			N/A		N/A
N/A	Surface Condition	Good

**Remove & Replace Entire Refuge.**
