Access Compliance Report

Public Rights-of-Way

(Island Curb Cuts)

Intersection ID: N/A	Main Street: E STONEWALL ST	Cross Street: S CALDWELL ST	Location: NW
ADA ID: D1A19A40AE0C	Curb Cut Type: MedianRefuge2	Initial Pass/Fail: Fail	Overall Compliance: No
Severity Score: 1.25			
Codes/Mitigation Info/Possible Solution		Field Measurements/Component Compliance

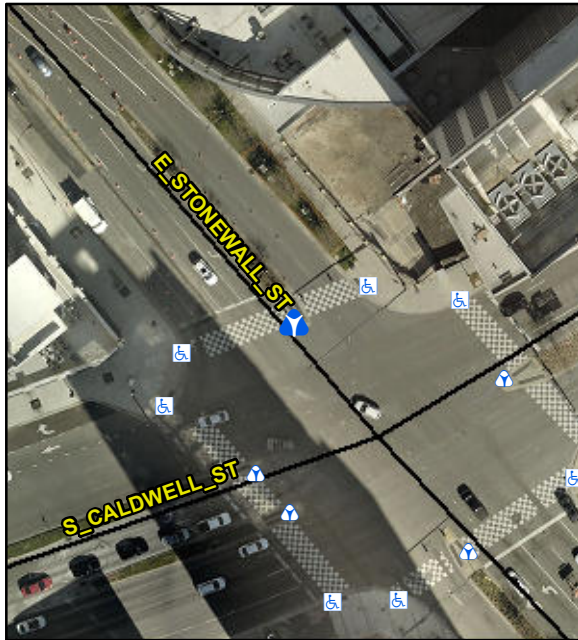
Compliance	Description	Data	Compliance	Description	Data
No	Refuge 1 Length (In)	15.0	N/A	Gutter 1 Ponding?	N/A
Yes	Refuge 1 Width (In)	156.0	N/A	Gutter 1 Lip Ht (In)	N/A
Yes	Refuge 1 Slope (%)	2.3	N/A	Gutter 1 Slope (%)	N/A
Yes	Refuge 1 X Slope (%)	2.0	N/A	Gutter 1 X Slope (%)	N/A
N/A	Painted X Walk1?	Yes	N/A	DWS 1 Provided?	N/A
N/A	X Walk 1 Direction	To E	N/A	DWS 1 Contrast?	N/A
N/A	X Walk 1 Width (In)	144.0	N/A	DWS 1 Length (In)	N/A
N/A	Road 1 Slope (%)	1.4	N/A	DWS 1 Full Width?	N/A
N/A	Road 1 X Slope (%)	1.9	N/A	DWS 1 Offset (In)	N/A
No	Refuge 2 Length (In)	15.0	N/A	Gutter 2 Ponding?	N/A
Yes	Refuge 2 Width (In)	156.0	N/A	Gutter 2 Lip Ht (In)	N/A
Yes	Refuge 2 Slope (%)	3.8	N/A	Gutter 2 Slope (%)	N/A
Yes	Refuge 2 X Slope (%)	2.1	N/A	Gutter 2 X Slope (%)	N/A
N/A	Painted X Walk2?	Yes	N/A	DWS 2 Provided?	N/A
N/A	X Walk 2 Direction	To W	N/A	DWS 2 Contrast?	N/A
N/A	X Walk 2 Width (In)	144.0	N/A	DWS 2 Length (In)	N/A

N/A	Road 2 Slope (%)	1.8	N/A	DWS 2 Full Width?	N/A
N/A	Road 2 X Slope (%)	0.1	N/A	DWS 2 Offset (In)	N/A
N/A	Refuge 3 Length (in)	N/A	N/A	Gutter 3 Ponding?	N/A
N/A	Refuge 3 Width (in)	N/A	N/A	Gutter 3 Lip Ht (in)	N/A
N/A	Refuge 3 Slope (%)	N/A	N/A	Gutter 3 Slope (%)	N/A
N/A	Refuge 3 XSlope (%)	N/A	N/A	Gutter 3 XSlope (%)	N/A
N/A	Painted X Walk3?	N/A	N/A	DWS 3 Provided?	N/A
N/A	X Walk 3 Direction	N/A	N/A	DWS 3 Contrast?	N/A
N/A	X Walk 3 Width (in)	N/A	N/A	DWS 3 Length (in)	N/A
N/A	Road 3 Slope (%)	N/A	N/A	DWS 3 Full Width?	N/A
N/A	Road 3 XSlope (%)	N/A	N/A	DWS 3 Offset (in)	N/A
Yes	Any Obstructions?	N/A	N/A	Storm Grate/Utility Hazard?	N/A
N/A	Obstruction Type		N/A	Storm Grate/Utility Type	
		N/A			N/A
N/A	Surface Condition	Good

Possible Solutions:

Remove & Replace Entire Refuge.
