Access Compliance Report

Public Rights-of-Way

(Island Curb Cuts)

Intersection ID: 12427	Main Street: S GRAHAM ST	Cross Street: S MINT ST	Location: N
ADA ID: D29620750F1F	Curb Cut Type: IslandRefuge3	Initial Pass/Fail: Fail	Overall Compliance: No
Codes/Mitigation Info/Possible Solution		Field Measurements/Component Compliance

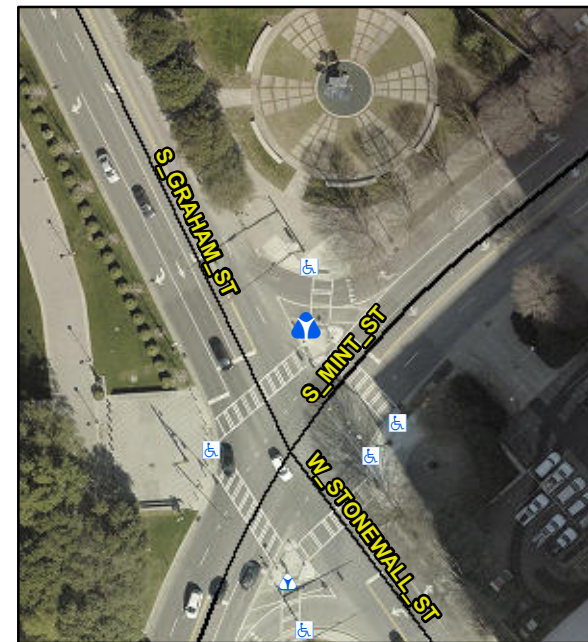
Compliance	Description	Data	Compliance	Description	Data
No	Refuge 1 Length (In)	24.0	N/A	Gutter 1 Ponding?	N/A
Yes	Refuge 1 Width (In)	97.0	N/A	Gutter 1 Lip Ht (In)	N/A
Yes	Refuge 1 Slope (%)	0.1	N/A	Gutter 1 Slope (%)	N/A
Yes	Refuge 1 X Slope (%)	1.6	N/A	Gutter 1 X Slope (%)	N/A
N/A	Painted X Walk1?	Yes	N/A	DWS 1 Provided?	N/A
N/A	X Walk 1 Direction	To SE	N/A	DWS 1 Contrast?	N/A
N/A	X Walk 1 Width (In)	110.0	N/A	DWS 1 Length (In)	N/A
N/A	Road 1 Slope (%)	0.3	N/A	DWS 1 Full Width?	N/A
N/A	Road 1 X Slope (%)	0.9	N/A	DWS 1 Offset (In)	N/A
No	Refuge 2 Length (In)	24.0	N/A	Gutter 2 Ponding?	N/A
Yes	Refuge 2 Width (In)	96.0	N/A	Gutter 2 Lip Ht (In)	N/A
Yes	Refuge 2 Slope (%)	2.6	N/A	Gutter 2 Slope (%)	N/A
Yes	Refuge 2 X Slope (%)	0.4	N/A	Gutter 2 X Slope (%)	N/A
N/A	Painted X Walk2?	Yes	N/A	DWS 2 Provided?	N/A
N/A	X Walk 2 Direction	To SW	N/A	DWS 2 Contrast?	N/A
N/A	X Walk 2 Width (In)	108.0	N/A	DWS 2 Length (In)	N/A

N/A	Road 2 Slope (%)	1.0	N/A	DWS 2 Full Width?	N/A
N/A	Road 2 X Slope (%)	0.1	N/A	DWS 2 Offset (In)	N/A
No	Refuge 3 Length (in)	27.0	N/A	Gutter 3 Ponding?	N/A
Yes	Refuge 3 Width (in)	96.0	N/A	Gutter 3 Lip Ht (in)	N/A
Yes	Refuge 3 Slope (%)	0.4	N/A	Gutter 3 Slope (%)	N/A
Yes	Refuge 3 XSlope (%)	3.2	N/A	Gutter 3 XSlope (%)	N/A
N/A	Painted X Walk3?	Yes	N/A	DWS 3 Provided?	N/A
N/A	X Walk 3 Direction	To N	N/A	DWS 3 Contrast?	N/A
N/A	X Walk 3 Width (in)	112.0	N/A	DWS 3 Length (in)	N/A
N/A	Road 3 Slope (%)	2.0	N/A	DWS 3 Full Width?	N/A
N/A	Road 3 XSlope (%)	2.6	N/A	DWS 3 Offset (in)	N/A
Yes	Any Obstructions?	N/A	N/A	Storm Grate/Utility Hazard?	N/A
N/A	Obstruction Type		N/A	Storm Grate/Utility Type	
		N/A			N/A
N/A	Surface Condition	Good

Possible Solutions:

Remove & Replace Entire Refuge.
