Access Compliance Report Public Rights-of-Way (Island Curb Cuts)

Main Street: FREEDOM DR **Cross Street: MARLENE ST** Location: Intersection ID: 9325 N/A **Curb Cut Type: MedianRefuge2** Initial Pass/Fail: Fail **Overall Compliance: No** ADA ID: D42B67F794A9 Severity Score: 13.75

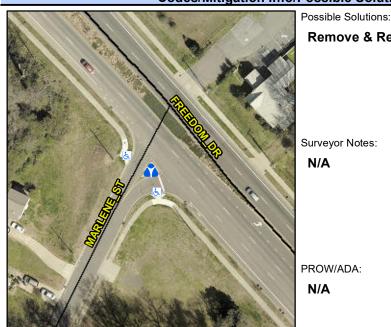
rieid Measur	ements/Cor	nponent Compilance
Com	pliance Description	Data Co	ompliance Description
No	Refuge 1 Length (In)	32.0 N/	A Gutter 1 Ponding?
Yes	Refuge 1 Width (In)	72.0 N/	A Gutter 1 Lip Ht (In)
Yes	Refuge 1 Slope (%)	0.5 N/	A Gutter 1 Slope (%)
Yes	Refuge 1 X Slope (%)	4.3 N/	A Gutter 1 X Slope (%)
N/A	Painted X Walk1?	No N/	A DWS 1 Provided?
N/A	X Walk 1 Direction	To S N/	A DWS 1 Contrast?
N/A	X Walk 1 Width (In)	N/A N/	A DWS 1 Length (In)
N/A	Road 1 Slope (%)	5.7 N/	A DWS 1 Full Width?
N/A	Road 1 X Slope (%)	4.0 N/	A DWS 1 Offset (In)
No	Refuge 2 Length (In)	32.0 N/	A Gutter 2 Ponding?
Yes	Refuge 2 Width (In)	72.0 N/	A Gutter 2 Lip Ht (In)
Yes	Refuge 2 Slope (%)	3.4 N/	A Gutter 2 Slope (%)
No	Refuge 2 X Slope (%)	5.3 N/	A Gutter 2 X Slope (%)
N/A	Painted X Walk2?	No N/	A DWS 2 Provided?
N/A	X Walk 2 Direction	To N N/	A DWS 2 Contrast?
N/A	X Walk 2 Width (In)	N/A N/	A DWS 2 Length (In)
N/A	Road 2 Slope (%)	5.4 N/	A DWS 2 Full Width?

N/A	Road 2 X Slope (%)	0.4 N/	A DWS 2 Offset (In)
N/A	Refuge 3 Length (in)	N/A N/	A Gutter 3 Ponding?
N/A	Refuge 3 Width (in)	N/A N/	A Gutter 3 Lip Ht (in)
N/A	Refuge 3 Slope (%)	N/A N/	A Gutter 3 Slope (%)
N/A	Refuge 3 XSlone (%)	N/A N/	A Gutter 3 XSlone (%)

Remove & Replace Entire Refuge.
