# Access Compliance Report

## Public Rights-of-Way

### (Island Curb Cuts)

Intersection ID: 10016842	Main Street: N_TRYON_ST	Cross Street: N/A	Location: W
ADA ID: D9401EB2EC1D	Curb Cut Type: MedianRefuge2	Initial Pass/Fail: Pass	Overall Compliance: Yes
Codes/Mitigation Info/Possible Solution		Field Measurements/Component Compliance	
Severity Score: 0.25

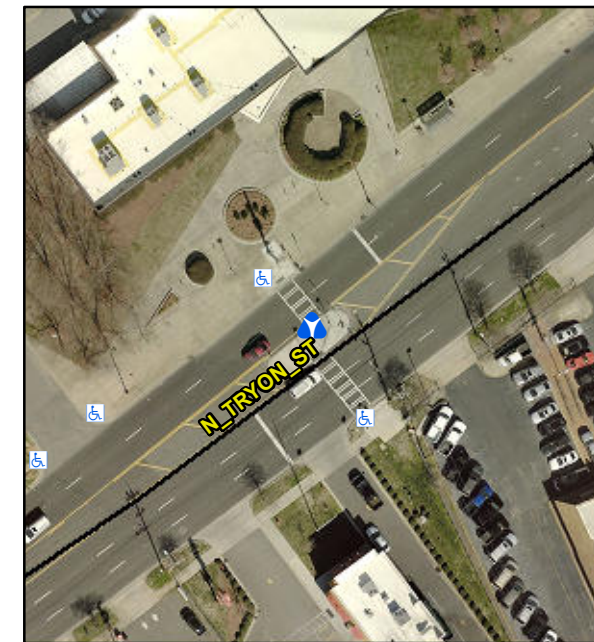
Compliance	Description	Data	Compliance	Description	Data
Yes	Refuge 1 Length (In)	91.0	Yes	Gutter 1 Ponding?	No
Yes	Refuge 1 Width (In)	96.0	Yes	Gutter 1 Lip Ht (In)	0.0
Yes	Refuge 1 Slope (%)	3.3	Yes	Gutter 1 Slope (%)	2.4
Yes	Refuge 1 X Slope (%)	0.6	Yes	Gutter 1 X Slope (%)	0.2
N/A	Painted X Walk1?	No	Yes	DWS 1 Provided?	Yes
N/A	X Walk 1 Direction	To NW	Yes	DWS 1 Contrast?	Yes
N/A	X Walk 1 Width (In)	N/A	Yes	DWS 1 Length (In)	24.0
N/A	Road 1 Slope (%)	0.6	Yes	DWS 1 Full Width?	Yes
N/A	Road 1 X Slope (%)	1.8	Yes	DWS 1 Offset (In)	0.0
Yes	Refuge 2 Length (In)	91.0	Yes	Gutter 2 Ponding?	No
Yes	Refuge 2 Width (In)	96.0	Yes	Gutter 2 Lip Ht (In)	0.0
Yes	Refuge 2 Slope (%)	2.3	Yes	Gutter 2 Slope (%)	2.9
Yes	Refuge 2 X Slope (%)	0.1	Yes	Gutter 2 X Slope (%)	0.1
N/A	Painted X Walk2?	No	Yes	DWS 2 Provided?	Yes
N/A	X Walk 2 Direction	To SE	Yes	DWS 2 Contrast?	Yes
N/A	X Walk 2 Width (In)	N/A	Yes	DWS 2 Length (In)	24.0

N/A	Road 2 Slope (%)	0.1	Yes	DWS 2 Full Width?	Yes
N/A	Road 2 X Slope (%)	3.1	Yes	DWS 2 Offset (In)	0.0
N/A	Refuge 3 Length (in)	N/A	N/A	Gutter 3 Ponding?	N/A
N/A	Refuge 3 Width (in)	N/A	N/A	Gutter 3 Lip Ht (in)	N/A
N/A	Refuge 3 Slope (%)	N/A	N/A	Gutter 3 Slope (%)	N/A
N/A	Refuge 3 XSlope (%)	N/A	N/A	Gutter 3 XSlope (%)	N/A
N/A	Painted X Walk3?	N/A	N/A	DWS 3 Provided?	N/A
N/A	X Walk 3 Direction	N/A	N/A	DWS 3 Contrast?	N/A
N/A	X Walk 3 Width (in)	N/A	N/A	DWS 3 Length (in)	N/A
N/A	Road 3 Slope (%)	N/A	N/A	DWS 3 Full Width?	N/A
N/A	Road 3 XSlope (%)	N/A	N/A	DWS 3 Offset (in)	N/A
Yes	Any Obstructions?	No	N/A	Storm Grate/Utility Hazard?	No
N/A	Obstruction Type		N/A	Storm Grate/Utility Type	
		N/A			N/A
N/A	Surface Condition	Good

Possible Solutions:

N/A
