Access Compliance Report

Public Rights-of-Way

(Island Curb Cuts)

Intersection ID: 10032944	Main Street: NEW_FASHION_WY	Cross Street: N/A	Location: SW
ADA ID: D942FBD22417	Curb Cut Type: MedianRefuge2	Initial Pass/Fail: Fail	Overall Compliance: No
Severity Score: 12.5			
Codes/Mitigation Info/Possible Solution		Field Measurements/Component Compliance

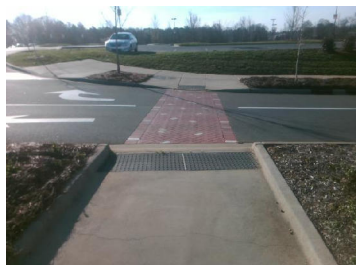
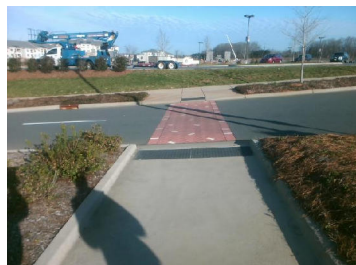
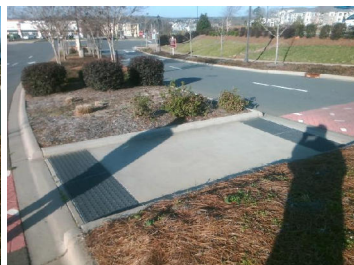
Compliance	Description	Data	Compliance	Description	Data
Yes	Refuge 1 Length (In)	88.5	N/A	Gutter 1 Ponding?	N/A
Yes	Refuge 1 Width (In)	91.0	N/A	Gutter 1 Lip Ht (In)	N/A
Yes	Refuge 1 Slope (%)	0.8	N/A	Gutter 1 Slope (%)	N/A
No	Refuge 1 X Slope (%)	7.5	N/A	Gutter 1 X Slope (%)	N/A
N/A	Painted X Walk1?	Yes	N/A	DWS 1 Provided?	N/A
N/A	X Walk 1 Direction	To SE	N/A	DWS 1 Contrast?	N/A
N/A	X Walk 1 Width (In)	80.0	N/A	DWS 1 Length (In)	N/A
N/A	Road 1 Slope (%)	7.1	N/A	DWS 1 Full Width?	N/A
N/A	Road 1 X Slope (%)	3.0	N/A	DWS 1 Offset (In)	N/A
Yes	Refuge 2 Length (In)	88.5	N/A	Gutter 2 Ponding?	N/A
Yes	Refuge 2 Width (In)	91.0	N/A	Gutter 2 Lip Ht (In)	N/A
Yes	Refuge 2 Slope (%)	0.9	N/A	Gutter 2 Slope (%)	N/A
No	Refuge 2 X Slope (%)	8.3	N/A	Gutter 2 X Slope (%)	N/A
N/A	Painted X Walk2?	Yes	N/A	DWS 2 Provided?	N/A
N/A	X Walk 2 Direction	To NW	N/A	DWS 2 Contrast?	N/A
N/A	X Walk 2 Width (In)	80.0	N/A	DWS 2 Length (In)	N/A

Possible Solutions:

Remove & Replace Entire Refuge.
