# Access Compliance Report

## Public Rights-of-Way

### (Island Curb Cuts)

Intersection ID: 10036505	Main Street: ROZZELLES_FERRY_RD	Cross Street: N/A	Location: W
ADA ID: D9B00AC90F9E	Curb Cut Type: MedianRefuge2	Initial Pass/Fail: Fail	Overall Compliance: No
Codes/Mitigation Info/Possible Solution		Field Measurements/Component Compliance	
Severity Score: 10

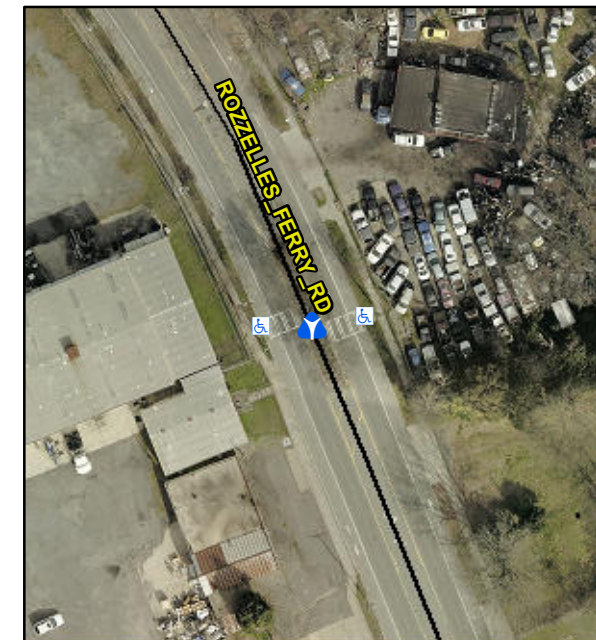
Compliance	Description	Data	Compliance	Description	Data
Yes	Refuge 1 Length (In)	92.5	N/A	Gutter 1 Ponding?	N/A
No	Refuge 1 Width (In)	50.0	N/A	Gutter 1 Lip Ht (In)	N/A
Yes	Refuge 1 Slope (%)	2.8	N/A	Gutter 1 Slope (%)	N/A
Yes	Refuge 1 X Slope (%)	2.7	N/A	Gutter 1 X Slope (%)	N/A
N/A	Painted X Walk1?	Yes	N/A	DWS 1 Provided?	N/A
N/A	X Walk 1 Direction	To W	N/A	DWS 1 Contrast?	N/A
N/A	X Walk 1 Width (In)	111.0	N/A	DWS 1 Length (In)	N/A
N/A	Road 1 Slope (%)	3.4	N/A	DWS 1 Full Width?	N/A
N/A	Road 1 X Slope (%)	1.8	N/A	DWS 1 Offset (In)	N/A
Yes	Refuge 2 Length (In)	92.5	N/A	Gutter 2 Ponding?	N/A
No	Refuge 2 Width (In)	50.0	N/A	Gutter 2 Lip Ht (In)	N/A
Yes	Refuge 2 Slope (%)	3.2	N/A	Gutter 2 Slope (%)	N/A
Yes	Refuge 2 X Slope (%)	3.5	N/A	Gutter 2 X Slope (%)	N/A
N/A	Painted X Walk2?	Yes	N/A	DWS 2 Provided?	N/A
N/A	X Walk 2 Direction	To E	N/A	DWS 2 Contrast?	N/A
N/A	X Walk 2 Width (In)	121.0	N/A	DWS 2 Length (In)	N/A

**Remove & Replace Entire Refuge.**

**\$ 3000.00**

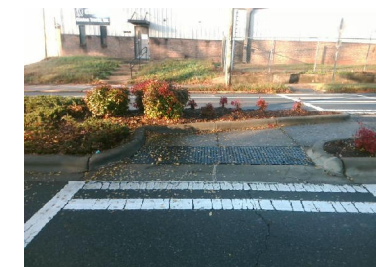
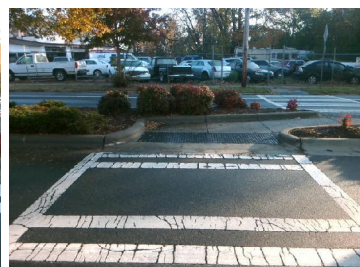
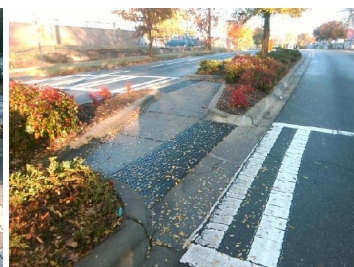
N/A	Road 2 Slope (%)	4.1	N/A	DWS 2 Full Width?	N/A
N/A	Road 2 X Slope (%)	1.7	N/A	DWS 2 Offset (In)	N/A
N/A	Refuge 3 Length (in)	N/A	N/A	Gutter 3 Ponding?	N/A
N/A	Refuge 3 Width (in)	N/A	N/A	Gutter 3 Lip Ht (in)	N/A
N/A	Refuge 3 Slope (%)	N/A	N/A	Gutter 3 Slope (%)	N/A
N/A	Refuge 3 XSlope (%)	N/A	N/A	Gutter 3 XSlope (%)	N/A
N/A	Painted X Walk3?	N/A	N/A	DWS 3 Provided?	N/A
N/A	X Walk 3 Direction	N/A	N/A	DWS 3 Contrast?	N/A
N/A	X Walk 3 Width (in)	N/A	N/A	DWS 3 Length (in)	N/A
N/A	Road 3 Slope (%)	N/A	N/A	DWS 3 Full Width?	N/A
N/A	Road 3 XSlope (%)	N/A	N/A	DWS 3 Offset (in)	N/A
Yes	Any Obstructions?	N/A	N/A	Storm Grate/Utility Hazard?	N/A
N/A	Obstruction Type		N/A	Storm Grate/Utility Type	
		N/A			N/A
N/A	Surface Condition	Good
