# Access Compliance Report

## Public Rights-of-Way

### (Island Curb Cuts)

Intersection ID: 23966	Main Street: CAROLINA_PAVILION_DR_N	Cross Street: SOUTH_BV	Location: N
ADA ID: DA12612220E2	Curb Cut Type: MedianRefuge2	Initial Pass/Fail: Fail	Overall Compliance: No
Codes/Mitigation Info/Possible Solution		Field Measurements/Component Compliance

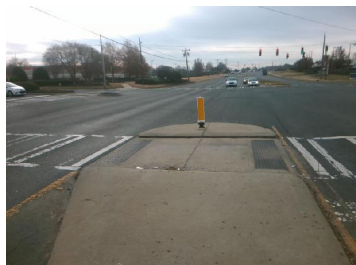
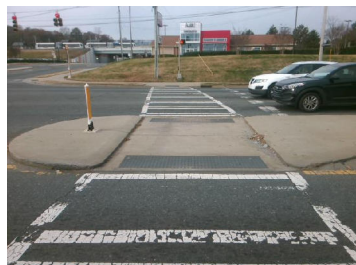
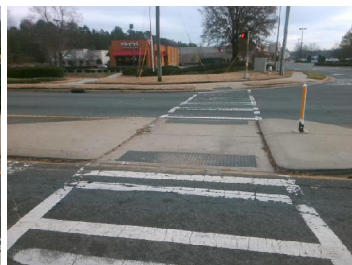
Compliance	Description	Data	Compliance	Description	Data
Yes	Refuge 1 Length (In)	85.0	N/A	Gutter 1 Ponding?	N/A
Yes	Refuge 1 Width (In)	120.0	N/A	Gutter 1 Lip Ht (In)	N/A
Yes	Refuge 1 Slope (%)	0.0	N/A	Gutter 1 Slope (%)	N/A
Yes	Refuge 1 X Slope (%)	2.3	N/A	Gutter 1 X Slope (%)	N/A
N/A	Painted X Walk1?	Yes	N/A	DWS 1 Provided?	N/A
N/A	X Walk 1 Direction	To W	N/A	DWS 1 Contrast?	N/A
N/A	X Walk 1 Width (In)	116.0	N/A	DWS 1 Length (In)	N/A
N/A	Road 1 Slope (%)	0.6	N/A	DWS 1 Full Width?	N/A
N/A	Road 1 X Slope (%)	1.5	N/A	DWS 1 Offset (In)	N/A
Yes	Refuge 2 Length (In)	85.0	N/A	Gutter 2 Ponding?	N/A
Yes	Refuge 2 Width (In)	120.0	N/A	Gutter 2 Lip Ht (In)	N/A
Yes	Refuge 2 Slope (%)	2.5	N/A	Gutter 2 Slope (%)	N/A
Yes	Refuge 2 X Slope (%)	0.8	N/A	Gutter 2 X Slope (%)	N/A
N/A	Painted X Walk2?	Yes	N/A	DWS 2 Provided?	N/A
N/A	X Walk 2 Direction	To E	N/A	DWS 2 Contrast?	N/A
N/A	X Walk 2 Width (In)	113.0	N/A	DWS 2 Length (In)	N/A

N/A	Road 2 Slope (%)	0.5	N/A	DWS 2 Full Width?	N/A
N/A	Road 2 X Slope (%)	2.5	N/A	DWS 2 Offset (In)	N/A
N/A	Refuge 3 Length (in)	N/A	N/A	Gutter 3 Ponding?	N/A
N/A	Refuge 3 Width (in)	N/A	N/A	Gutter 3 Lip Ht (in)	N/A
N/A	Refuge 3 Slope (%)	N/A	N/A	Gutter 3 Slope (%)	N/A
N/A	Refuge 3 XSlope (%)	N/A	N/A	Gutter 3 XSlope (%)	N/A
N/A	Painted X Walk3?	N/A	N/A	DWS 3 Provided?	N/A
N/A	X Walk 3 Direction	N/A	N/A	DWS 3 Contrast?	N/A
N/A	X Walk 3 Width (in)	N/A	N/A	DWS 3 Length (in)	N/A
N/A	Road 3 Slope (%)	N/A	N/A	DWS 3 Full Width?	N/A
N/A	Road 3 XSlope (%)	N/A	N/A	DWS 3 Offset (in)	N/A
Yes	Any Obstructions?	N/A	N/A	Storm Grate/Utility Hazard?	N/A
N/A	Obstruction Type		N/A	Storm Grate/Utility Type	
		N/A			N/A
N/A	Surface Condition	Good

**Remove & Replace Entire Refuge.**
